**Canadian Natural Resources Limited  
GENERAL PRESSURE VESSEL INFORMATION**

**Job # 10.113190**

<b>District: GP South</b>		<b>Skid No. 58757</b>				
<b>Facility: Hamburg Water injection</b>		<b>Location (LSD): 13-20-96-09 W6M</b>				
<b>Vessel Name &amp; Equipment Number: Free Water Knock Out</b>						
<b>Orientation: Horizontal</b>						
<b>Status: In Service</b>		<b>Regulatory Inspection</b>				
<b>PRESSURE VESSEL NAMEPLATE DATA</b>						
"A" or "G" or "S" (Sask.) or BC Registration Number. <b>A0435016</b>		CRN Number <b>A 2352.32</b>				
Vessel serial number: 2040 V100		Size: 8 ft x 38 ft approx				
Shell thickness: 31.7 mm		Shell material: SA 516 70N				
Head thickness: 30.7 mm		Head material: SA 516 70N				
Tube wall thickness:		Tube material:				
Tube diameter:		Tube length:				
Channel thickness:		Channel material:				
Design pressure	Shell: 2779 (403 psi)	Operating pressure	Shell:			
	Tubes:		Tubes:			
Design Temp.	Shell: 38°C	Operating temperature	Shell:			
	Tubes:		Tubes:			
X-ray: RT-1		Heat treatment: No

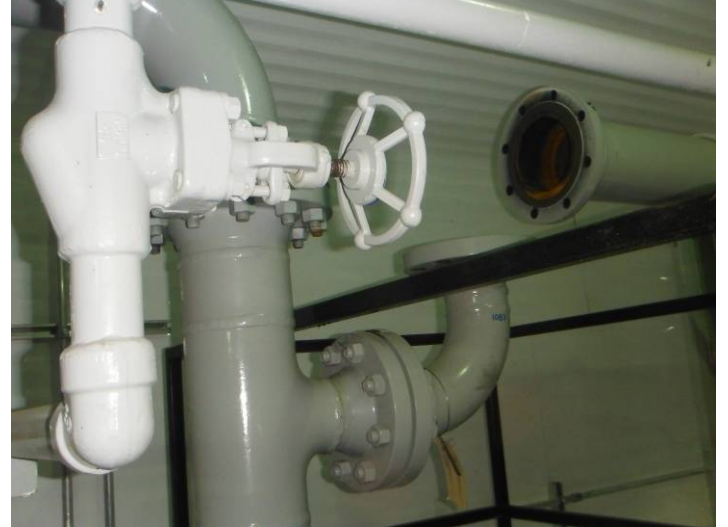
<b>Valving</b> Ensure no leaks are visible. Valves are properly supported and chained if necessary.		X			<b>All valves are well supported. Liquid seepage at pressure gauge valve.</b>
<b>PSV</b> Ensure PSV is set at pressure at or below that of vessel. Discharge piping is same size as inlet to valve and is properly supported and routed. Ensure no block valves between psv and vessel or if there are they are locked open.	X				<b>Located on inlet piping – removed for service No block valve between vessel and PSV.</b>
<b>NDE methods</b> Was UT/ MPI done on vessel (MI coordinator to review results)	X				<b>Ultrasonic corrosion survey carried out – pipe metal thickness detected below nominal minus corrosion allowance. Thickness calculations carried out: 3” Elbow – nominal thickness is 5.5mm / min thickness is 4.1mm / T min thickness is 1.6mm 4” Elbow – nominal thickness is 6.0mm / min thickness is 5.0mm / T min thickness is 1.6mm.</b>

Liquid seepage at pressure gauge valve

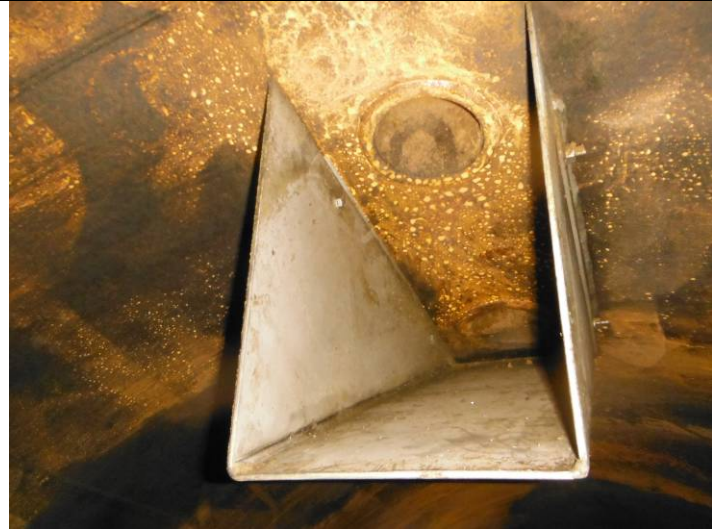
Internal Inspection Items	G	F	P	N/A	Comments
<b>Coating</b> Assess coating. Describe area coated, general condition of coating.				X	Vessel is not internally coated.
<b>Anodes.</b> How many, type, condition. % consumed. Are they being replaced?			X		Two anodes consumed 95% and 25% consumed. Will be replaced.
<b>Internal Piping</b> Is there any? If so, carbon or stainless steel. Describe condition, dents, corrosion, erosion, etc. Ensure supports are secure and any bolts are suitable for future use.	X				4 inch gas draw stem piping is carbon steel and in good condition. No corrosion or mechanical damage.
<b>Vortex Breaker</b>	X				Three stainless steel vortex breakers are bolted in place and are in good condition.
<b>Baffles, deflector plates, Weir.</b> If present, describe condition. Look closely at welds attached to vessel wall.	X				Inlet deflector plate and weir plate are stainless steel and bolted securely to shell. No damage.

Inlet deflector

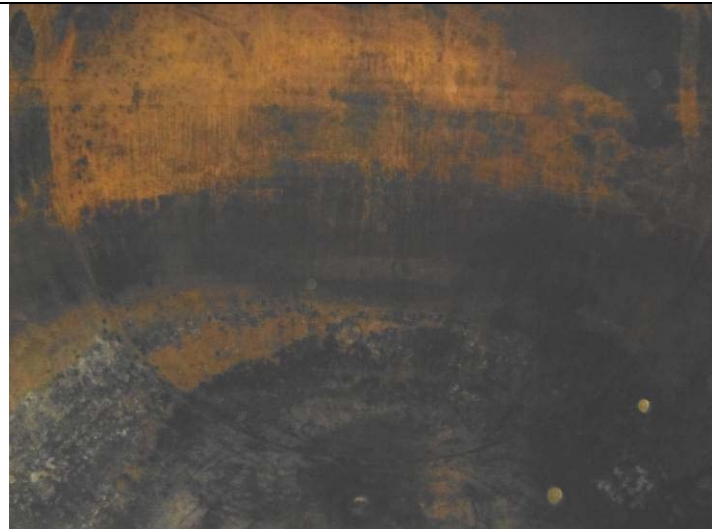
South head

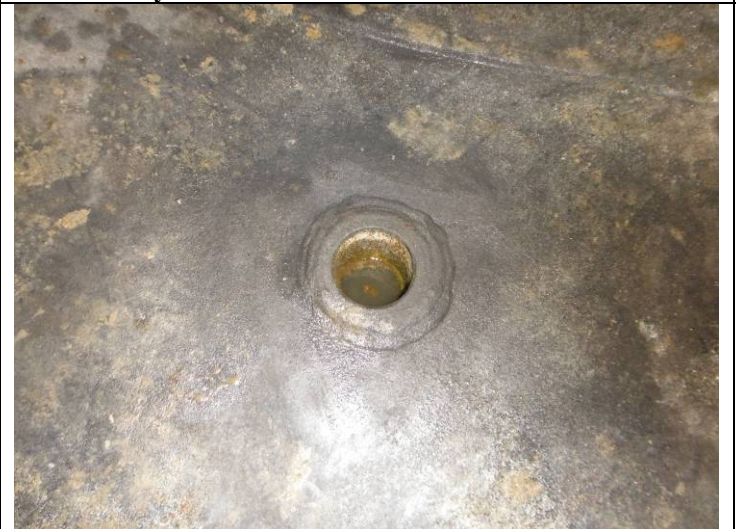
Bottom shell

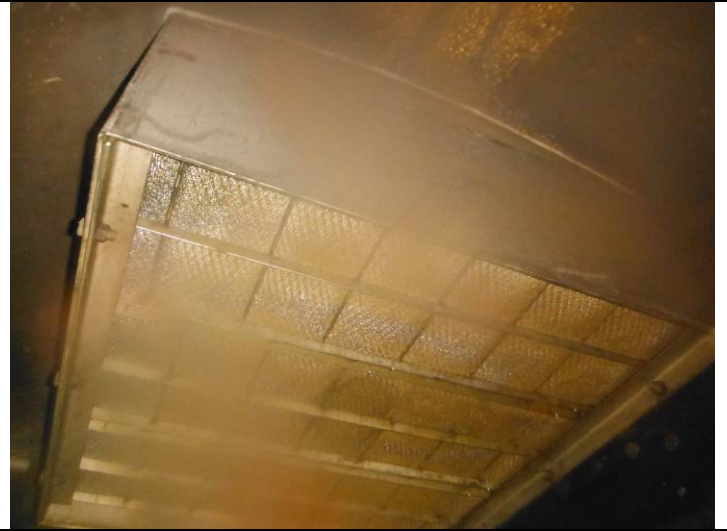
<b>Demister pad</b> Is it in place? Is it clean? If any corrosion is apparent in vessel, lift pad and check top head for corrosion.	X			<b>Demister pad was found clean and in good condition at the time of inspection.</b>
<b>Welds</b> Inspect all welds, including attachment welds. Record all service-related damages and if there is any discuss with Chief Inspector before closing.	X			<b>Welds were in good condition, no corrosion or mechanical damage at time of inspection.</b>
<b>Recommendations or corrective actions (indicate if fit for service)</b> <b>Recommendations: 1. Repair valve at pressure gauge. 2. Fill weld isolated pit on manway using an approved CNRL weld procedure.</b> <b>Summary:</b> Vessel is in overall good condition, visual external inspection, visual internal and ultrasonic corrosion survey performed – Manway metal thickness measured below nominal <u>nearing</u> corrosion allowance. One isolated pit identified at 14 inch manway throat. Nominal 12.7 mm. Measured pit depth to 0.110 inch (2.8 mm) deep. Long term corrosion rate based on greatest thickness loss (manway throat) 0.175 mm per year - Loss from new 2.8 mm. Retirement Date to “T”min is year 2044. Using MAWP of vessel, Maximum allowable working pressure of vessel. <b>June 27:</b> Pit was further excavated by REED Energy to remove corrosion and blended out to a max depth of 0.350 inch (8.9 mm). Nominal 12.7 mm – 8.9 mm removed = 3.8 mm remaining wall. <b>June 29:</b> Pit was fill-welded by REED Energy. MT inspection carried out on repair-No cracking detected. <b>Vessel is fit for service.</b>

Demister pad

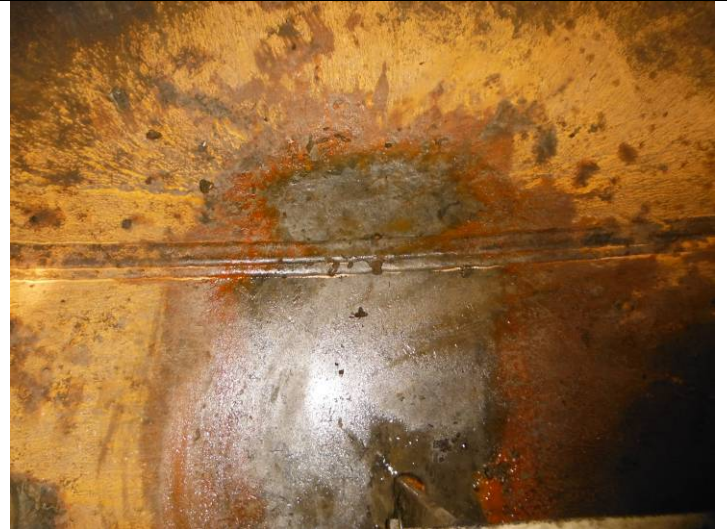
North head to shell weld 6:00 position

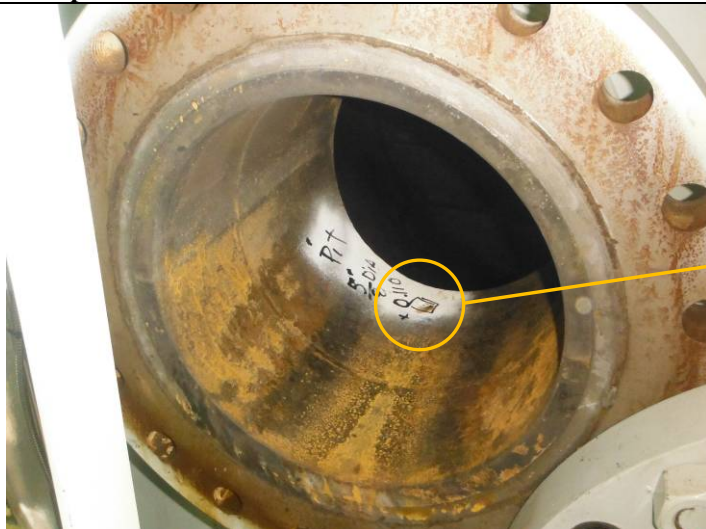
<b>Float</b> Check for restricted movement	X				None.
<b>North Head</b> Note all corrosion, erosion or mechanical damage. (If vessel is horizontal identify direction of this head)		X			Head is in good condition - No corrosion or mechanical damage. 14 inch manway throat: 1 isolated pit 5/8 inch dia. x 0.110 inch deep. No external UT access.
<b>South Head</b> Note all corrosion, erosion or mechanical damage. (If vessel is horizontal identify direction of this head)	X				Good condition - No corrosion or mechanical damage.
<b>Shell Sections</b> Record number of shell sections. Record location, size and depth of all erosion, corrosion or mechanical damage. Describe general condition. If any corrosion greater than corrosion allowance is observed in either shell or head, discuss with Chief Inspector before closing vessel.	X				4 shell sections in good condition. Thin, tight scale on throughout. No corrosion or mechanical damage.

North 14 inch manway - Isolated pit 5/8 inch dia. x 0.110 inch depth

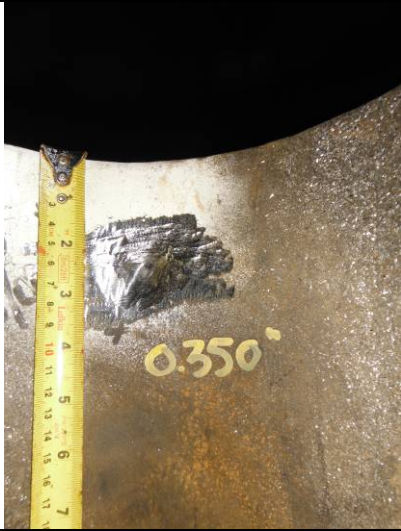
Pit excavated to 0.350 inch depth

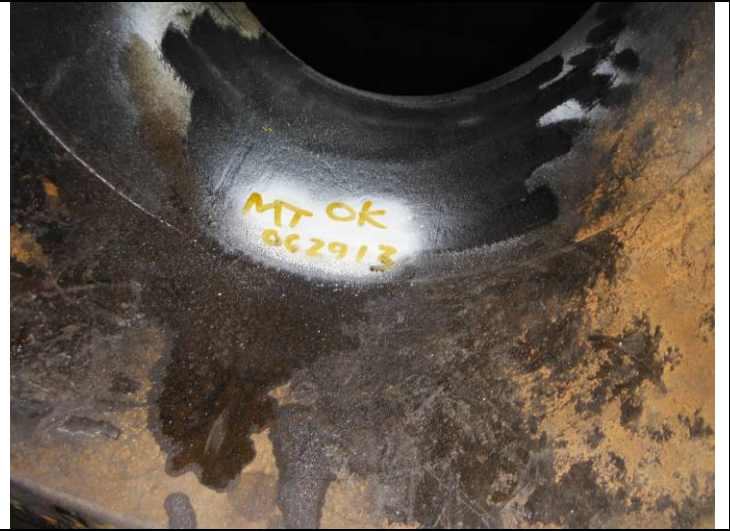
Final repair MT carried out – No cracking detected.
