GENERAL NDE REPORT				No. 001			
Date		Feb 20 2020	Page	1	of	4	
RTD Job #:		4016382					_

APPLUS RTD QUALITY SERVICES INC. #104, 11302 - 98 AVENUE ALBERTA, CANADA T8V 8H4 TEL: (780) 814-7227 FAX: (780) 402-3030  Client: Canadian Natural Resources Limited Address: 6744 airport road Fort St. John V1J-4M6 P.O.#: Client Rep.: Mandy Nelson  Description: Magnetic Particle/ Ultrasonic thickness inspection Surface Condition: Weldment Machined Painted Ground Sandblasted Other											
_		C PARTICLI	E INSPECTI Bench		Asset No · 1	2112 (	Calibration D	ue Date:	07/05/2020		
Equipment Type:											
⊠ U	LTRASON	NIC THICK	NESS MEAS	UREMENT							
Method: P/E Dual T/T Other Instrumentation: Manufacturer; Olympus RTD Ass Cal. Block(s): Type; IIW RTD Ass Couplant: Manufacturer; Magnaflux											
Probe Type	Angle	Frequency	Size	Reference Level (dB)	Scanning Level (dB)	Range	Skip Value	Beam Travel	Transfer Value (dB)		
Olympus	0°	5mhz	1/2"	80%		25mm					
				INSPECT	ION DETAI	LS					
Scope: Carry out Magnetic Particle on firetubes for free water knock out A0068932 Carry out Ultrasonic thickness inspection on firetubes for free water knock out A0068932  Ref: A0068932 Results: Ultrasonic thickn

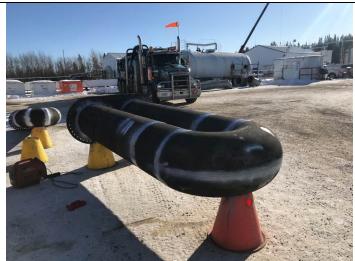
Overview of vessel
