**Canadian Natural Resources Limited
GENERAL PRESSURE VESSEL INFORMATION**

Job 4016101

District: Fort St. John, BC	Skid No.
Facility: Pee Jay Battery Nancy Unit # 3	Location (LSD): d-65-H / 94-A-15
Vessel Name Equipment Number: Free Water Knockout Drum	
Orientation: Horizontal	
Status: In Service	Regulatory Inspection

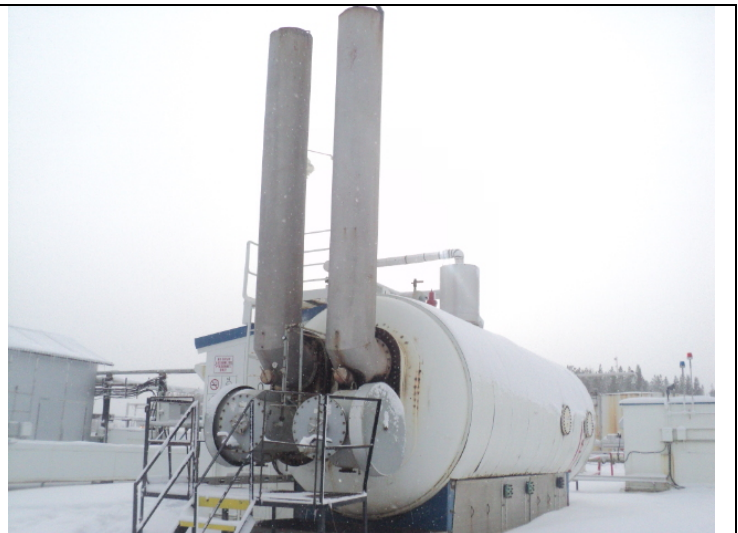
Overview North Head

External Inspection Items	G	F	P	N/A	Comments
Insulation Verify sealed around manways, nozzles, no damage present, and there is no egress of moisture.		X			Cladding in fair overall condition – no open or torn sections- minor exposed insulation on the north head due to no caulking and poor sealant – minor evidence of egress of moisture at 12 O'clock from openings in the roof
External Condition Assess paint condition, areas peeling, record any corrosion, damage, etc (record location, size and depth of corrosion or damage)		X			Paint in fair condition – minor flaking and peeling to less than 10% of shell surface concentrated at 12 O'clock - isolated areas with spotting external corrosion – pitting to 0.020 inch max
Leakage Record any leakage at flanges, threaded joints, weep holes on repads, etc.		X			Evidence of minor seepage detected at threaded connection to liquid level controller- causing external staining on side shell Evidence of minor seepage detected at inlet flange connection – causing external staining on side shell

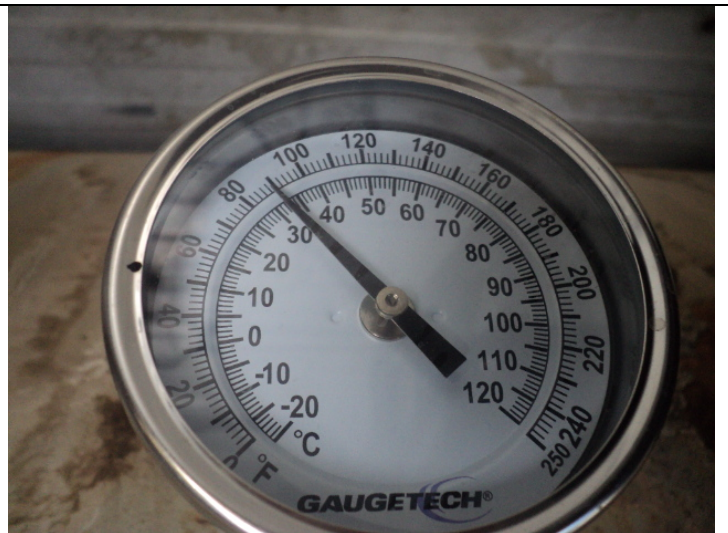
Temperature Gauge

Gauges Ensure gauges are visible, working, no leakage, and suitable for range of MAWP/ Temp.	X				Gauges are clear and functional – no leaks Suitable for MAWP: 50 – 400° F Suitable for MDMT: -20 - 120°C
External Piping Ensure pipe is well supported. All clamps, supports, shoes, etc. in place. Look for evidence of structural overload, deflection, etc. Paint condition, external corrosion?	X				Piping is well supported – all clamps in place – no evidence of structural overload or deflection – paint in good general condition – minor chipping – no corrosion or damage
Valving Ensure no leaks are visible. Valves are properly supported and chained if necessary.	X				No leaks detected – valves are properly supported
PSV Ensure PSV is set at pressure at or below that of vessel. Discharge piping is same size as inlet to valve and is properly supported and routed. Ensure no block valves between PSV and vessel or if there are they are locked open.	X				PSV is set at vessel MAWP - Discharge piping is same size as valve outlet and is properly supported and routed – seal is intact – no block valve – discharges to closed system.

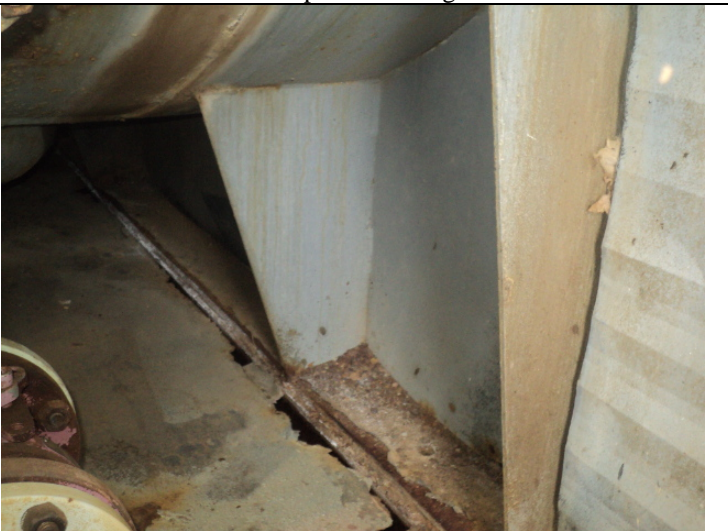
Saddle Assess condition of paint, fire protection, and concrete. Look for corrosion, buckling, dents, etc. Look at vessel surface area near supports. Verify no signs of leakage at attachment to vessel and attachment welds are acceptable. Ground wire attached?	X				Paint in good condition – no corrosion, buckling or dents – attachment welds are acceptable with no sign of leaks – ground wire attached to skid
Anchor Bolts Hammer tap to ensure secure. Look for cracking in treads or signs of deformation.	X				Vessel is securely welded to skid floor – no deformation
Concrete foundation Check for cracks, spalling, etc.				X	None
Ladder / Platform Describe general condition, ensure support is secure to vessel, and describe any hazards.				X	None
Nozzle Assess paint, look for leakage, and ensure stud threads are fully engaged. Record any damage, deflection, etc. Are nozzles gusseted?	X				Paint in good condition – no leaks – stud threads fully engaged – no damage or deflection – no gussets Isolated area on the inlet nozzle with spotting external corrosion – minor paint flaking.

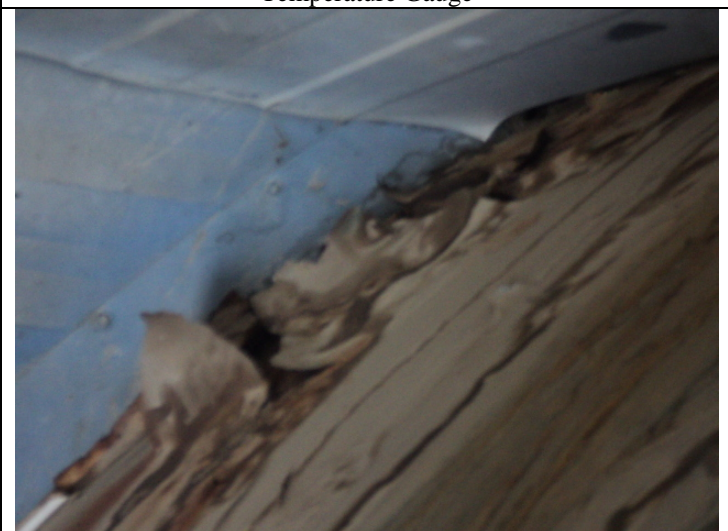
Paint peeling at 12 O'clock

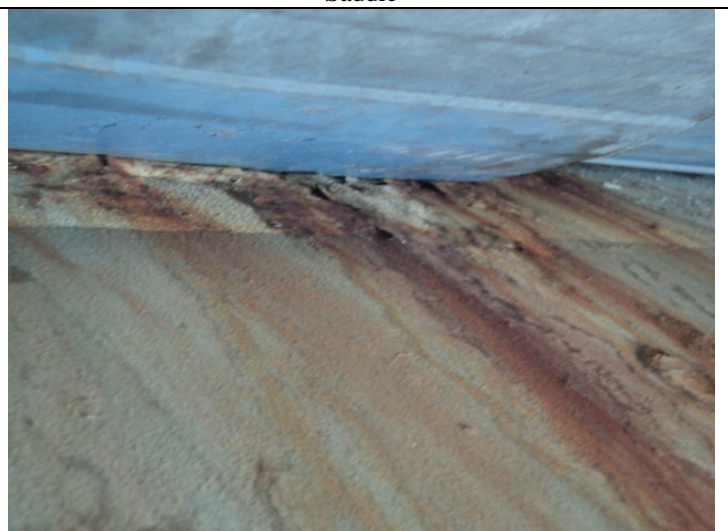
Shell at 12 O'clock

<p>NDE methods Was UT/ MPI done on vessel (MI coordinator to review results)</p>	<p>X</p>			<p>Ultrasonic corrosion survey carried out – shell and pipe metal thickness detected below nominal. Thickness calculations carried out: UT point 735 (shell) – nominal thickness is 9.5 mm / min thickness is 8.1 mm / T min thickness is 7.9mm UT point 795 (4” elbow) – nominal thickness is 8.6 mm / min thickness is 7.1 mm / T min thickness is 2.5 mm 3” Circ band - normal thickness is 7.6 mm/min thickness is 3.4 mm/T min thickness is 2.5mm.</p>
<p>Other</p>				
<p>Recommendations or corrective actions: (Vessel is Fit for Service or describe corrective actions required) (MIC to review corrective actions with Operations, discuss with Chief Inspector where necessary, and get remedial action implemented) Recommendations: 1) Recommend to address and correct areas of seepage at next maintenance opportunity Summary: This vessel is in good condition, visual external and ultrasonic thickness inspection carried out – shell and pipe metal thickness detected below nominal. Thickness calculations carried out to ensure sufficient metal exists for safe operation. Corrosion rate based, on greatest thickness loss (shell) 0.026mm per year. Retirement Date to “T”min is year 2028. Vessel is fit for service.</p>

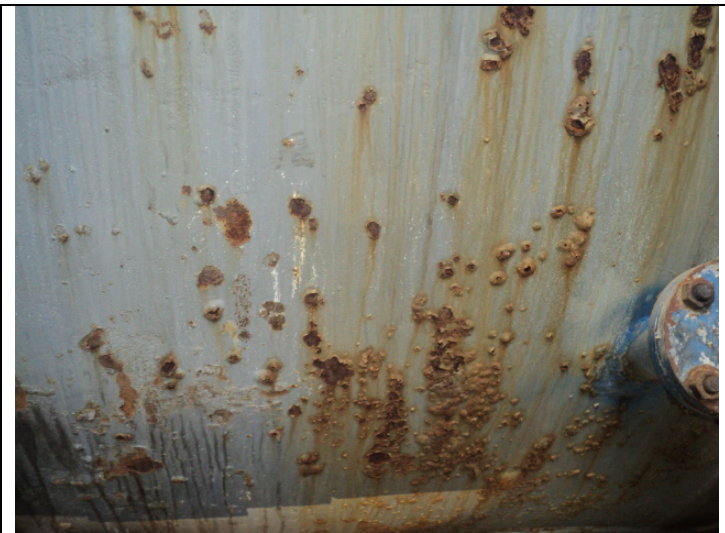
Spotting external corrosion on shell

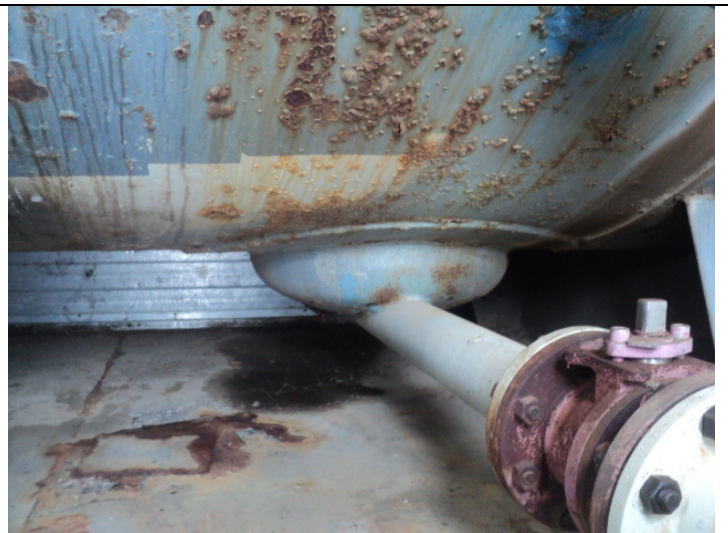
Spotting external corrosion on lower shell and boot

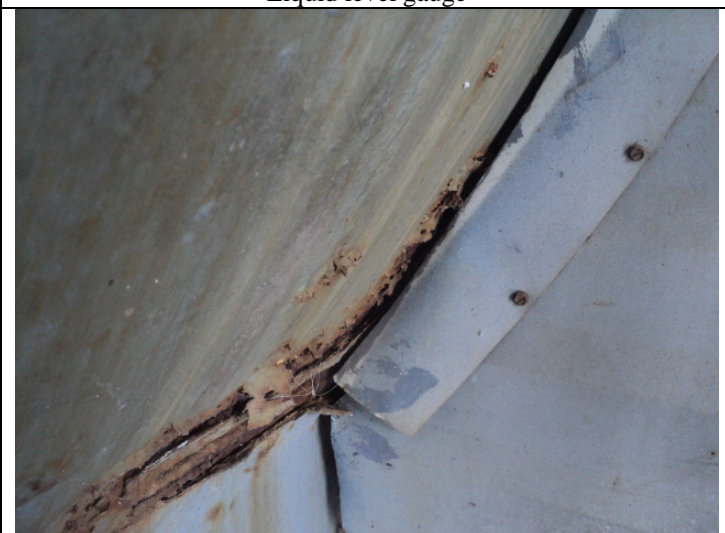
General condition of north head seal

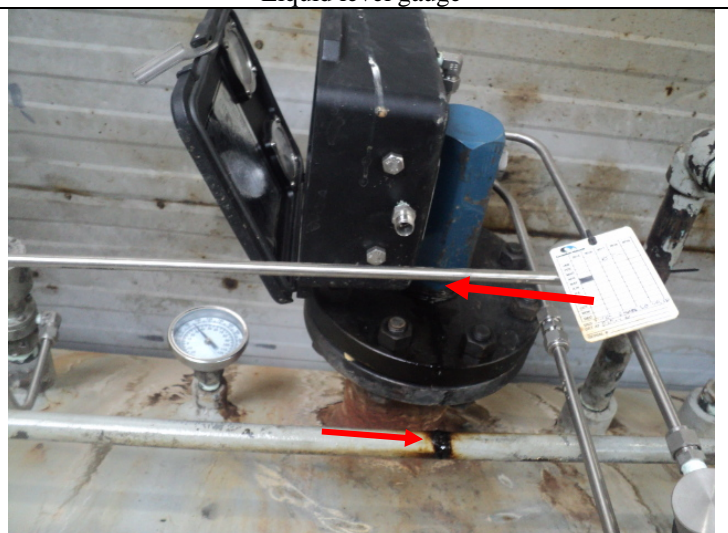
Liquid level gauge evidence of seepage at threaded connection

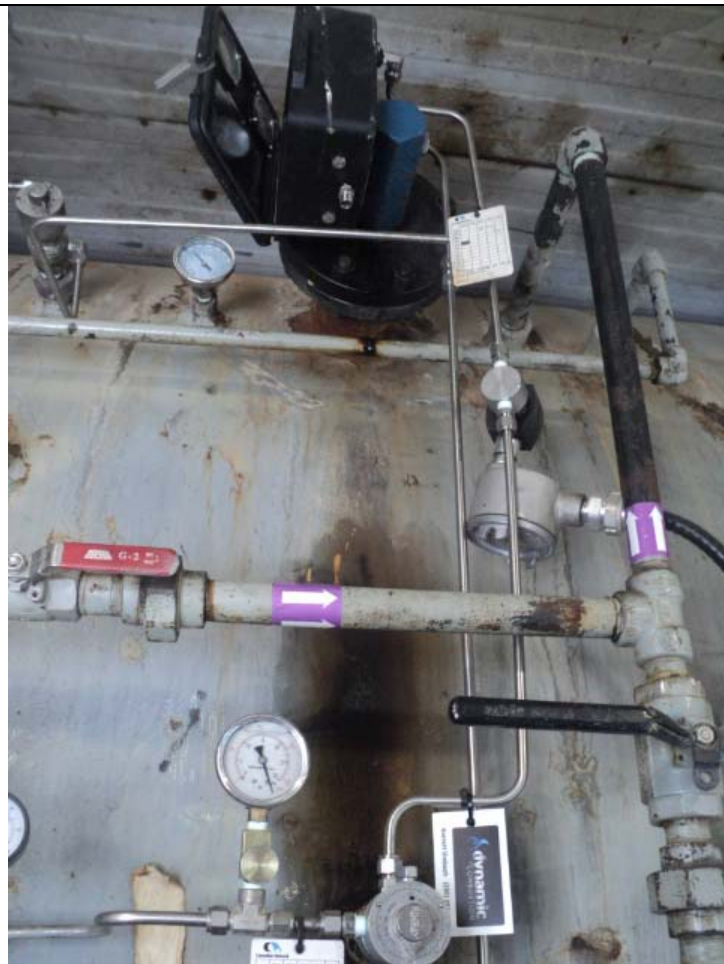
Evidence of external staining due to seepage

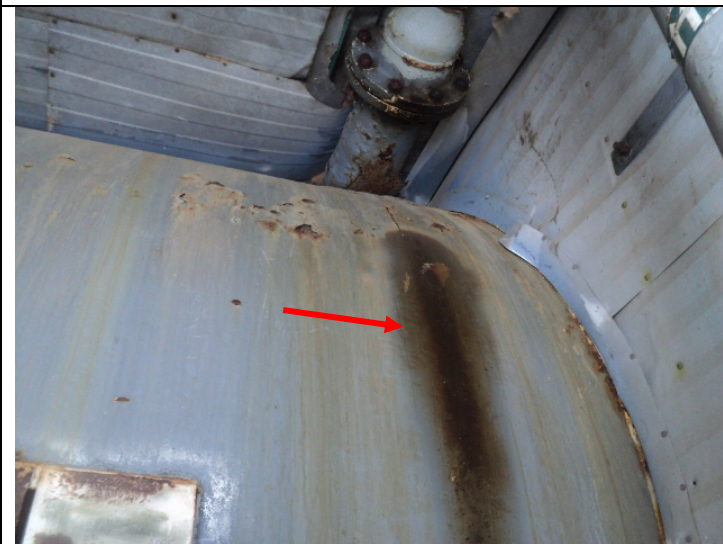
Evidence of external staining due to seepage
