**Canadian Natural Resources Limited  
GENERAL PRESSURE VESSEL INFORMATION**

**Job 10.112837**

District: <b>Fort St. John North</b>	Skid No.
Facility: <b>Chowade Gas Gathering</b>	Location (LSD): <b>b-49-L/94-B-09</b>
Vessel Name Equipment Number: <b>Flare Knock Out Drum</b>	
Orientation: <b>Horizontal</b>	
Status: <b>In Service</b>	<b>Regulatory Inspection</b>

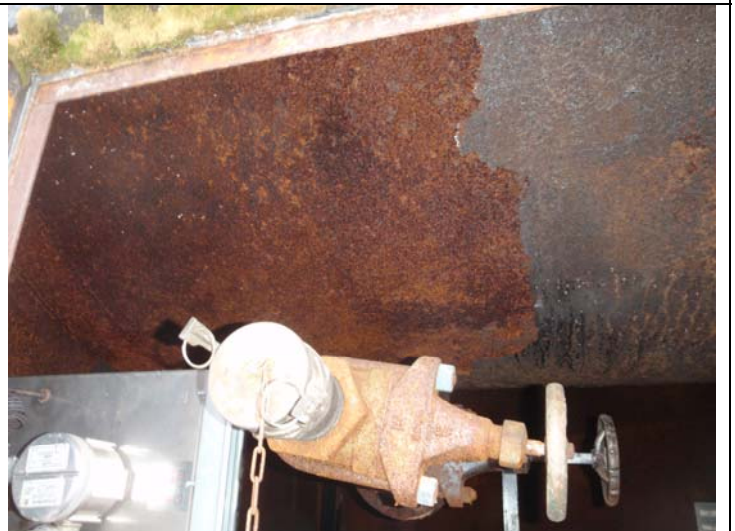
Under belly overview – Paint loss and surface corrosion to 100%
