**Canadian Natural Resources Limited  
GENERAL PRESSURE VESSEL INFORMATION**

**Job 10.112774**

District: <b>Fort St. John North</b>	Skid No.
Facility: <b>Adsett Water Injection Facility</b>	Location (LSD): <b>b-63-G/94-J-02</b>
Vessel Name Equipment Number: <b>Inlet Separator</b>	
Orientation: <b>Horizontal</b>	
Status: <b>Not In Service</b>	<b>Regulatory Inspection</b>

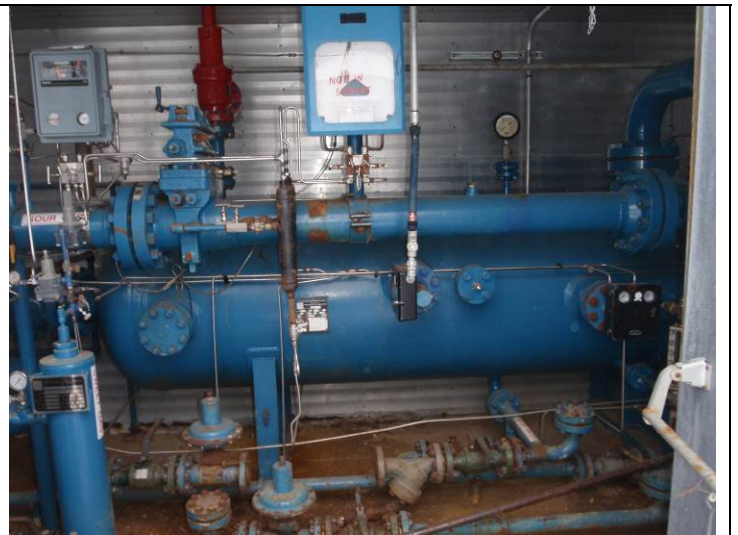
Overview

<b>External Inspection Items</b>	G	F	P	N/A	<b>Comments</b>
<b>Insulation</b> Verify sealed around manways, nozzles, no damage present, and there is no egress of moisture.				X	<b>Vessel not insulated</b>
<b>External Condition</b> Assess paint condition, areas peeling, record any corrosion, damage, etc (record location, size and depth of corrosion or damage)	X				<b>Paint in good overall condition – no exposed metal – no corrosion</b>
<b>Leakage</b> Record any leakage at flanges, threaded joints, weep holes on repads, etc.	X				<b>No leaks observed</b>
<b>Saddle/skirt</b> Assess condition of paint, fire protection, and concrete. Look for corrosion, buckling, dents, etc. Look at vessel surface area near supports. Verify no signs of leakage at attachment to vessel and attachment welds are acceptable. Ground wire attached?	X				<b>Saddle is in good condition – no corrosion or exposed metal – no buckling or dents – no sign of leaks at attachment welds – vessel is grounded through skid package</b>

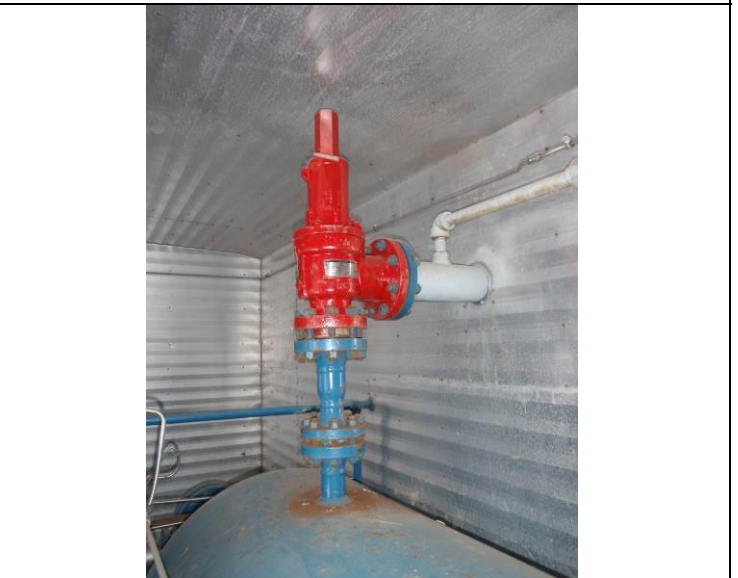
<b>Valving</b> Ensure no leaks are visible. Valves are properly supported and chained if necessary.					<b>Valves properly supported – no visible leaks</b>
<b>PSV</b> Ensure PSV is set at pressure at or below that of vessel.	X				<b>Located on outlet piping – set at MAWP of vessel. Seal intact – no block valve – discharge piping same size as outlet orifice.</b>
<b>NDE methods</b> Was UT/ MPI done on vessel (MI coordinator to review results)				X	<b>No NDE at this Time.</b>
<b>Other</b>					
<b>Recommendations or corrective actions : Vessel is Fit for Service or describe corrective actions required)</b> (MIC to review corrective actions with Operations, discuss with Chief Inspector where necessary, and get remedial action implemented) <b>Recommendations:</b> No recommendations at this time. <b>Summary: This vessel is in good condition, visual inspection carried.</b> <b>Vessel is fit for service.</b>
