# VESSEL INSPECTION SUMMARY

Report #: **137854-WF-1**  
Inspect Date: 05/28/2009  
Page: 1 of 2  
IRISNDT #: 137854

Client: CNRL District: Bonneville Heavy Oil Field: Frog Lake  
Facility: 06-32-055-03W4 Unit: N/A LSD: 06-32-055-03W4  
Jurisdiction #: A0218208 Equip Tag #: N/A Serial #: 26978A  
CRN #: C4936.23 Nat'l Bd #: N/A Year Built: 1985  
Manufacturer: Western Rockbit LTD Equipment Description: Propane Bullet  
Status: Out Of Service Date Removed From Service: Service: Unknown  
MAWP Shell 1724 kPa @ 66 °C Height/Length: 720 in. Code Stamp: ☒ Y ☐ N  
MAWP Tube Select @ Pick Size/Diameter: 108 in. O.D. Insulated: ☐ Y ☒ N  
Support Type: Saddle RT: 2 Volume: ft<sup>3</sup> / m<sup>3</sup> PWHT: ☐ Y ☒ N  
C.A. 0 Coated ☐ Y ☒ N Clad: ☐ Y ☒ N Manway: ☒ Y ☐ N

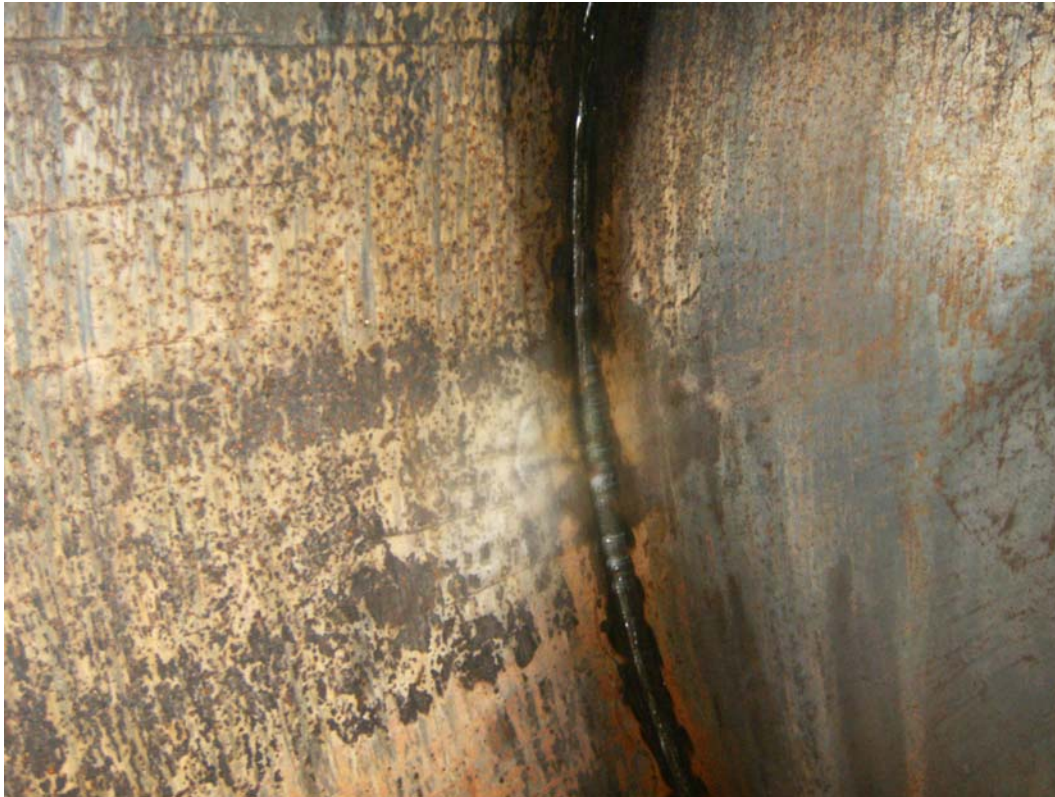
- The vessel was opened and cleaned for internal inspection.
- No corrosion, erosion or pitting is present on any internal components. Previous inspection and/or original fabrication markings are still visible on the shell walls.

A0218208\_Internal View of Shell-Good Condition\_28May09

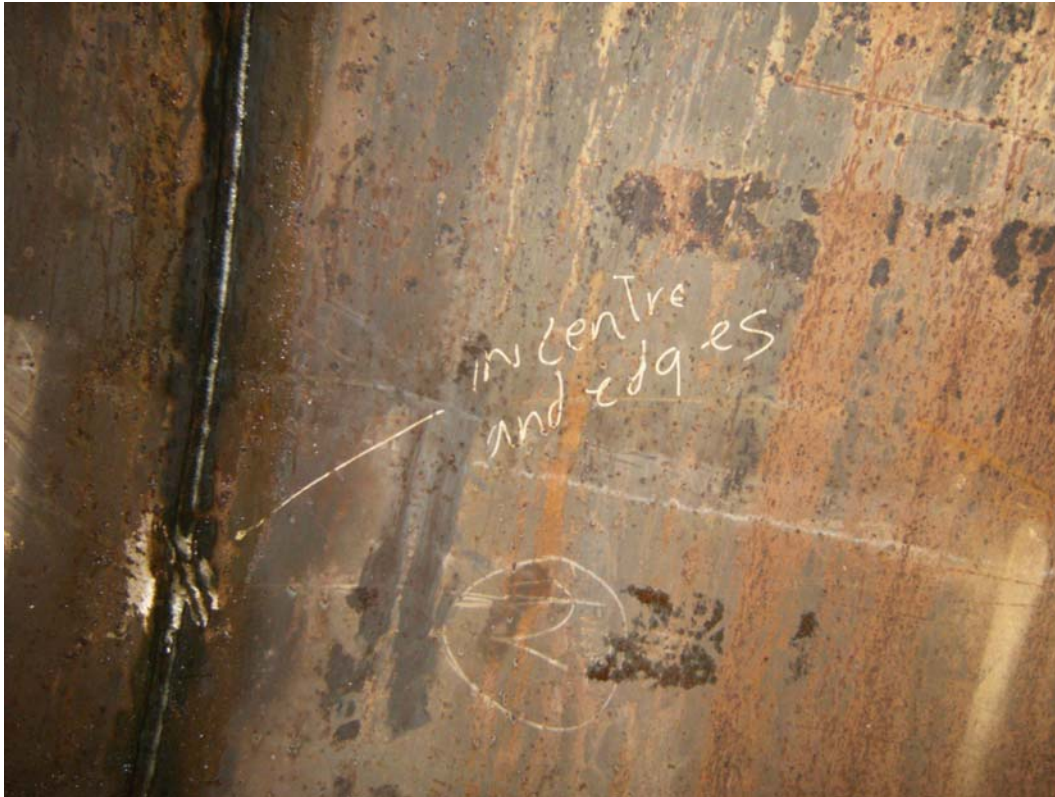
A0218208\_Previouse inspection or original fabrication markings still visible\_28May09

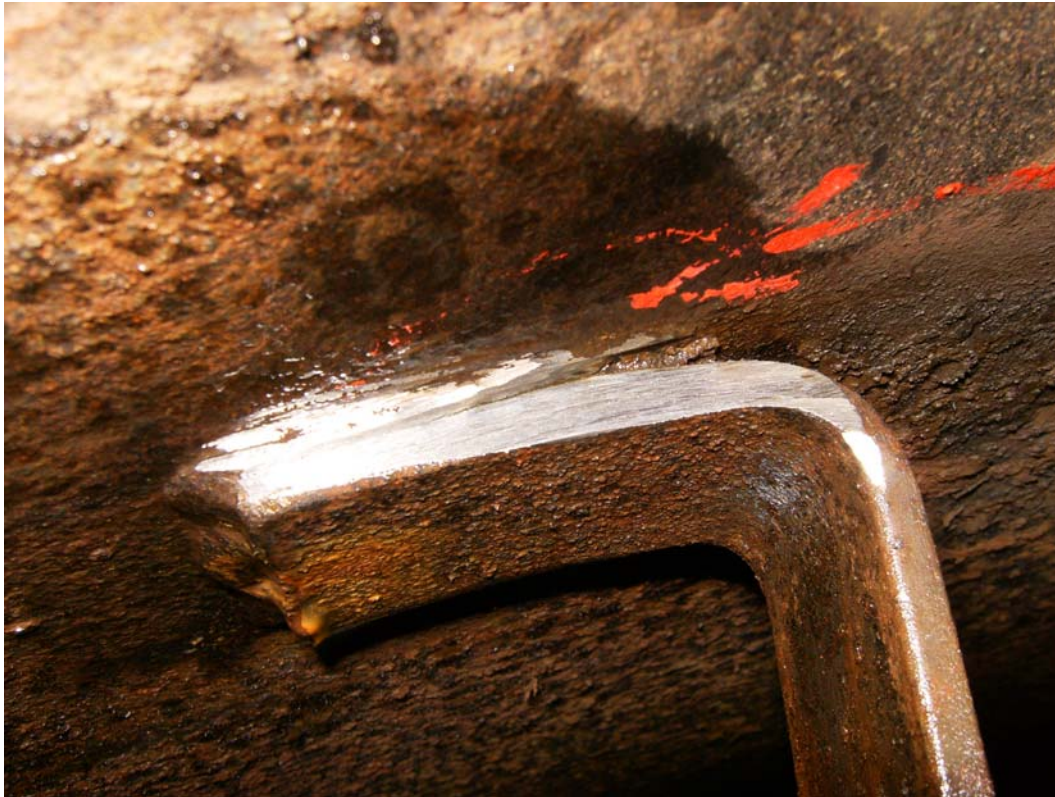
- All nozzle and man way seating surfaces are in good condition.
- Wet fluorescent MT inspection was carried out on all internal welds. The support bracket for the internal inlet piping is fillet welded to the top shell. MT revealed a crack along the fusion zone of the fillet weld. All other areas inspected were acceptable to code. Refer to IRISNDT report MT-139176-01 & 137854-MT-KS-01 for details.

A0218208\_Fillet Weld Crack on Internal Piping Support Bracket\_28May09

- The fillet weld for the inlet pipe bracket was removed by grinding. The bracket and the shell were cleaned to sound metal by grinding. The area on the shell to accept the new fillet weld was scanned with UT to ensure no laminar flaws are present in the parent material. The areas on the shell and bracket that were cleaned to sound metal were inspected with dry powder MT. No relevant indications were found with UT or MT; refer to IRISNDT reports 137854-MT-WF-01 & 137854-UT-WF-01 for details. The bracket was fitted back into the original position and the bracket and shell was preheated to 180F prior to welding. E-7018 3/32" electrodes were utilized for welding. The root weld was inspected with MT before continuing with the weld fill; refer to MT report #137854-MT-WF-01 for details. After welding was complete the area was allowed to slow cool and wet black MT was carried out on the full fillet weld. No rejectable indications were noted; refer to MT report #137854-MT-WF-02 for details.

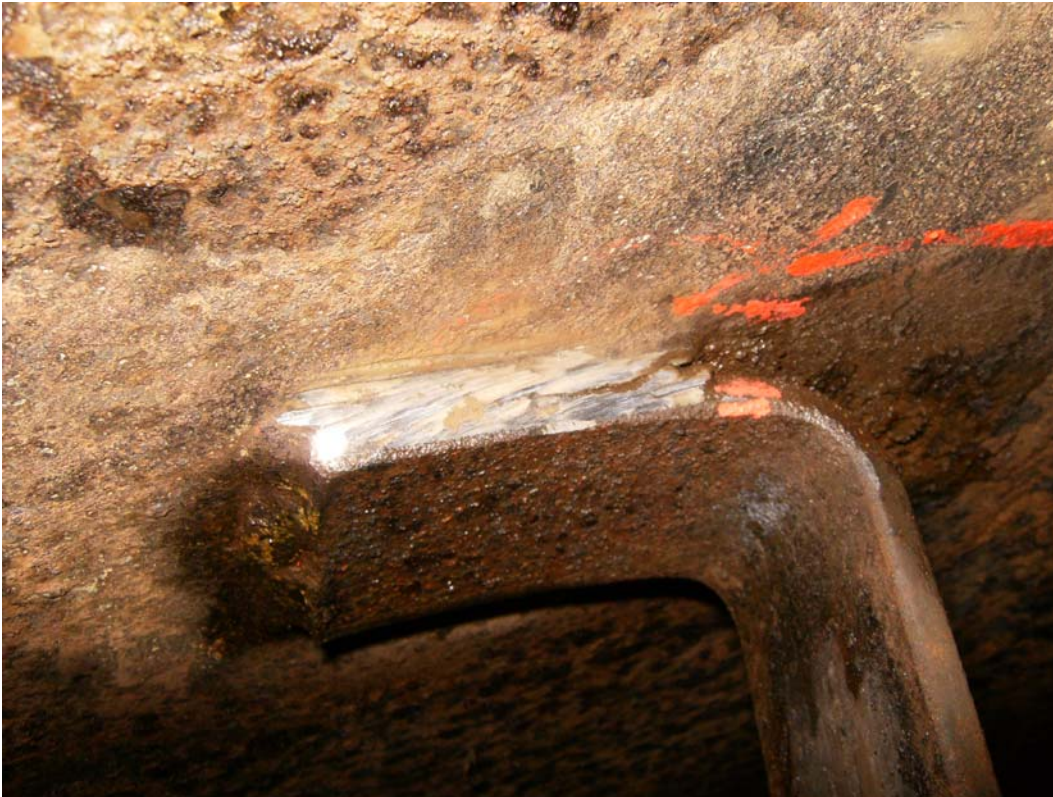
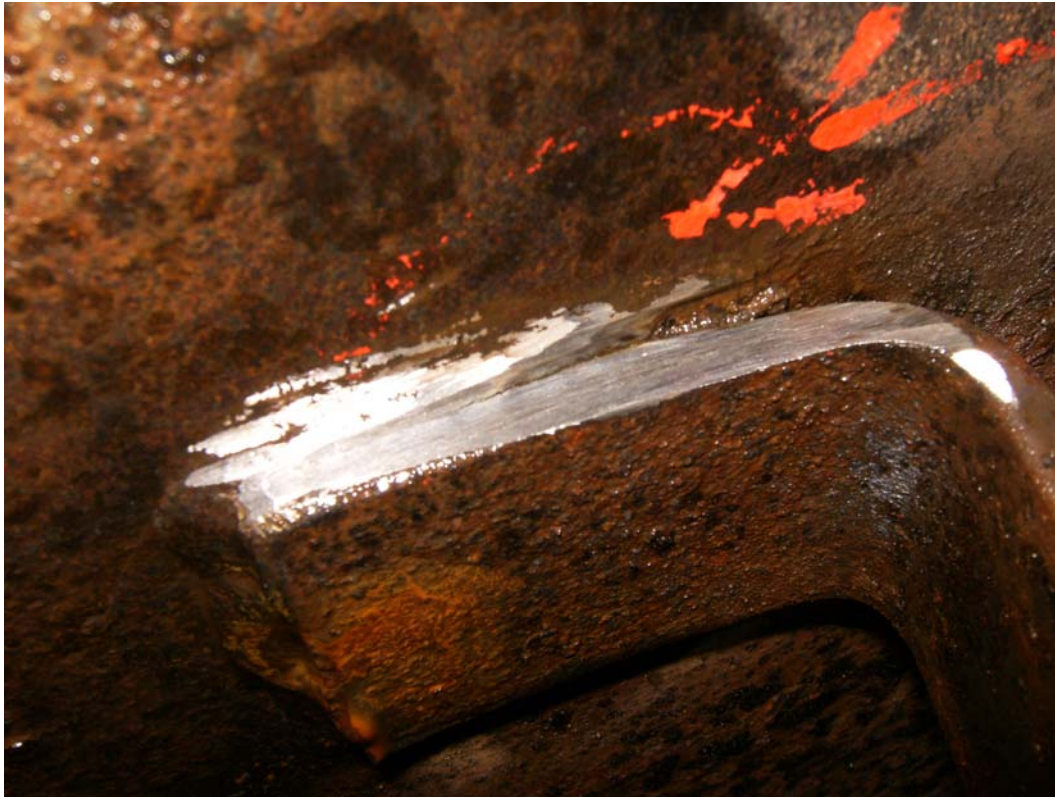
A0218208\_Fillet Weld Crack Along Fusion Zone--\_28May09

A0218208\_Fillet Weld Crack Along Fusion Zone-\_28May09

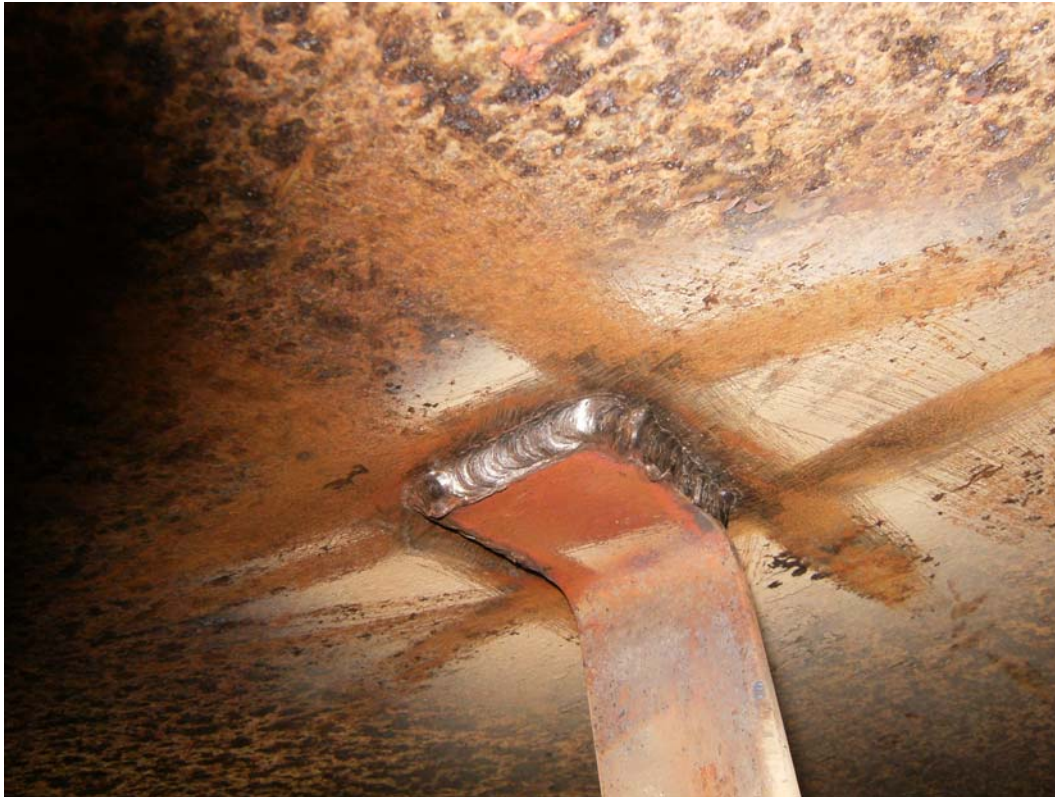
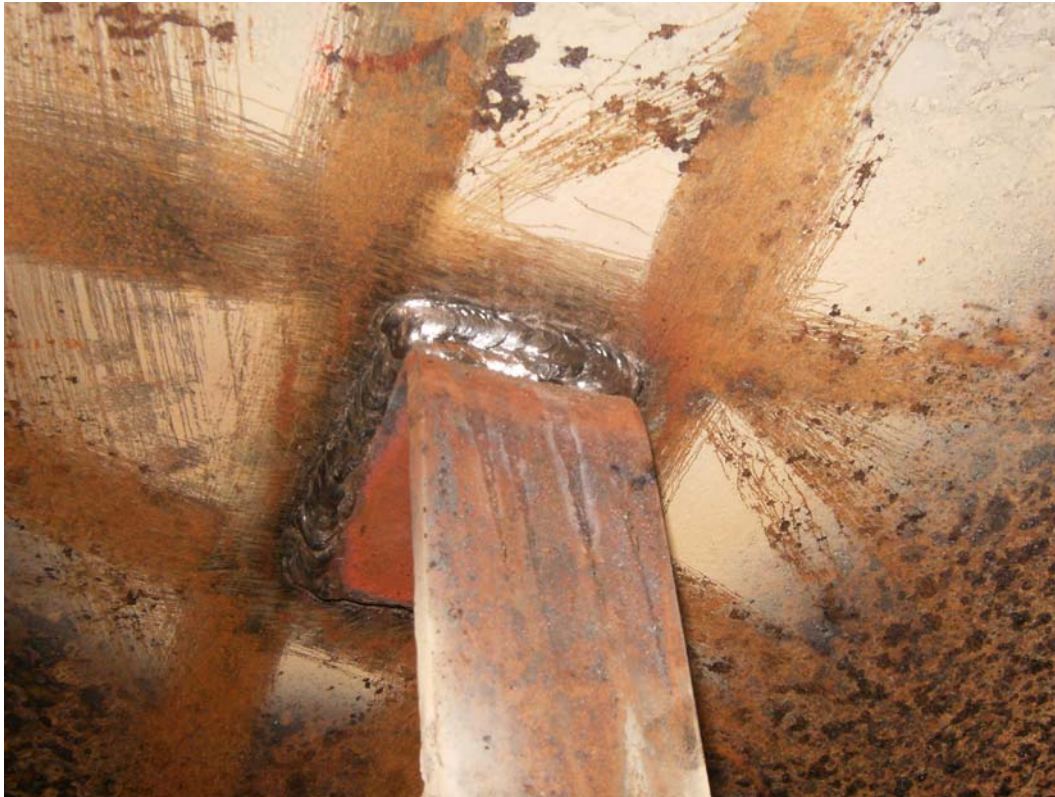
A0218208\_Completed Weld Repair on Inlet Piping Bracket-\_28May09

A0218208\_Completed Weld Repair on Inlet Piping Bracket\_28May09
