VESSEL INSPECTION SUMMARY

Report #: 137845-KS-7
Inspect Date: 05/20/2009
Page: 1 of 2
IRISNDT #: 137845

Client: CNRL District: Medicine Hat west Field: Claresholm
Facility: 15-36-012-27W4M Unit: Plant LSD: 15-36-012-27W4M
Jurisdiction #: A2791337 Equip Tag #: N/A Serial #: T-6640
CRN #: K7390.2 Nat'l Bd #: N/A Year Built: 1992
Manufacturer: Larson & D'Amico Equipment Description: Slug Catcher
Status: In Service Date Removed From Service: Service: Sweet
MAWP Shell 75 Psi @ 120 °F Height/Length: in. Code Stamp: Y N
MAWP Tube Select @ Pick Size/Diameter: in. ID / OD Insulated: Y N
Support Type: Saddle RT: 4 Volume: 17.43 m³ PWHT: Y N
C.A. 1.6mm Coated Y N Clad: Y N Manway: Y N

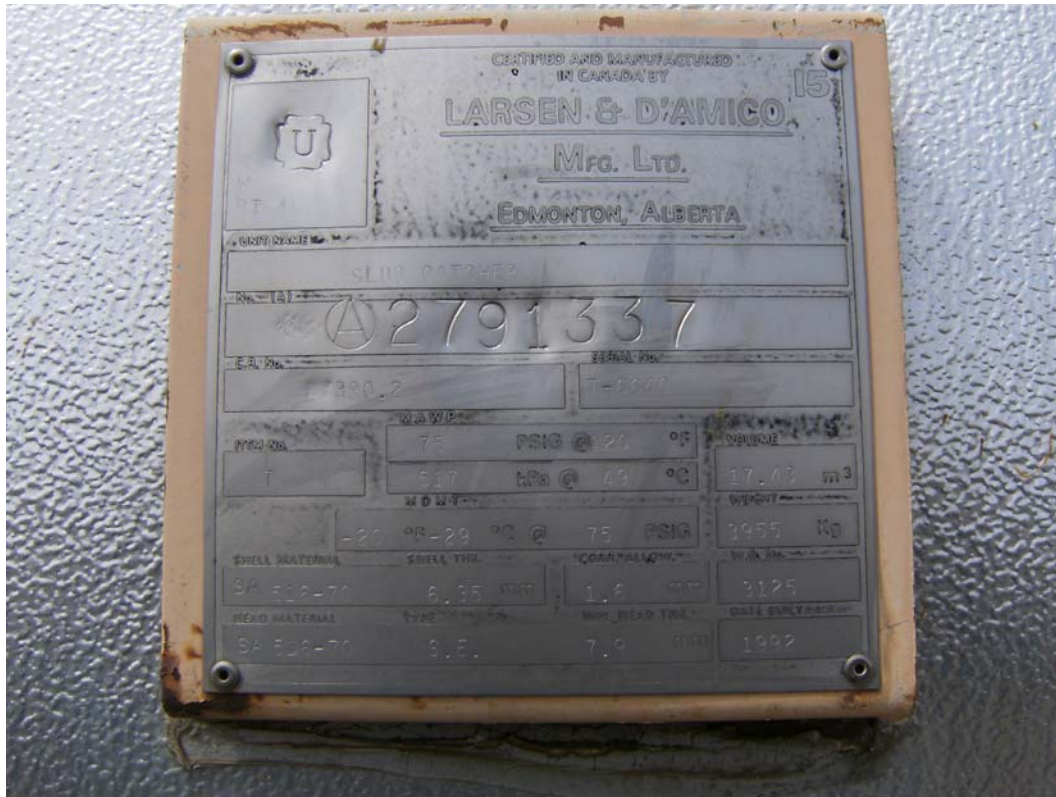
A2791337_Nameplate_09JUn09

Nameplate was intact and legible.

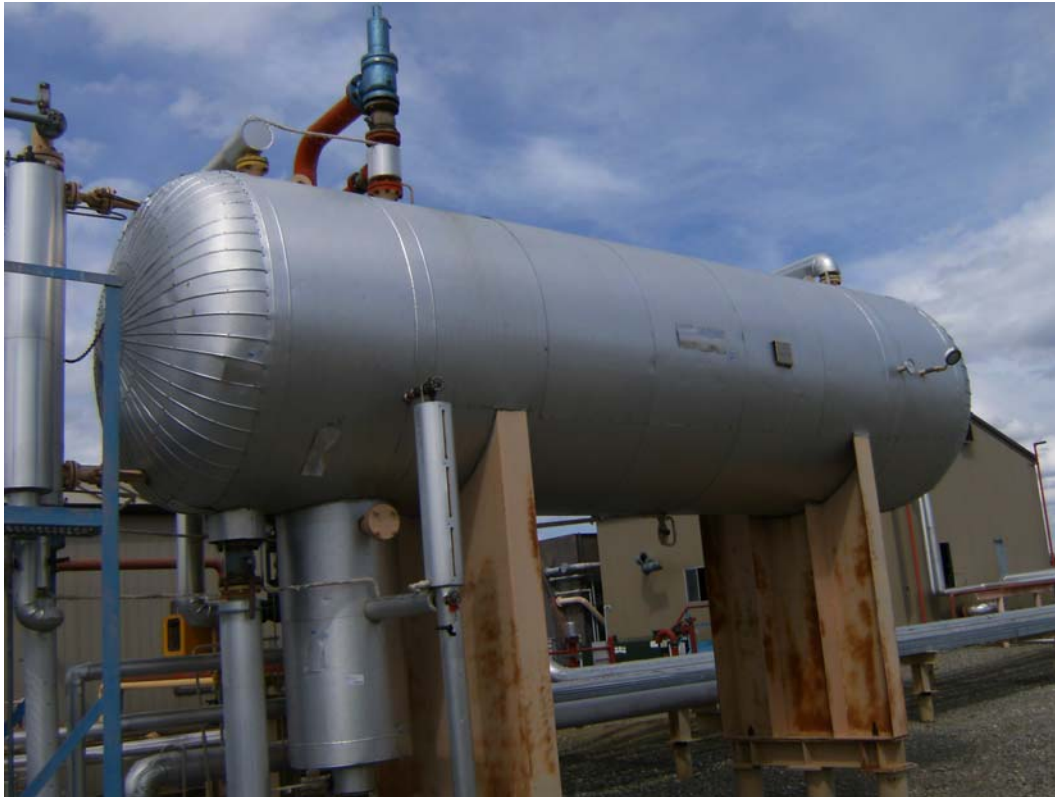
A2791337_External condition of vessel and sump section_20May09

The vessel was operating at the time of inspection. No process leaks or vibrations were noted at the time of inspection. The vessel is insulated. Insulation is in good condition with minor damage at some isolated areas. Insulation is wet at the bottom section and areas on both sides. Mild corrosion noted through UT port holes around these areas.

Replace the wet and damaged insulation to avoid CUI.
