**Canadian Natural Resources Limited
GENERAL PRESSURE VESSEL INFORMATION**

District: Grande Prairie, AB	Skid No.
Facility: North Tony Creek Gas Gathering	Location (LSD): 10-10-63-20-W5M
Vessel Name Equipment Number: Test Separator	
Orientation: Vertical	
Status: Not operating	Regulatory Inspection

Photo Table

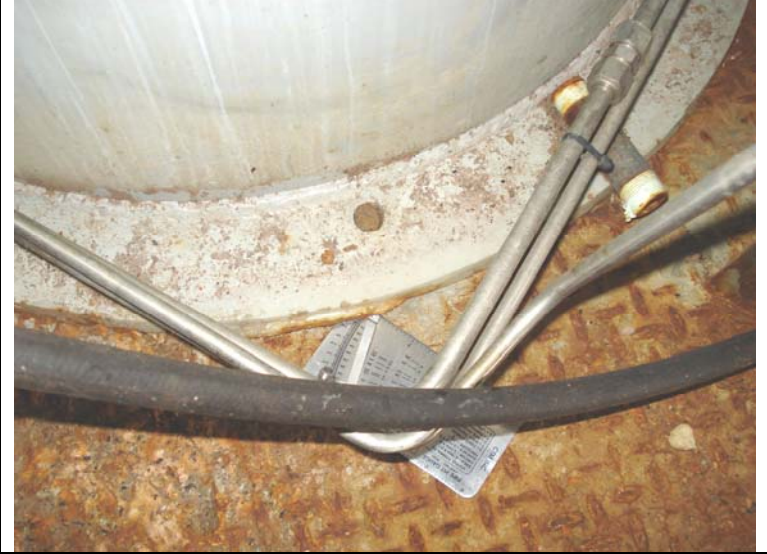
Anchor Bolts Hammer tap to ensure secure. Look for cracking in treads or signs of deformation.			x		<ul style="list-style-type: none"> • Vessel is not mounted. Vessel appears to be welded but is not fused to skid.
Concrete foundation Check for cracks, spalling, etc.				x	
Ladder / Platform Describe general condition, ensure support is secure to vessel, describe any hazards.				x	
Nozzle Assess paint, look for leakage, and ensure stud threads are fully engaged. Record any damage, deflection, etc. Are nozzles gusseted?		x			<ul style="list-style-type: none"> • Paint in fair condition. • All studs fully engaged. • No damage or deflection noted, no gussets. • Slight surface corrosion occurring.
Gauges Ensure gauges are visible, working, no leakage, and suitable for range of MAWP/ Temp.	x				<ul style="list-style-type: none"> • All gauges are visible, and within the MAWP and Temp of vessel.
External Piping Ensure pipe is well supported. All clamps, supports, shoes, etc. in place. Look for evidence of structural overload, deflection, etc. Paint condition, external corrosion?		x			<ul style="list-style-type: none"> • All piping well supported. • All clamps and shoes in place. • No overload or deflection noted. • Paint in fair with slight surface corrosion noted.

Skirt weld, note not welded.
