CLIENT	CANADIAN NATURAL RESOURCES LTD	
FACILITY	NORTH TONY FIELD	
	LSD 10-10-63-20 W5M	
ITEM	SEPARATOR	
BY: NR	DATE: 05/2008	DWG.# 72

**EQUIPMENT:** SEPARATOR PIPING

**Canadian Natural Resources Limited  
GENERAL PRESSURE VESSEL INFORMATION**

District: Grande Prairie, AB	Skid No.
Facility: North Tony Creek Gas Gathering	Location (LSD): 10-10-63-20-W5M
Vessel Name Equipment Number: Test Separator	
Orientation: Vertical	
Status: Not operating	<b>Regulatory Inspection</b>

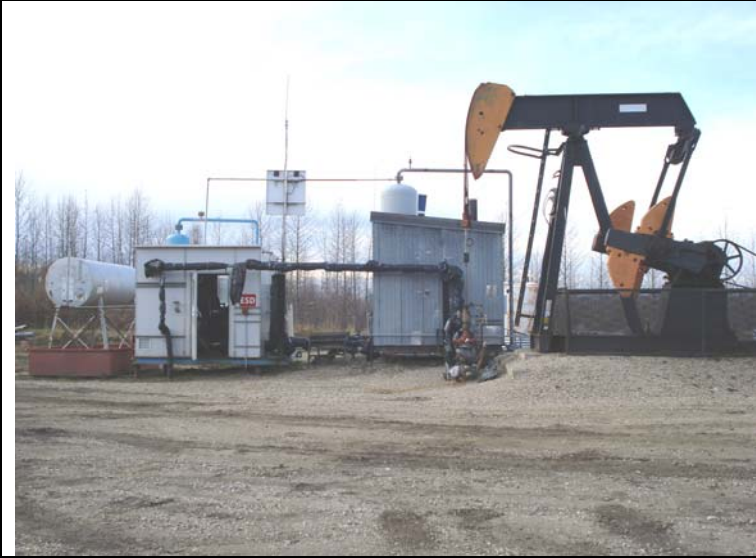
Site Overview

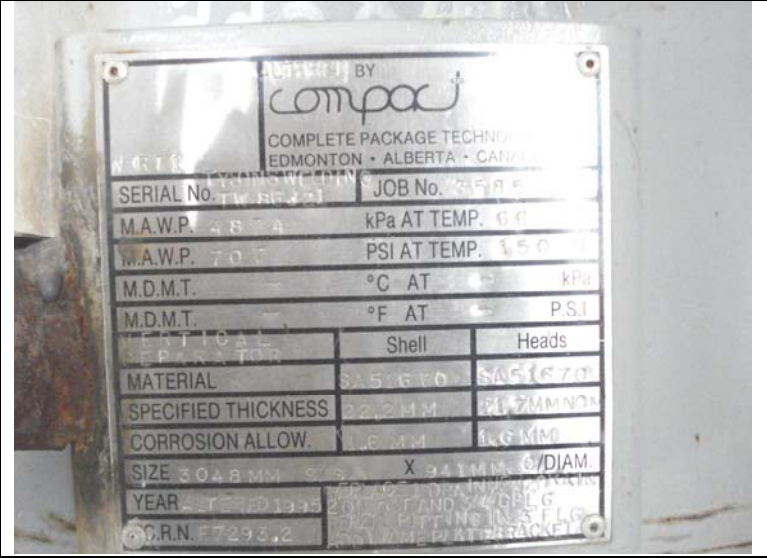
Data Plate (Alteration)

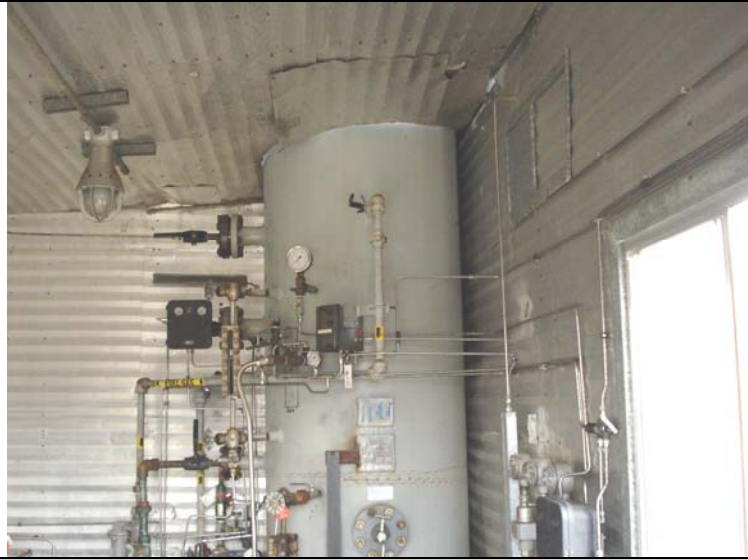
Vessel view.

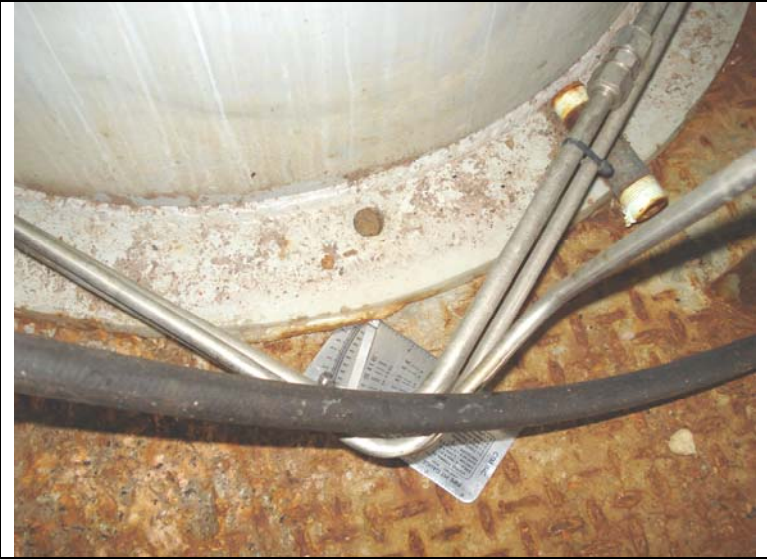
<b>Anchor Bolts</b> Hammer tap to ensure secure. Look for cracking in treads or signs of deformation.			x		<ul style="list-style-type: none"> <li>• <b>Vessel is not mounted. Vessel appears to be welded but is not fused to skid.</b></li> </ul>
<b>Concrete foundation</b> Check for cracks, spalling, etc.				x	
<b>Ladder / Platform</b> Describe general condition, ensure support is secure to vessel, describe any hazards.				x	
<b>Nozzle</b> Assess paint, look for leakage, and ensure stud threads are fully engaged. Record any damage, deflection, etc. Are nozzles gusseted?		x			<ul style="list-style-type: none"> <li>• <b>Paint in fair condition.</b></li> <li>• <b>All studs fully engaged.</b></li> <li>• <b>No damage or deflection noted, no gussets.</b></li> <li>• <b>Slight surface corrosion occurring.</b></li> </ul>
<b>Gauges</b> Ensure gauges are visible, working, no leakage, and suitable for range of MAWP/ Temp.	x				<ul style="list-style-type: none"> <li>• <b>All gauges are visible, and within the MAWP and Temp of vessel.</b></li> </ul>

Skirt weld, note not welded.

<b>Other</b>					
<p><b>Recommendations or corrective actions : Vessel is Fit for Service or describe corrective actions required)</b>  (MIC to review corrective actions with Operations, discuss with Chief Inspector where necessary, and get remedial action implemented)  <b>Recommendations: Weld skirt to skid.</b>  <b>Summary: This vessel is in good condition, visual external and ultrasonic thickness survey carried out – no metal thickness detected below nominal minus corrosion allowance.</b>  <b>Vessel is fit for service</b></p>

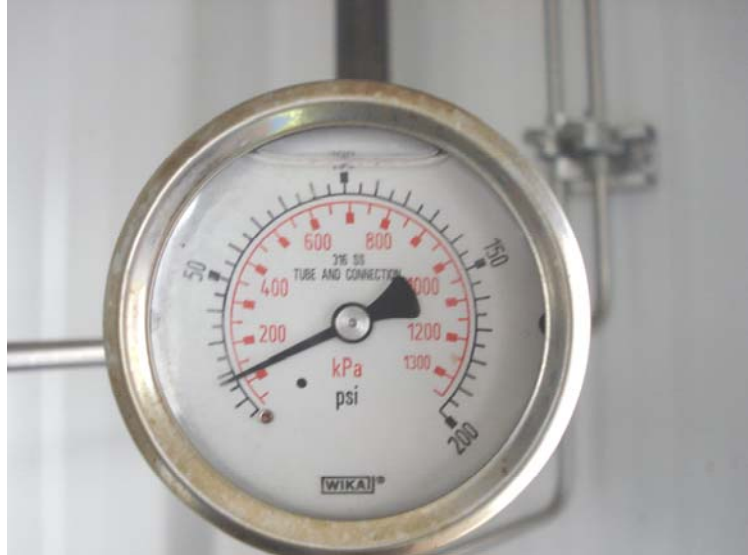
Pressure Gauge

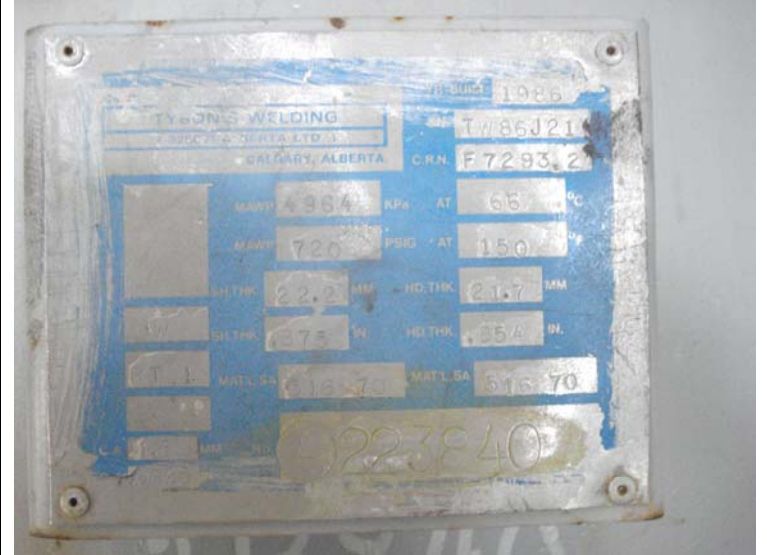
Data Plate
