Client: CNRL District: St. Albert Field: Cherhill
 Facility: Cherhill Comp Unit / Skid #: N/A LSD: 15-08-057-05W5
 Jurisdiction #: A0419465 Equip Tag #: 06-09 Sep Serial #: 97168A
 CRN #: L-0404.2 Nat'l Bd #: N/A Year Built: 1998
 Manufacturer: Kanbuilt Industries Inc Equipment Description: Separator
 Status: In Service - Date Removed From Service: _____ Service: Sweet
 MAWP Shell: 720 Psi @ 100 °F Height/Length: 10 Ft. Code Stamp: Y N
 MAWP Tube: _____ @ _____ Size/Diameter.: 36 in. O.D. Insulated: Y N
 MDMT: -20 °F RT: RT-2 Volume: _____ PWHT: Y N
 Support Type: Skirt Manway: Y N
 C.A.: 0.0625 in. Coated: Y N Clad: Y N J.E.: _____ Remote Access: - _____

**VESSEL INSPECTION
SUMMARY**

Report #: **123812-KK-08**
 Inspect Date: 04/21/2010
 Page: 4 of 7
 IRISNDT #: 123812

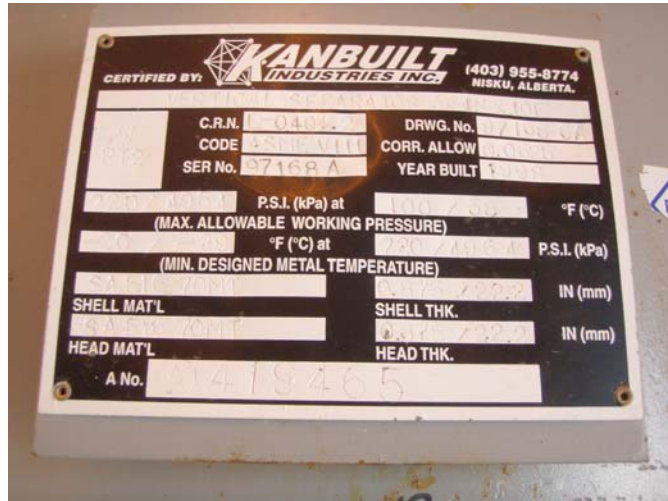
01-A0419465 Data Plate

Data plate is securely attached and easy to read.

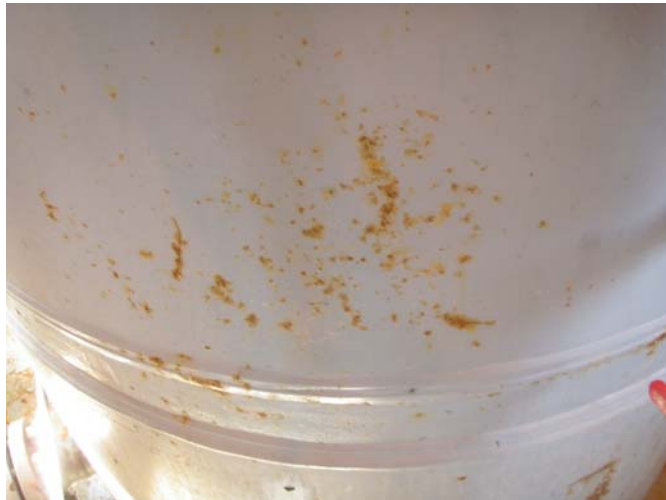
There are isolated rough surfaces, staining, thick/ rough paint, and chipping or flaking paint noted throughout.

The vessel is painted and is in fair visual condition with chipping and flaking paint noted throughout.

04-A0419465 Surface Corrosion

Clean and repaint this vessel in the areas where paint is flaking.

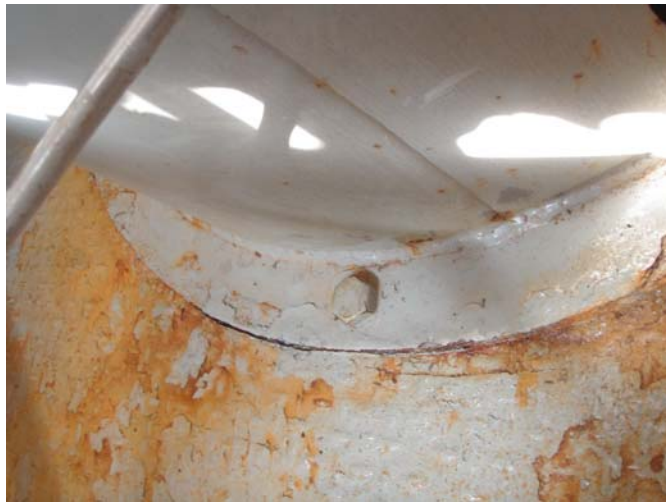
There is corrosion and flaking paint noted at the floor where the vessel base is bolted.

05-A0419465 Base Corrosion

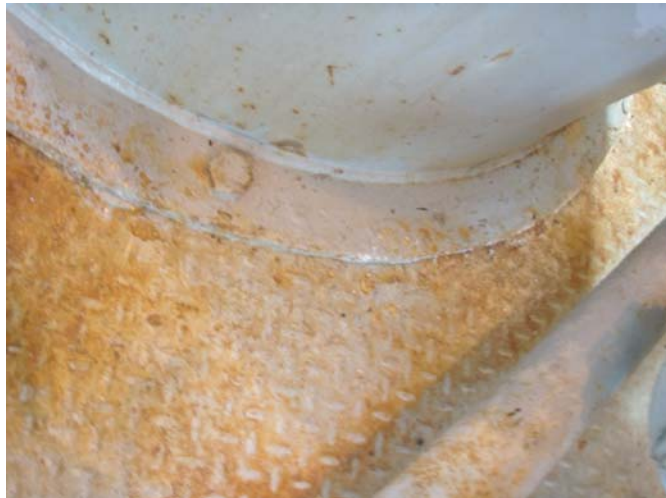
06-A0419465 Base Corrosion 2
