VESSEL INSPECTION SUMMARY

Report #: **123812-KK-07**  
 Inspect Date: 04/21/2010  
 Page: 1 of 7  
 IRISNDT #: 123812

Client: CNRL District: St. Albert Field: Cherhill  
 Facility: Cherhill Comp Unit / Skid #: N/A LSD: 15-08-057-05W5M  
 Jurisdiction #: A0419466 Equip Tag #: N/A Serial #: 97168C  
 CRN #: L-0405.2 Nat'l Bd #: N/A Year Built: 1998  
 Manufacturer: Kanbuilt Industries Inc Equipment Description: Flare Knock Out Drum  
 Status: In Service - Date Removed From Service: \_\_\_\_\_ Service: Sweet  
 MAWP Shell: 50 Psi @ 100 °F Height/Length: 8 Ft. Code Stamp:  Y  N  
 MAWP Tube: \_\_\_\_\_ @ \_\_\_\_\_ Size/Diameter.: 48 in. O.D. Insulated:  Y  N  
 MDMT: -20 °F RT: RT-2 Volume: \_\_\_\_\_ PWHT:  Y  N  
 Support Type: Saddle Manway:  Y  N  
 C.A.: 0.0625 in. Coated:  Y  N Clad:  Y  N J.E.: \_\_\_\_\_ Remote Access:  - \_\_\_\_\_

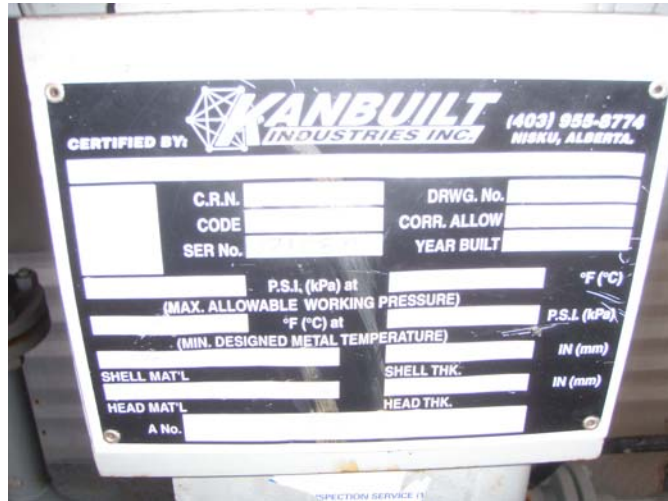
Comments:  
 Data plate securely attached and easy to read.

**01-A0419466 Data Plate**

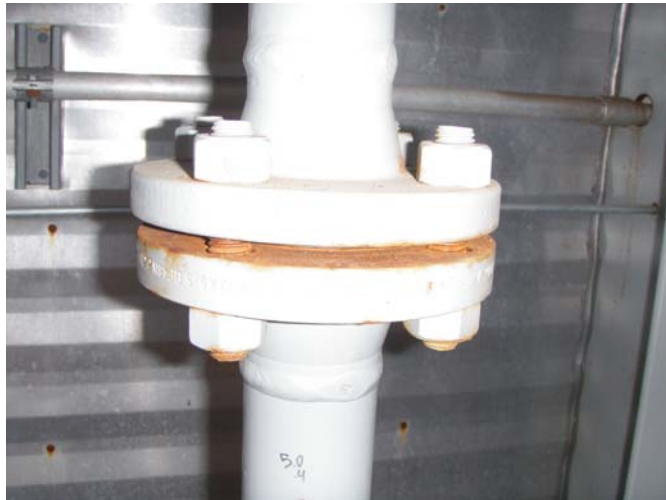
Minor surface corrosion was noted on the drain piping flanges. This corrosion can be easily removed with light wire brushing.

**04-A0419466 Flange Face Flash Corrosion**

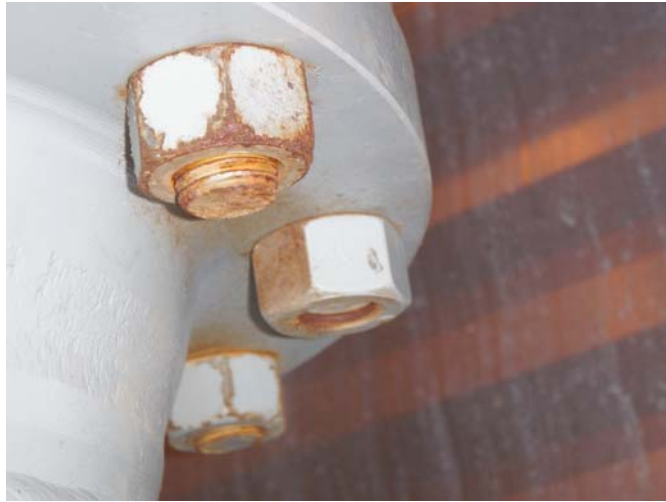
There is 1 Bolt with questionable thread engagement on inlet flange.

**05-A0419466 Inlet Flange Bolting**

Ensure that inlet piping bolts are adjusted accordingly to make sure there is proper thread engagement.
