**Canadian Natural Resources Limited
GENERAL PRESSURE VESSEL INFORMATION**

Job 10.180106

District: Fort St. John, BC.	Skid No.
Facility: Adsett Water Injection Facility	Location (LSD): b-63-G/94-J-02
Vessel Name Equipment Number: Separator	
Orientation: Horizontal	
Status: Not in Service	Regulatory Inspection

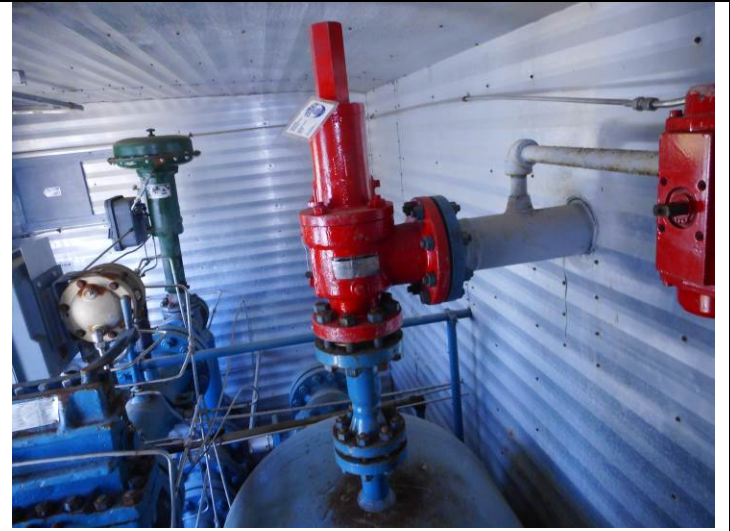
Valving Ensure no leaks are visible. Valves are properly supported and chained if necessary.	X				Valves properly supported – no visible leaks
PSV Ensure PSV is set at pressure at or below that of vessel.	X				Located at top shell – set at MAWP of vessel. Seal intact – no block valve – discharge piping same size as outlet orifice.
NDE methods Was UT/ MPI done on vessel (MI coordinator to review results)	X				Ultrasonic thickness survey carried out no – metal thickness detected below nominal minus corrosion allowance.
Other					
<p>Recommendations or corrective actions : (Vessel is Fit for Service or describe corrective actions required) (MIC to review corrective actions with Operations, discuss with Chief Inspector where necessary, and get remedial action implemented) Recommendations: No recommendations at this time. Summary: This vessel is in good condition, visual external and ultrasonic thickness inspection carried out – no metal thickness detected below nominal minus corrosion allowance. Corrosion rate based on greatest thickness loss (nozzle) 0.041mm per year. Retirement Date to “T”min is year 2148. Vessel is fit for service.</p>
