VERTICAL VESSEL - GENERAL INSPECTION FORM						
District: Ft St John, B.C.			Skid No.			
Facility: South Buick			Location (LSD): d-78-I / 94-A-11			
Vessel Name & Equipment Number: Gas Separator #2 V-100						
Orientation: Vertical						
Status: In Service			Regulatory Inspection			
PRESSURE VESSEL NAMEPLATE DATA						
"A" or "G" or "S" (Sask.) or BC Registration Number. A#431523			CRN Number N-3413-21			
Vessel serial number: 96-8536-0			Size: 48" X 10'			
Shell thickness: 1.250"			Shell material: N/S			
Head thickness: 1.220"			Head material: N/S			
Tube wall thickness: N/A			Tube material:			
Tube diameter: N/A			Tube length:			
Channel thickness:			Channel material:			
MAWP	Shell: 720 PSI		Operating pressure	Shell: 0		
	Tubes:			Tubes:		
Design Temp.	Shell: 100 deg F		Operating temperature	Shell: 0		
	Tubes:			Tubes:		
X-ray: RT-1			Heat treatment: Yes			
Code parameters: ASME Sec VIII			Joint efficiency (if on nameplate):

Canadian Natural Resources Limited

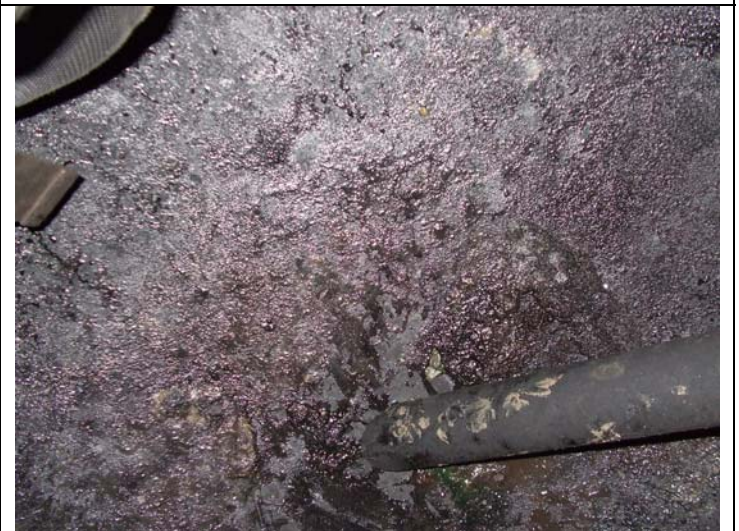
Internal Inspection Items	G	F	P	N/A	Comments
Coating Assess coating. Describe area coated, general condition of coating.				X	None.
Anodes. How many, type, condition. % consumed. Are they being replaced?				X	None.
Internal Piping Is there any? If so, carbon or stainless steel. Describe condition, dents, corrosion, erosion, etc. Ensure supports are secure and any bolts are suitable for future use.	X				Siphon tube is in good overall condition. No mechanical damage, corrosion or erosion was found.
Trays How many? Type of material. Are valves in place. Check for erosion/ corrosion; wear on tray valve legs. Cleanliness?				X	None.
Baffles, deflector plates, etc. If present, describe condition. Look closely at welds attached to vessel wall.	X				Deflector plates found in good condition welds were firmly secured to the shell.
Bottom Head Note all corrosion, erosion or mechanical damage. (If vessel is horizontal identify direction of this head)	X				Bottom head is in good overall condition. No mechanical damage, corrosion or erosion was found.
