**Canadian Natural Resources Ltd.  
GENERAL PRESSURE VESSEL INFORMATION**

**Job# 105.01192**

District: <b>Fort St John, BC</b>	Skid No. <b>Inlet Separator Building</b>
Facility: <b>East Buick Creek Compressor Station</b>	Location (LSD): <b>d-17-D / 94-A-15</b>
Vessel Name Equipment Number: <b>Inlet Separator</b>	
Orientation: <b>Vertical</b>	
Status: <b>In service</b>	<b>Regulatory Inspection</b>

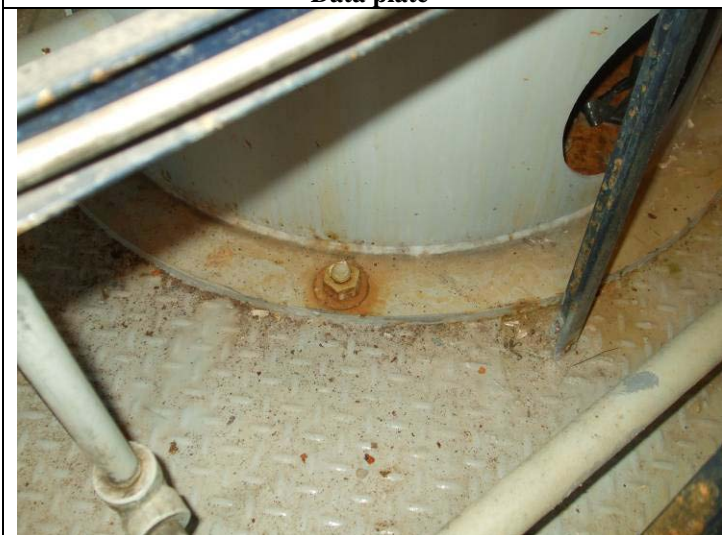
<b>Anchor Bolts</b> Hammer tap to ensure secure. Look for cracking in treads or signs of deformation.	X				<b>Anchor bolts are secured to skid deck. No signs of deformation.</b>
<b>Concrete foundation</b> Check for cracks, spalling, etc.				X	<b>None</b>
<b>Ladder / Platform</b> Describe general condition, ensure support is secure to vessel.				X	<b>None</b>
<b>Nozzle</b> Assess paint, look for leakage, and ensure stud threads are fully engaged. Record any damage, deflection, etc. Are nozzles gusseted?	X				<b>Stud threads are fully engaged to nuts. No damage or deflections observed – no leaks. Paint in good condition. Nozzles are not gusseted.</b>
<b>Gauges</b> Ensure gauges are visible, working, no leakage, and suitable for range of MAWP/ Temp.	X				<b>Gauges are visible, working and suitable for MAWP/ Temp Pressure gauge: 0 to 1000 PSI / 100 PSI @ gauge. Temp gauge: -40 to 120 deg F / 40 deg F @ gauge.</b>

Base firmly bolted secure
