A2791337_Nameplate_09JUn09

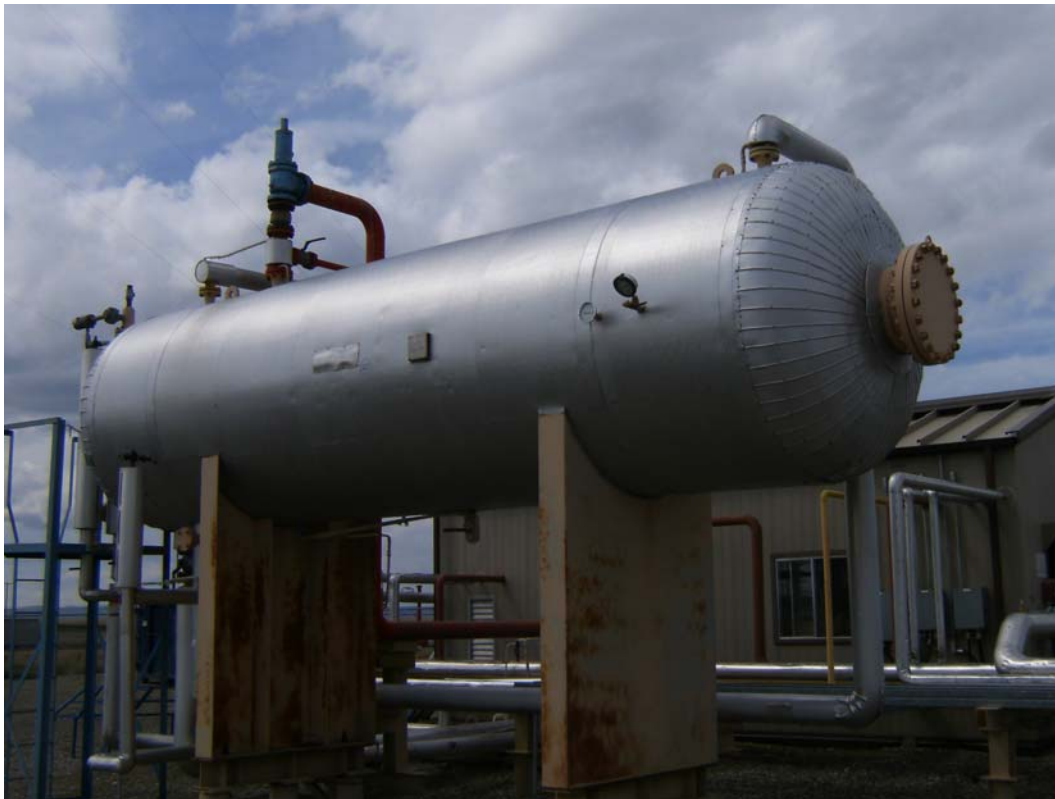
A2791337_vessel external condition_20May09
