Canadian Natural Resources Limited GENERAL PRESSURE VESSEL INFORMATION Job # 10.112227												
District: Fort St. Jo	hn BC.	Skid No.										
Facility: Milligan C	Location (LSD): d-31-G-94-H-2											
Vessel Name Equipment Number: 3 Phase Horizontal Separator												
Orientation: Horizontal												
Status: In Serv			Decade town In succession									
Status: In Service Regulatory Inspection PRESSURE VESSEL NAMEPLATE DATA												
"A" or "G" o	r "S" (Sask.) or BC R	CRN Number:										
	A0454495	L 7688.213										
Vessel serial number		Size: 48 in. x 15 ft.										
Shell thickness: 57.2		Shell material: SA 516-70N										
Head thickness: 54.9	91mm	Head material: SA 516-70N										
Tube wall thickness:	:	Tube material:										
Tube diameter:				Tube length:								
Channel thickness:	Channel material:											
Design pressure	Shell: 1440 PSI	Operating pressure		Shell:	0 – 2000 PSI

Date: September 27, 2012

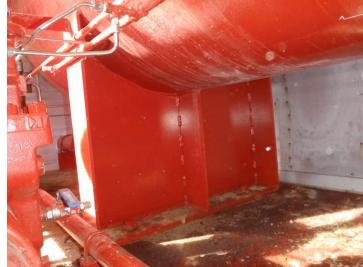
Overview Saddle bolted to skid floor
