Report #: 91517-MD-58
Inspect Date: 05/02/2011
Page: 1 of 10
Insp. Co. Job #: 91517

Equipment Photographs:

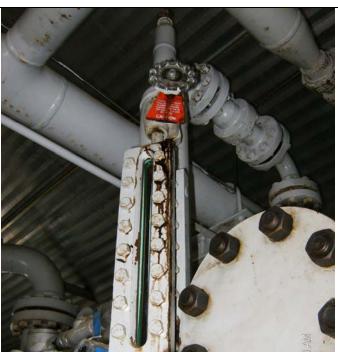
03 minor surface corrosion at previous UT location

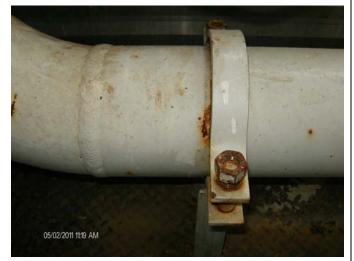
Sight Glass		Accept	clean and intact							
Ladder / Platform			no ladder or platform for separator							
Leaks	\perp	Yes	evidence of leak from sight glass	Ш		\boxtimes				
Piping from Vessel	Ш	Reject	inlet saddle clamp is not secure							
Previous UT Survey	\boxtimes		UT C	ompan	y:					
External Visual Observations	3									
		N	Airen peint fleting and chipping peterless vessel are		ad minima. The					
			Ainor paint flaking and chipping noted on vessel, supply the corresion survey was performed as well as between							
surface corrosion noted where the previous UT corrosion survey was performed as well as between the flanges. There is evidence of a process leak from the upper sight glass top packing. The inlet piping saddle clamp has poor thread engagement. A UT										
corrosion survey was performed at the time of inspection with no metal loss noted.										
, , , , , , , , , , , , , , , , , , , ,

05 inlet piping anchor bolting thread engagement

Recommendations:										
Tighten or replace upper sight glass packing. Tighten inlet piping saddle clamp support to ensure full thread engagement. Maintain										
the inspection and UT corr	the inspection and UT corrosion survey frequency.
