**PRESSURE VESSEL
VISUAL INSPECTION
REPORT**

Report #: **150170-CA-01**
 Inspect Date: 01/10/2011
 Page: 1 of 11
 Insp. Co. Job #: 150170

Insp. Comp: Matrix_Inspection District: Edson Field: Peppers
 Location: Peppers Sour Unit / Skid #: N/A LSD: 07-17-052-23W5M
 Jurisdiction #: A0458976 Equip Tag #: N/A Serial #: 6569-50
 CRN #: E9867.213 Nat'l Bd #: N/A Year Built: 2000
 Manufacturer: Presson Equipment Description: Indirect Fired Glycol Line Heater
 Status: In Service - Standby Equip. Type: Exch.: Line Heater Service: Sour
 MAWP Shell: ATM --- @ Volume: N/A Code Stamp: Y N
 MAWP Tube: 35654 kPa @ 93 °C Height/Length: 300 in. Insulated: Y N
 MDMT: N/A RT: RT-1 Size/Diameter.: 96 in. O.D. PWHT: Y N
 Support: Saddle Vessel on Original CNRL Inventory List: Y N Manway: Y N
 C.A.: N/A Coated: N/A Clad: N/A J.E.: 1.00 Remote Access: -

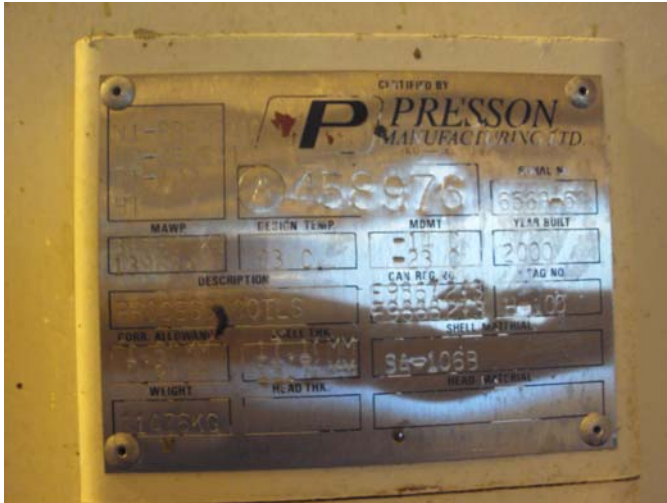
01-Data Plate 1

There are 3 data plates attached to the vessel, all pertaining to the internal coils. Two are for the original construction of the equipment and one is an alteration plate for the low pressure coil. All are clear and readable.

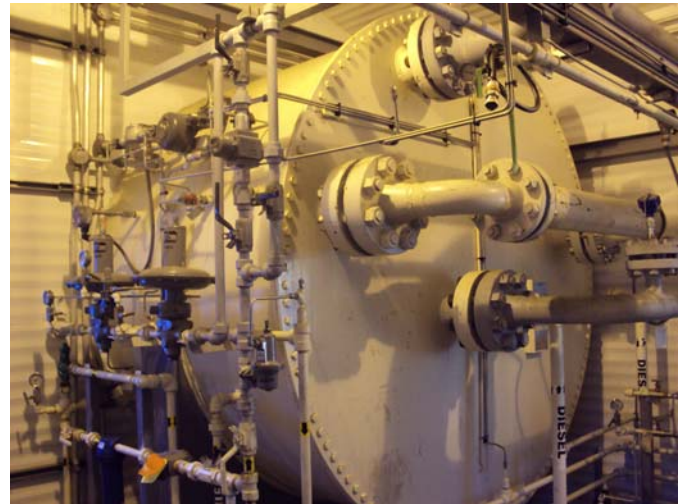
04-Vessel Overview Inside

All exposed areas on the shell and heads are inside the skid building and are painted. The paint is in good condition with no evidence of peeling, wear, chipping or other degradation. All painted areas are free of corrosion and pitting.

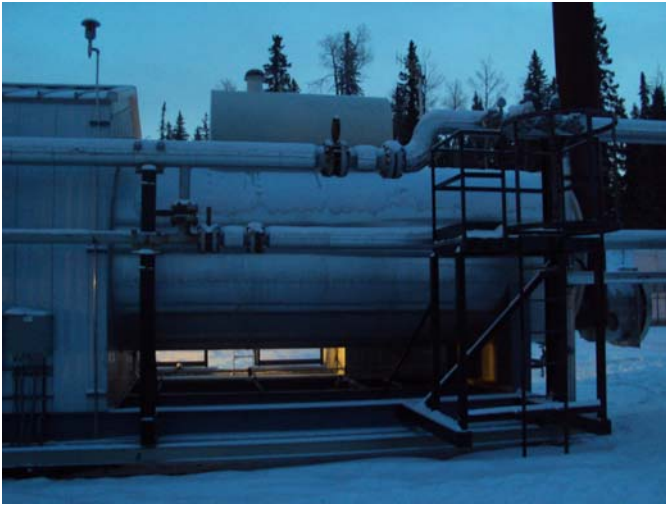
05-Vessel Overview Outside

Areas on the vessel outside the building are insulated and cladded. The cladding is free of rips, punctures, tears or other damage. No bulging or staining was noted.

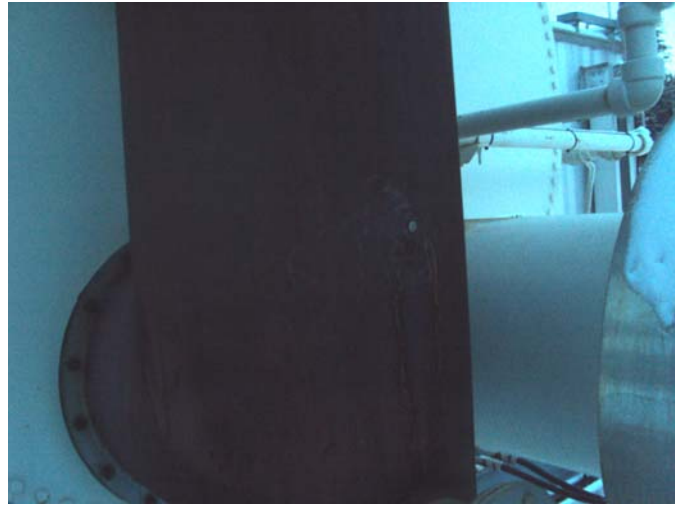
A bolt was found inserted into the side of the stack. It appears to be for draining as no environmental protection was found on the top, i.e.: cover or other protection from rain or snow ingress, or an added sample point. There appears to be some preferential corrosion attack on the stack around the inserted bolt

06-Drain Plug on Stack
