**Canadian Natural Resources Limited
GENERAL PRESSURE VESSEL INFORMATION**

District: Fort St. John BC.	Skid No.
Facility: Bucking Horse Compressor Station	Location (LSD): d-44-A/94-G-10
Vessel Name Equipment Number: Glycol Contactor	
Orientation: Vertical	
Status: In Service	Regulatory Inspection

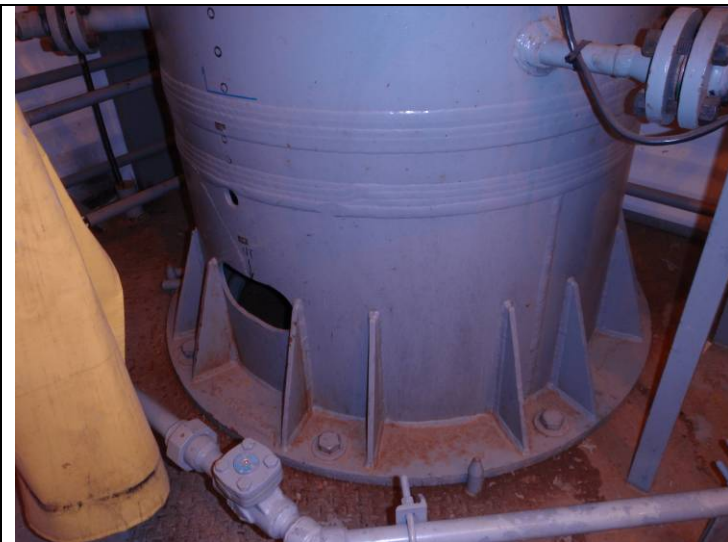
Skirt bolted to skid floor

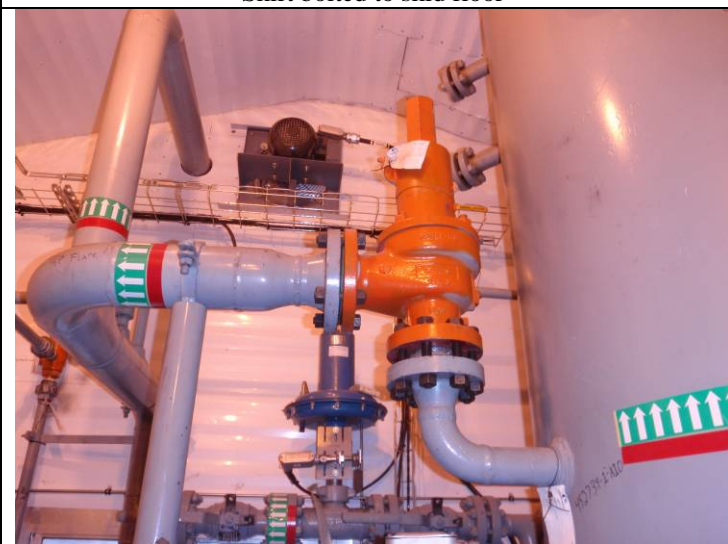
Valving Ensure no leaks are visible. Valves are properly supported and chained if necessary.	X				No leaks are visible- valves are supported properly.
PSV Ensure PSV is set at pressure at or below that of vessel.	X				Location: lower shell - set at MAWP of vessel. Discharge piping is same size as valve outlet. PSV seal in place – no block valve between vessel and PSV.
NDE methods Was UT/ MPI done on vessel (MI coordinator to review results)	X				Ultrasonic corrosion survey carried out – pipe metal thickness detected below nominal minus corrosion allowance. Thickness calculations carried out: UT point 1235 (1” Elbow) – nominal thickness is 7.8mm / min thickness is 6.2mm / T min thickness is 1.6mm.
<p>Recommendations or corrective actions : Vessel is Fit for Service or describe corrective actions required) (MIC to review corrective actions with Operations, discuss with Chief Inspector where necessary, and get remedial action implemented)</p> <p>Recommendations: No recommendations at this time</p> <p>Summary: Vessel is in overall good condition, visual external inspection and ultrasonic corrosion survey performed— pipe metal thickness detected below nominal minus corrosion allowance. Thickness calculations carried out to ensure sufficient metal exists for safe operation.</p> <p>Short term corrosion rate based on greatest thickness loss – no corrosion rate to assess.</p> <p>Vessel is fit for service.</p>
