**Canadian Natural Resources Limited
GENERAL PRESSURE VESSEL INFORMATION Job # 10.111579**

District: Fort St. John BC.	Skid No.
Facility: Jedney Field	Location (LSD): b-62-E/94-G-8
Vessel Name Equipment Number: Test Separator	
Orientation: Vertical	
Status: In Service	Regulatory Inspection

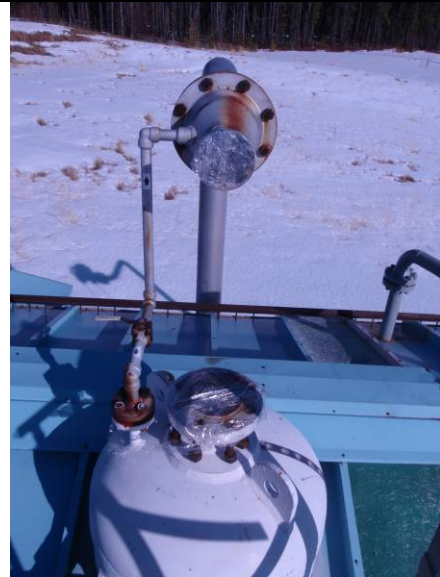
Top head.- Outlet piping and PSV removed

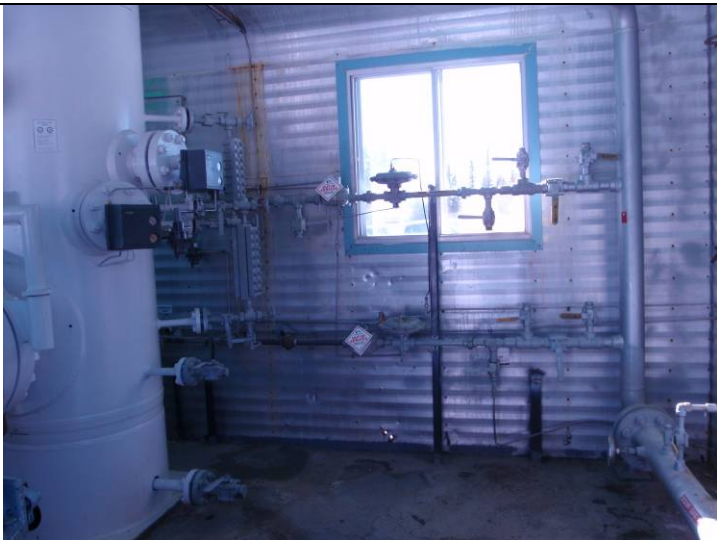
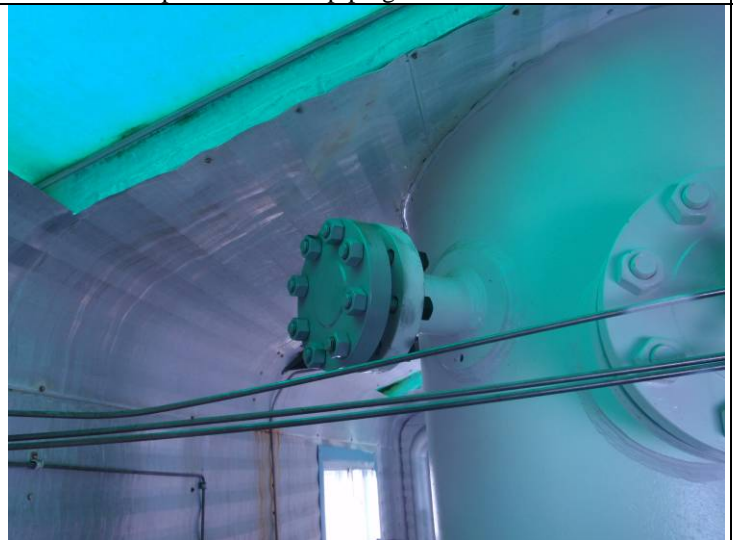
Dump piping is connected

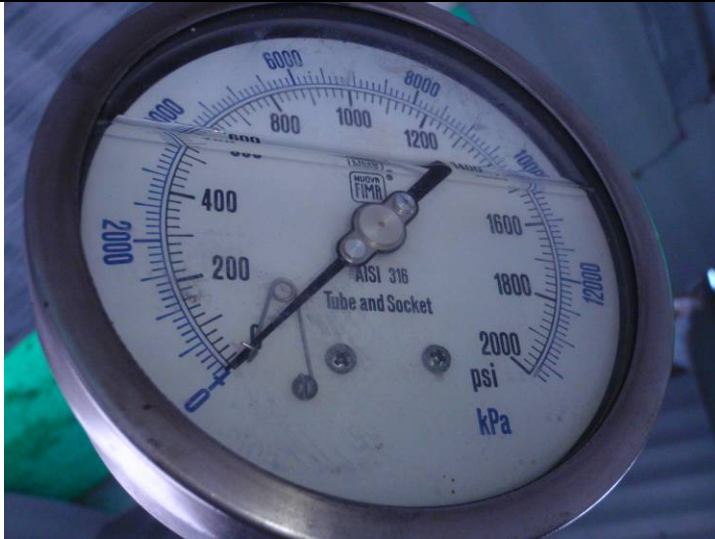
Pressure gauge

Inlet piping disconnected.
