**Canadian Natural Resources Limited
GENERAL PRESSURE VESSEL INFORMATION**

Job # 10.111579

District: Fort St. John BC.	Skid No.
Facility: Jedney Gas Plant	Location (LSD): a-62-E/94-G-8
Vessel Name Equipment Number: Condensate Storage Vessel	
Orientation: Horizontal	
Status: In Service	Regulatory Inspection

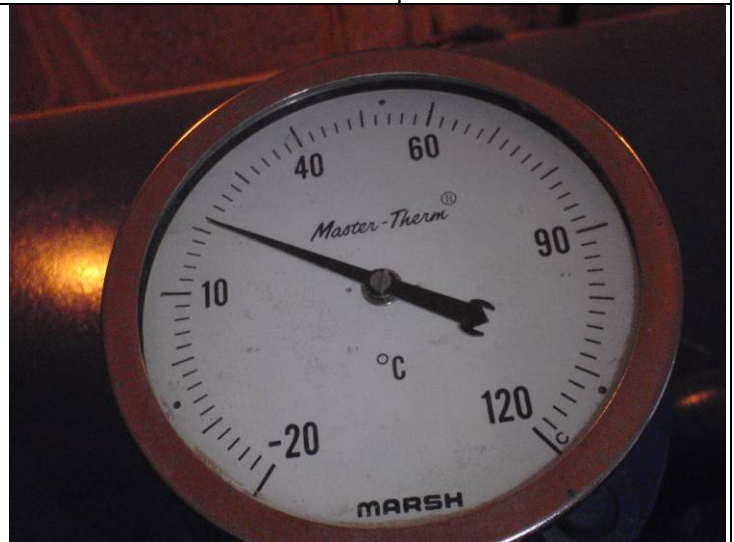
Overview

Summary: Vessel is in overall good condition, visual external inspection and ultrasonic corrosion survey performed—pipe metal thickness detected below nominal minus corrosion allowance. Thickness calculations carried out to ensure sufficient metal exists for safe operation.

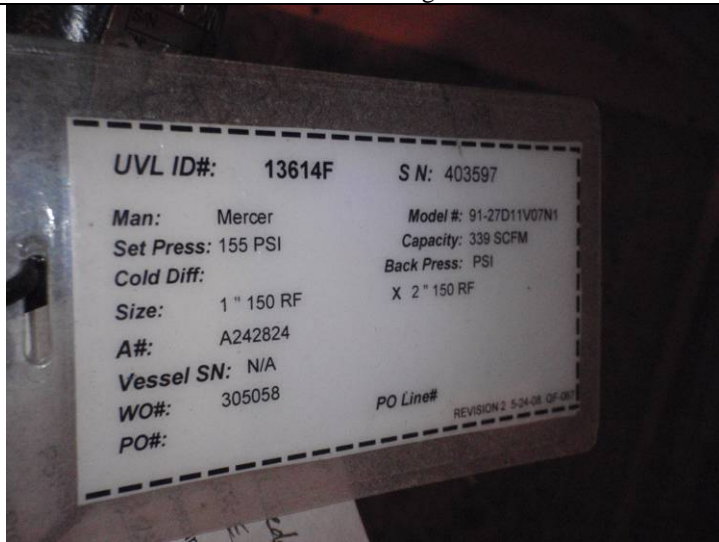
Valving Ensure no leaks are visible. Valves are properly supported and chained if necessary.	X				No leaks are visible. Valves are supported properly.
PSV Ensure PSV is set at pressure at or below that of vessel.	X				Location: Top shell - set below MAWP of vessel. Discharge piping is same size as valve outlet. PSV seal in place – no block valve between vessel and PSV.
