Client	Canadian Natural Resources Ltd.	Inspection Date	Jul 2, 2019		
Prov. Reg. #	AB 0662699	Inspection Type	VE / UT		
Equipment Type	Horizontal Glycol Cooler	Location	Gold Creek		
Tag/Equip.		LSD	AB 13-26-067-05W6		
Status	In Service	Downhole LSD			
Manufacturer	Calhex Industries Ltd	Area			
Serial Number	16-1139	Year Built	2016		
CRN #	Y2702.2	Service	Glycol		
Comp/Unit Id	Glycol Area	Manway	None		
Nat.Board #		Coating			
Interim Insp'n		Interim Type			
Next Thorough Insp	2024	Next Insp Type	VE / UT		
Length		Height			
Volume		Client Reference			
Owner	Canadian Natural Resources Ltd.	RT		HT	YES
Foreman	Chris Maxsom	RAE Job No.	8364		
ABSA	Plant: H Vessel: T Process: H Special: B	ASME	Sec. VIII div. 1		
History Log

Report No: KM004790

RAE Engineering and Inspection Ltd 4810 - 93 Street Edmonton, AB, T6E 5M4 ph: 780-469-2401 fx: 780-468-2422		Inspection Date: 2-Jul-19	Ultrasonic Thickness Examination
			Page: 1 of 4	
	Client: Canadian Natural Resources Ltd.		RAE Report #: 19-8364-LC-UT-65	
Address: Suite 2500, 855-2St., SW, Calgary, AB, T2P4J8		Project #: 8364		
Client P.O.#: NA		Location/LSD: Gold Creek / 13-26-067-05 W6		
Client Representative: NA		Procedure: NDE-701B UT-1 REV.

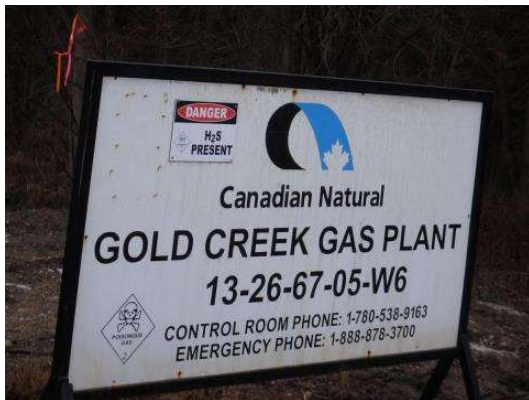
Figure: 1

Vessel Location

The cooler was located outside any building structures.

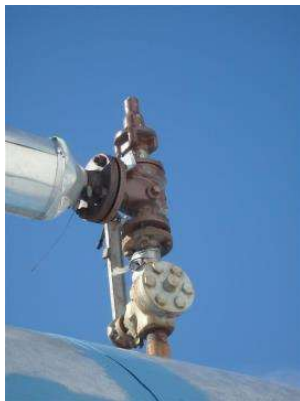
Figure: 2

The Pressure Safety Valve (PSV) was installed outside. The PSV for this particular vessel was attached to the piping. The orientation of the PSV was vertical. It was also noted that the PSV was in good condition. The seal on the PSV was intact and the PSV was easily accessible for inspection. The set pressure of this particular PSV is acceptable to the maximum allowable working pressure of the vessel.

PSV Overview

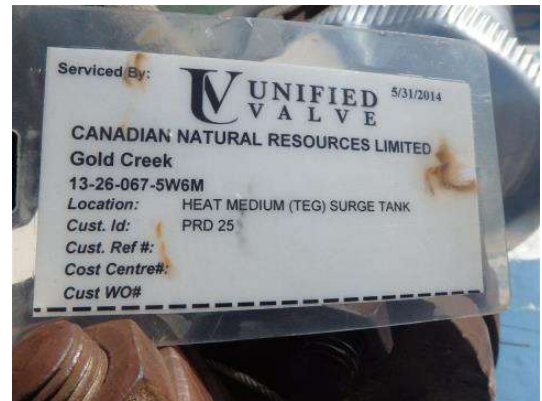
Figure: 3

PSV Service Tag

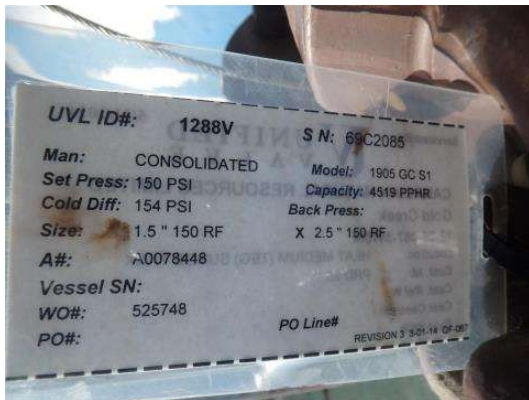
Figure: 4

PSV Service Tag 1

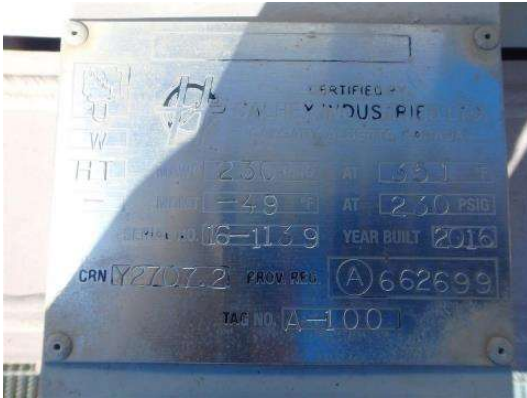
Figure: 5

Cooler Nameplate

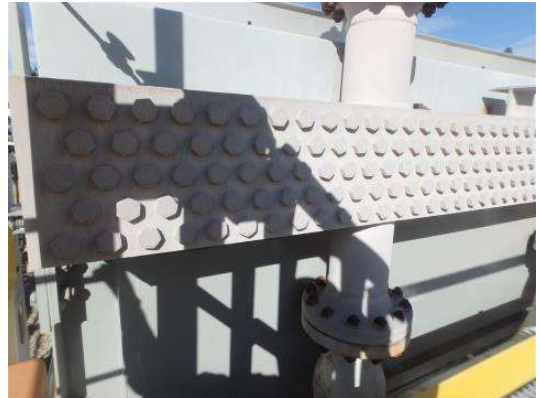
Figure: 6

The cooler was located outside of any building structures. The cooler was identified by it's A/serial number. The cooler was in good condition. No dents or damage evident on the surface of the cooler. This cooler was mounted horizontally. The louvers appeared to be in good operating condition. The cooler was supported by the cooler housing.

Cooler Overview

Based on the scope of this inspection, the vessel appears suitable for continued service.

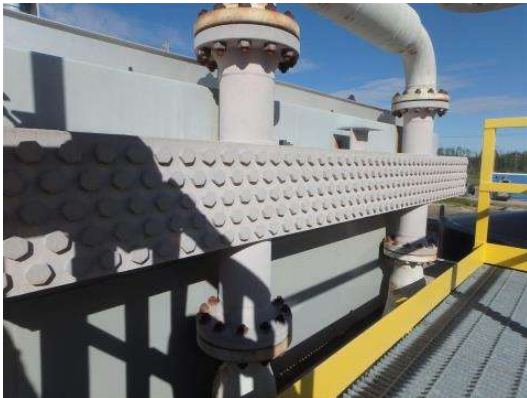
Figure: 7

Cooler Overview 1

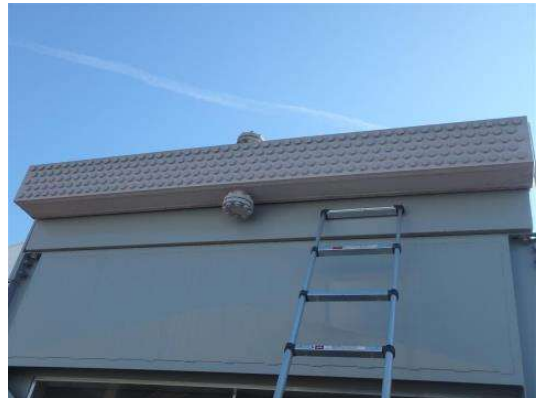
Figure: 8

Cooler Overview 2

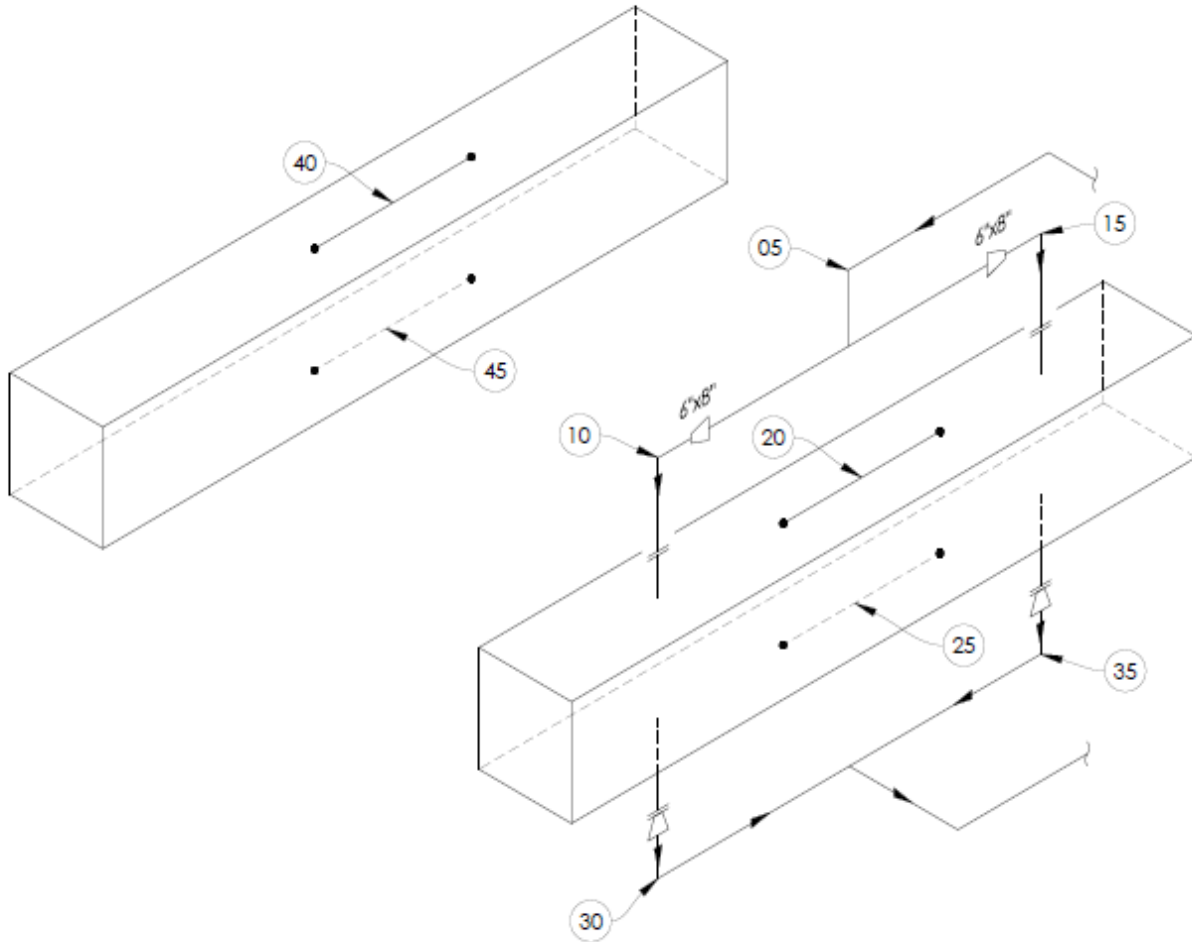
ISO Drawing of Equipment and TMLs

**Results:** The measurements obtained from the inspection locations showed the thickness of all of the components inspected to be consistent in thickness, however no nominal thicknesses were available. There were no signs of wall thinning, internal corrosion, erosion, laminations or inclusions at the time of inspection. All piping measurements were within the 12.5% mill tolerance, as per ASTM specifications.
