Orphan Well Association Inspection Requirements 2016

Location: 07-24-048-27 w4	OW	A Job Numbe	r: 60	2447	
OWA Contact: <u>Sason Alfke</u>	Am	re Location.	1709	17/2016 9/2016	
Inspector: Todd Thomson	Leav	e Location:	Hugi	9/2016	
Was the landowner contacted:	Yes	□ No	☐ Ci	rown	
Name/number of Landowner: $_\mathcal{D}$					
Method of contact and comments:	Phone &	wantse	all be	fore accessing	
Land use (cultivated/pasture/field):	partial	y fence	1 longe		
		, , , , , , , ,			
OWA Coordinator must be contacted IMMEDIATELY if a hazard exists on location. Report with costs to be submitted within 24 hours of inspection date					
Noport With cools to be dubilitied Within 21 hours of mappedien and					
General Observations					
OWA Sign (mandatory)	✓ Yes		No		
AER closure sign	☑ Yes		No		
H2S (if yes, H2S sign required)	✓ Yes		No		
Location Entrance Sign	☑ Yes		No		
Wellhead chained/locked or handle removed	☑ Yes		No		
Wellhead fencing secure	☑ Yes		No		
Winter access (add comments)	□ Yes	2	No

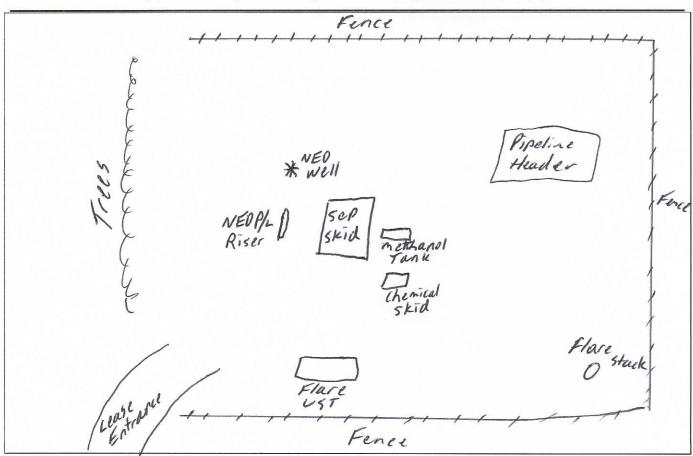
SITE DIAGRAM - Show Lease Entrance

Comments (including landowner interactions/requests as applicable): Site has a directeneryy riser. Suspect methonal tank a chemical pump/tank may be direct energy's withcy are just utilizing it.
