Well & Lease Inspection Form

Well Name: LOG Leduc 11A-31-49-26

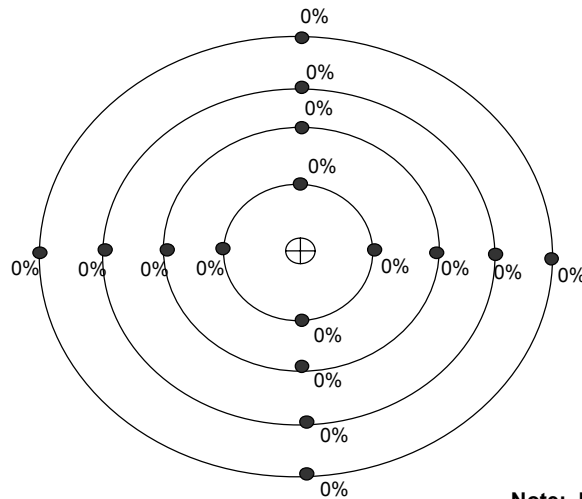
Note: Rings are in 2 meter intervals

Could Positive Results be due to Possible Surface Contamination: Y N Unknown

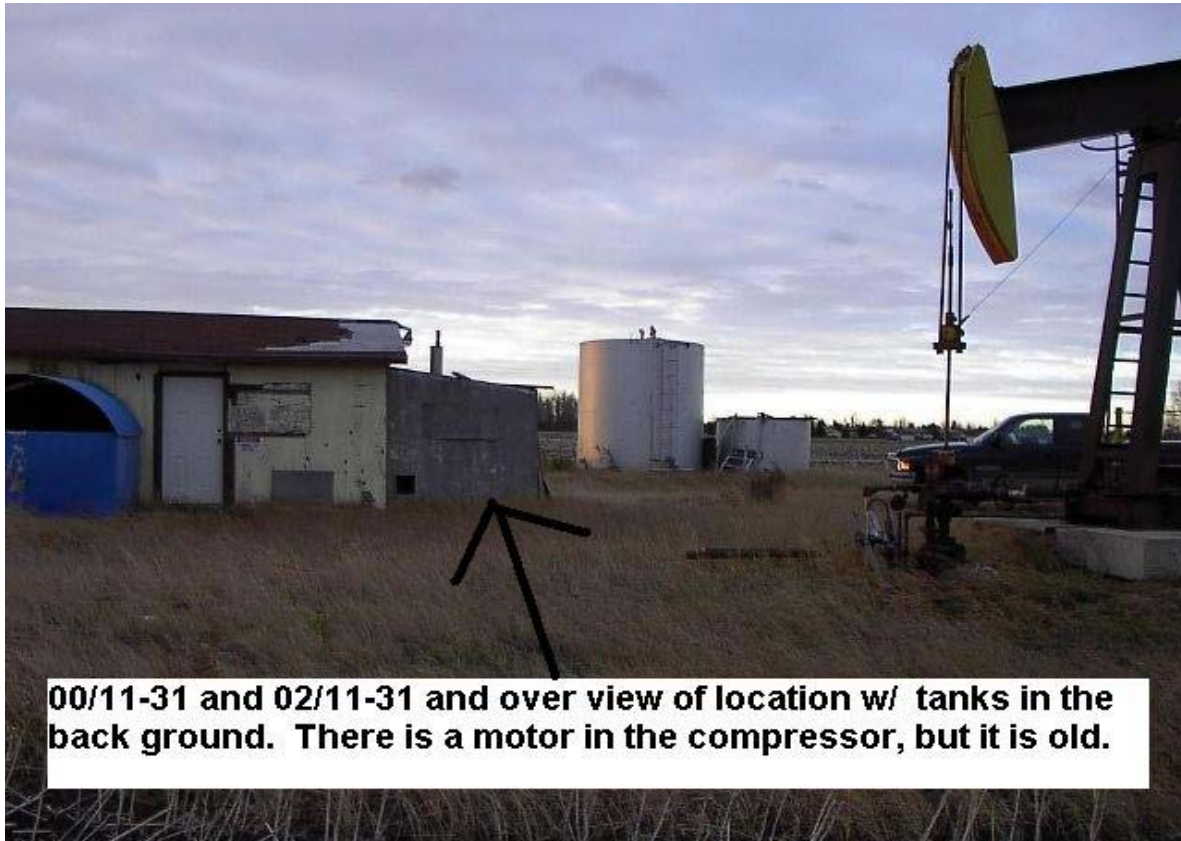
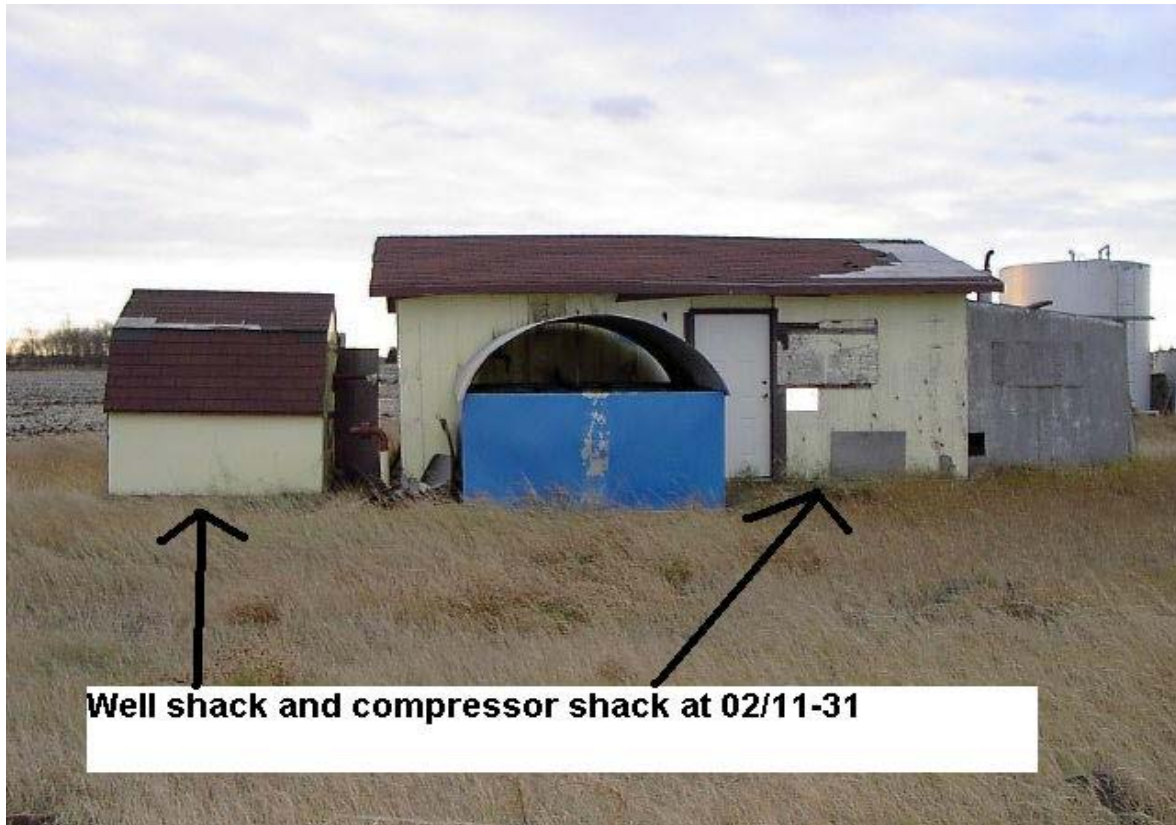
Pictures:

General Comments: Same location as 00/ 11-31-49-26w4m the equipment is mostly scrap quality. The thread-let for the bubble test was stripped; used a plastic bag to conduct the test.

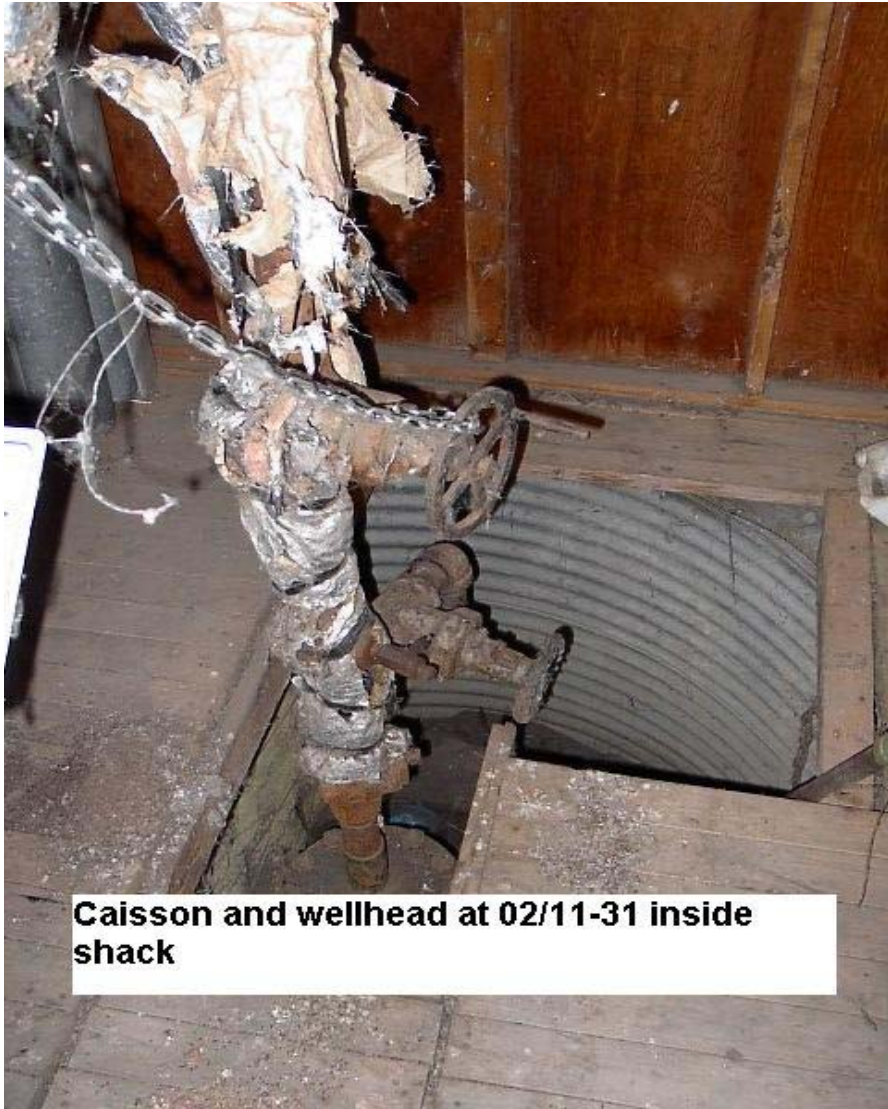
Caisson and wellhead at 02/11-31 inside shack
