**Canadian Natural Resources Limited
GENERAL PRESSURE VESSEL INFORMATION**

Job # 05.001539

District: Ft. St. John B.C.	Skid No.
Facility: Halfway Battery	Location (LSD): 05-12-87-25-W6M.
Vessel Name Equipment Number: Group Separator	
Orientation: Horizontal	
Status: In Service	Regulatory Inspection

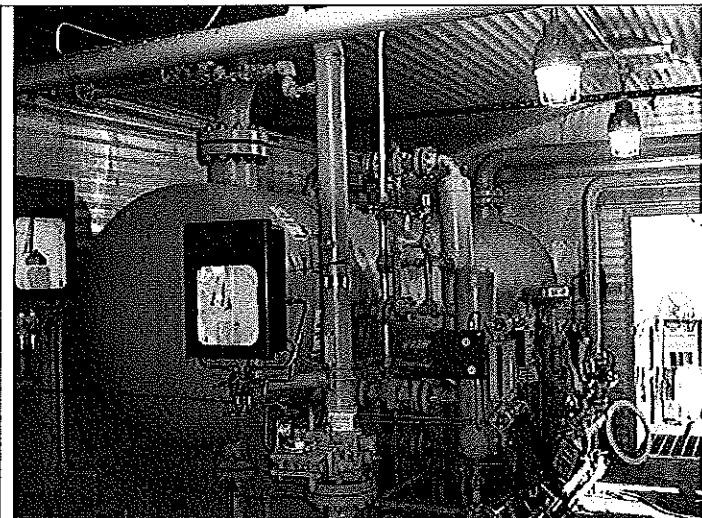
Over view

Leaking flange
