**Canadian Natural Resources Limited
GENERAL PRESSURE VESSEL INFORMATION**

Job # 05.001958

District: Ft. St. John B.C.	Skid No.
Facility: Halfway Battery	Location (LSD): 05-12-87-25-W6M.
Vessel Name Equipment Number: Group Separator	
Orientation: Horizontal	
Status: In Service	Regulatory Inspection

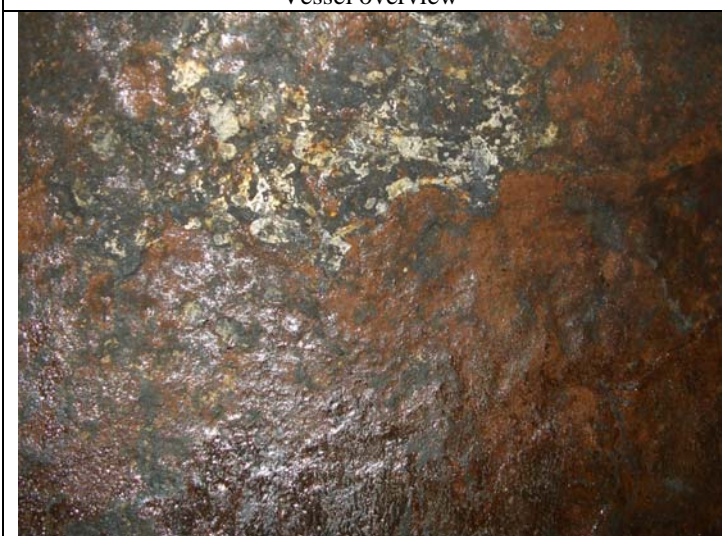
Lower shell pitting to 0.120"

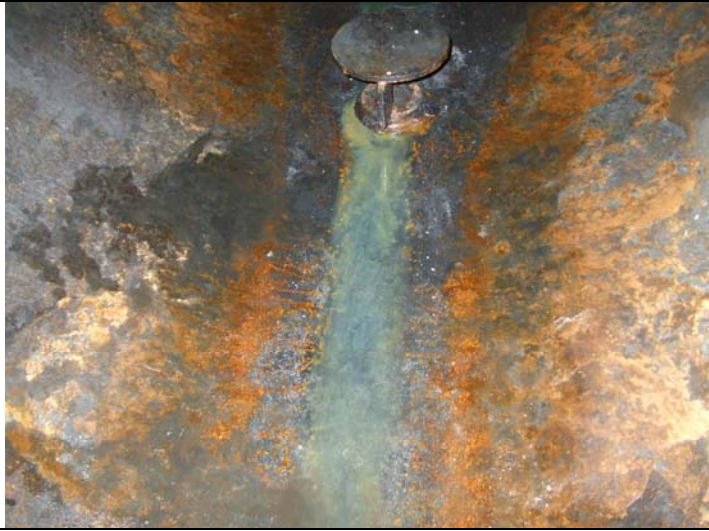
Lower shell pitting to 0.120"

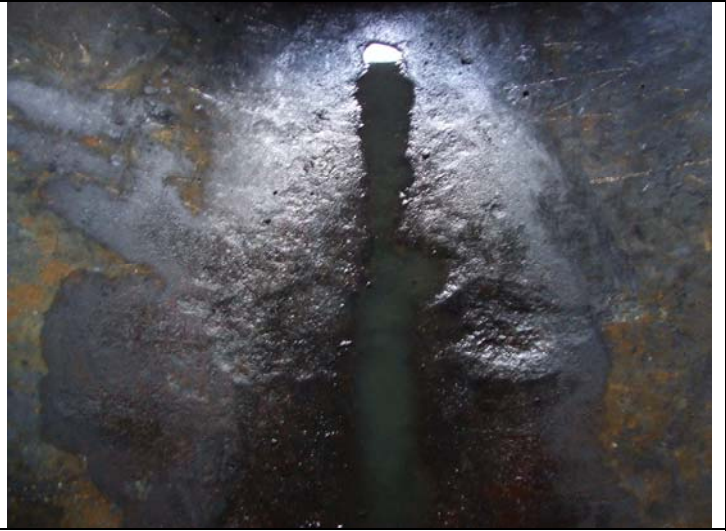
Lower shell pitting to 0.120" @ manway
