**Canadian Natural Resources Limited
GENERAL PRESSURE VESSEL INFORMATION**

Job # 105.00774

District: Ft St John B.C.	Skid No.
Facility: Halfway Battery	Location (LSD): 05-12-87-25-W6M.
Vessel Name & Equipment Number: Test Separator	
Orientation: Vertical	
Status: In service	Regulatory Inspection

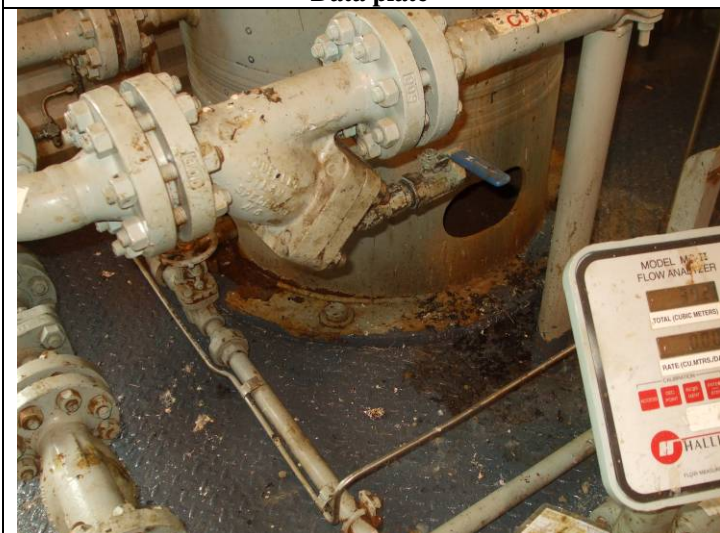
Skirt anchored securely
