**Canadian Natural Resources Limited  
GENERAL PRESSURE VESSEL INFORMATION**

District: <b>Ft. St. John B.C.</b>	Skid No.
Facility: <b>Halfway Battery</b>	Location (LSD): <b>05-12-87-25-W6M.</b>
Vessel Name Equipment Number: <b>Test Separator (oil)</b>	
Orientation: <b>Vertical</b>	
Status: <b>In Service</b>	Regulatory Inspection

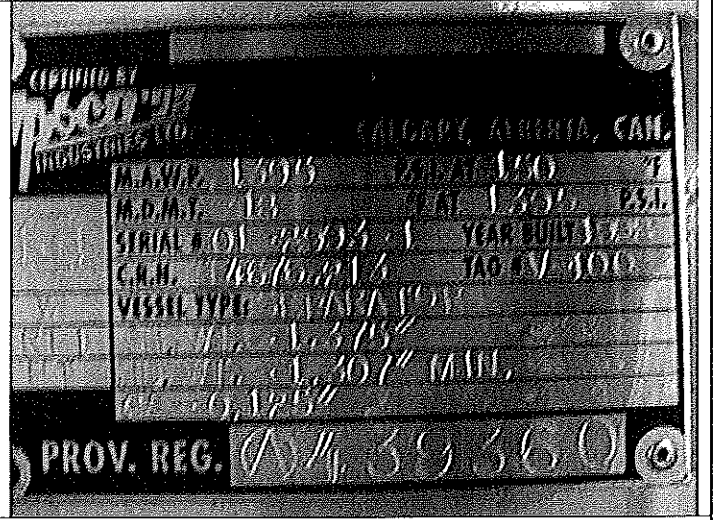
Data Plate

"A" or "G" or "S" (Sask.) or BC Registration Number. A# <b>439360</b>		CRN Number: N <b>4676.21</b>	
Vessel serial number: <b>01-2993-1</b>		Size: <b>32 in OD X 94 in. S/S</b>	
Shell thickness: <b>34.9 mm</b>		Shell material: <b>SA 516 70 N</b>	
Head thickness: <b>33.2 mm</b>		Head material: <b>SA 516 70 N</b>	
Tube wall thickness:		Tube material:	
Tube diameter:		Tube length:	
Channel thickness:		Channel material:	
Design pressure	Shell: <b>1395 psi</b>	Operating pressure	Shell:
	Tubes:		Tubes:
Design Temp.	Shell: <b>150 deg. F</b>	Operating temperature	Shell:
	Tubes:		Tubes:
X-ray: <b>RT-1</b>		Heat treatment: <b>Yes</b>	
Code parameters: <b>ASME VIII Div. 1</b>		Coated: <b>No</b>	
Manufacturer: <b>Opsco</b>		Year built: <b>1998</b>	
Corrosion allowance: <b>3.2 mm</b>		Manway: <b>Yes</b>
