**Canadian Natural Resources Limited
GENERAL PRESSURE VESSEL INFORMATION**

Job # 105.00774 / 10.110433

District: Ft St John B.C.	Skid No.
Facility: Halfway Battery	Location (LSD): 05-12-87-25-W6M
Vessel Name & Equipment Number: Group Separator	
Orientation: Horizontal	
Status: In service	Regulatory Inspection

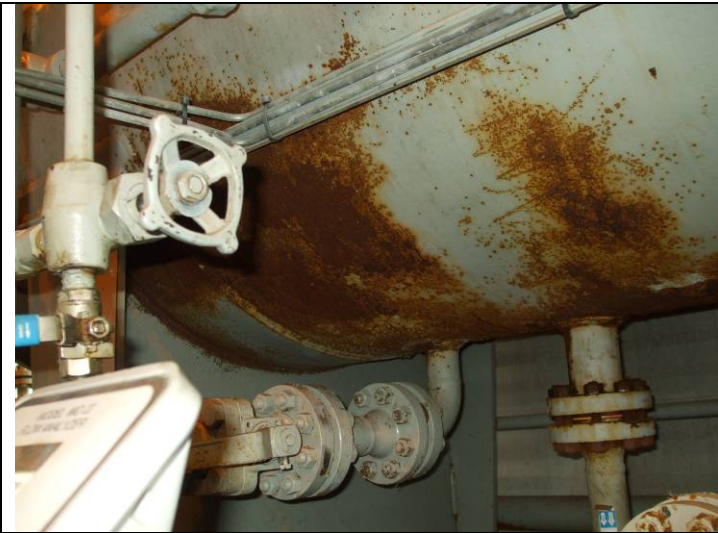
External corrosion to 30% of shell

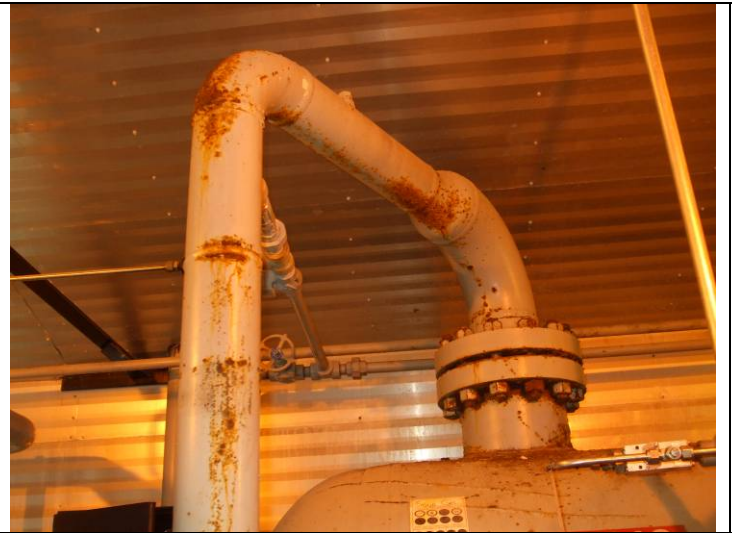
Anchor Bolts Hammer tap to ensure secure. Look for cracking in treads or signs of deformation.	X				Firmly bolted to the skid floor. No signs of deformation.
Concrete foundation Check for cracks, spalling, etc.				X	None.
Ladder / Platform Describe general condition, ensure support is secure to vessel, describe any hazards.				X	None.
Nozzle Assess paint, look for leakage, and ensure stud threads are fully engaged. Record any damage, deflection, etc. Are nozzles gusseted?	X				Stud threads are fully engaged to nuts. No damage or deflections observed – no leaks. Paint in good condition. Nozzles are not gusseted.
Gauges Ensure gauges are visible, working, no leakage, and suitable for range of MAWP/Temp.	X				Gauges visible, appears to be functional, no leaks and suitable for range of MAWP/Temp. Pressure gauge: 0-1500 PSI / 100 PSI @ gauge. Temperature gauge: 0-250 deg F / 50 deg F @ gauge.
External Piping Ensure pipe is well supported. All clamps, supports, shoes, etc. in place. Look for evidence of structural overload, deflection, etc. Paint condition, external corrosion?		X			Piping is well supported; all clamps, supports, and shoes are in place. No structural overloads or deflections noted. Exposed metal with volcanic corrosion is present to approx 30% of all piping, as best effort pitting was noted to approx 0.020" deep.

<p>NDE methods Was UT/ MPI done on vessel (MI coordinator to review results)</p>	X			<p>Ultrasonic thickness survey carried out – pipe metal thickness detected below nominal minus corrosion allowance. Thickness calculations carried out – 2 inch 90 degree elbow - nominal thickness is 5.5 mm, min thickness is 3.6 mm, T min thickness is 2.6 mm.</p> <p>The float column has some internal corrosion as well – determined to be 8 inches diameter and 8.2 mm thick – At current MAWP, this column does not have sufficient metal for safe operation – Nominal thickness is 8.2 mm, min thickness is 6.6 mm, T min thickness is 6.4 mm.</p> <p>Note: There appears to be a general corrosion problem with the drain and dump piping – however not much change from the 2008 corrosion survey.</p>
<p>Recommendations or corrective actions : Vessel is Fit for Service or describe corrective actions required) (MIC to review corrective actions with Operations, discuss with Chief Inspector where necessary, and get remedial action implemented)</p> <p>Recommendations: 1. Grit blast and repaint this vessel & all corroded piping. 2. Reduce the moisture content inside this building. 3. Plan for corrosion monitoring on the dump and drain piping every 1 to 2 years. 4. Replace 8 inch float column – corrosion throughout.</p> <p>Summary: This vessel is in good over all condition, visual external and ultrasonic thickness survey carried out - pipe metal thickness detected below nominal minus corrosion allowance. Thickness calculations carried out to ensure sufficient metal exists for safe operation.</p> <p>Vessel is fit for continued service.</p>

External corrosion to 30% of the piping surfaces

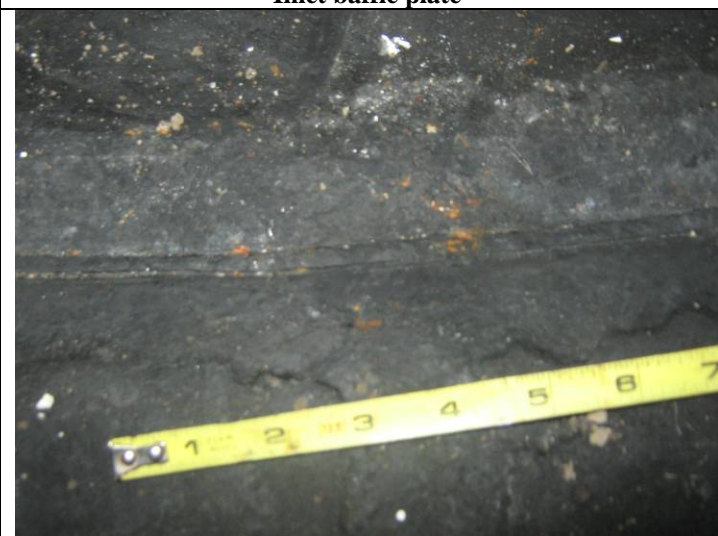
Corrosion at north head to shell weld

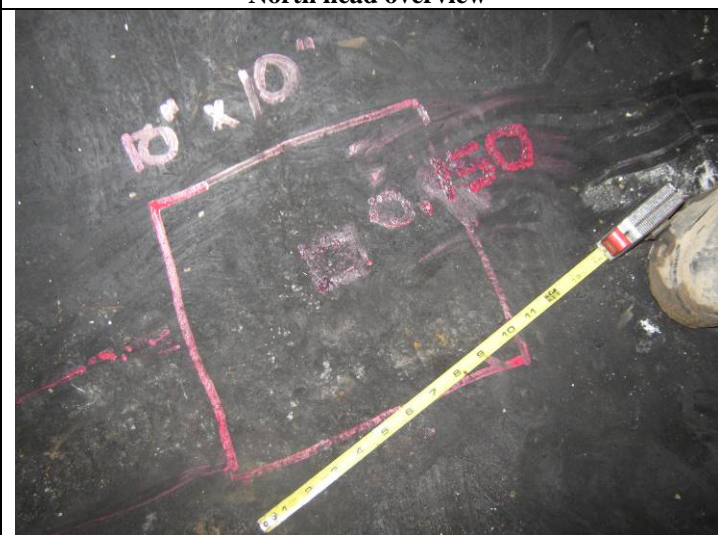
<p>Shell Sections Record number of shell sections. Record location, size and depth of all erosion, corrosion or mechanical damage. Describe General condition.</p>		X			2 shell sections. Water side of vessel has corrosion at the 5:00 to 7:00 position to 0.150 inch mainly in two localized areas: 1. 10" x 10" area 27 inches from north head to shell weld. 2. 16" x 18" area located at the mid shell drain nozzles. Calculations carried out: Nominal thickness 50.8 mm. Min thickness is 46.8 mm. T _{min} =42.9 mm
<p>Demister pad Is it in place? Is it clean? If any corrosion is apparent in vessel, lift pad and check top head for corrosion.</p>		X			The demister pad is compacted and out of place. Operations notified.

Water side corrosion to max depth of 0.150 inch

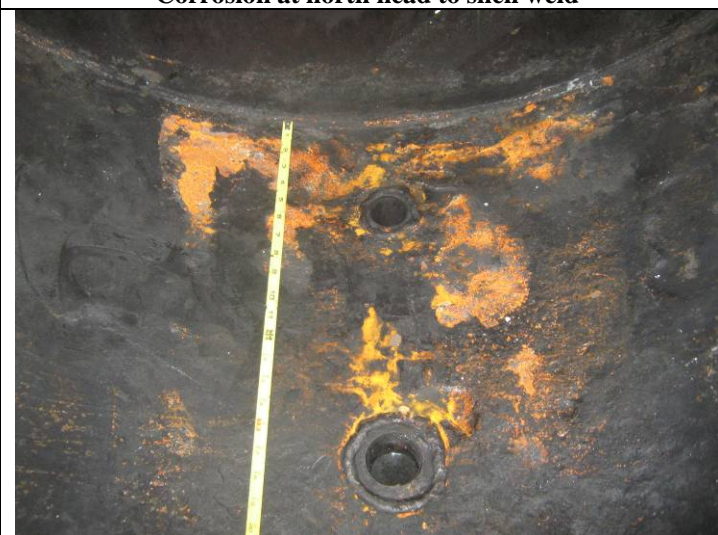
Water side corrosion at weir plate to max depth of 0.150 inch

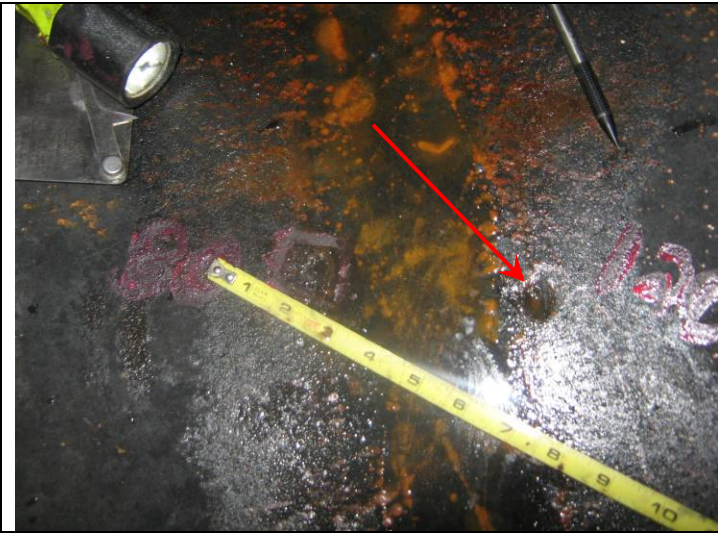
Oil side isolated pitting to 0.120 inch

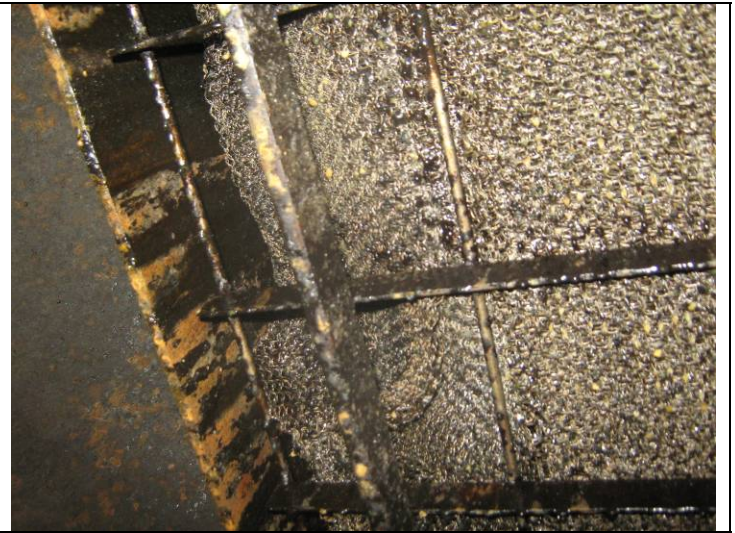
Demister pad partially compressed

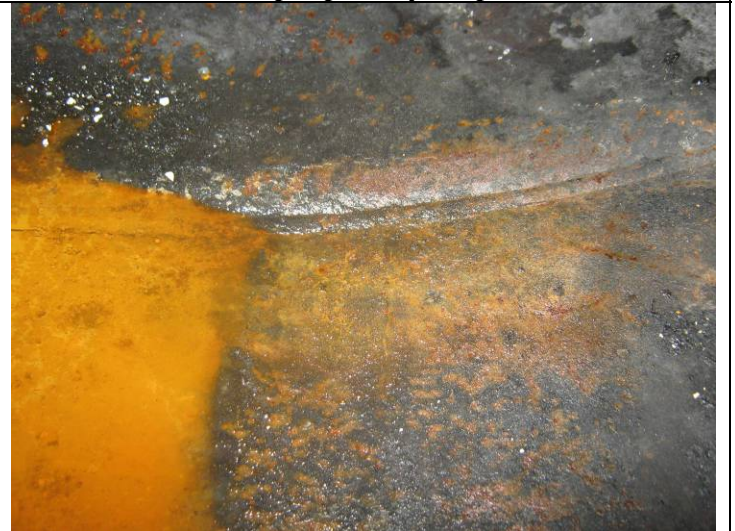
South head weld – minimal corrosion

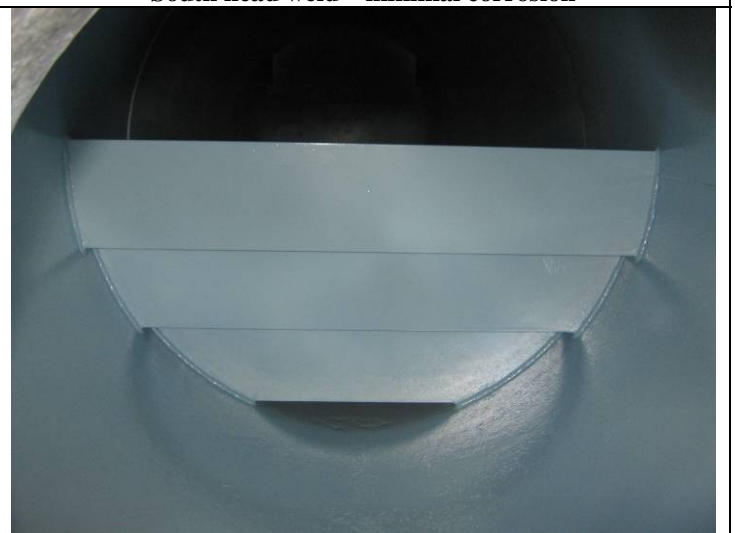
Lower half of vessel internally coated
