**Canadian Natural Resources Limited
GENERAL PRESSURE VESSEL INFORMATION**

Job # 10.110452

District: Fort St John, B.C.	Skid No.
Facility: Flat Rock Compressor Station	Location (LSD): 5-2-85-17 W6M
Vessel Name Equipment Number: Treater	
Orientation: Horizontal	
Status: In Service	Regulatory Inspection

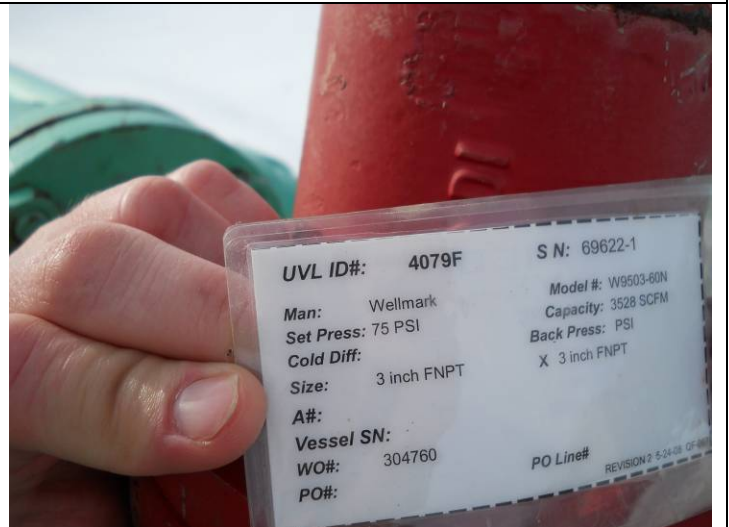
PSV Tag

UVL ID#: 4079F	S N: 69622-1
Man: Wellmark	Model #: W9503-60N
Set Press: 75 PSI	Capacity: 3528 SCFM
Cold Diff:	Back Press: PSI
Size: 3 inch FNPT	X 3 inch FNPT
A#:	
Vessel SN:	
WO#: 304760	PO Line#
PO#:	REVISION 2 6-24-09 OF 888

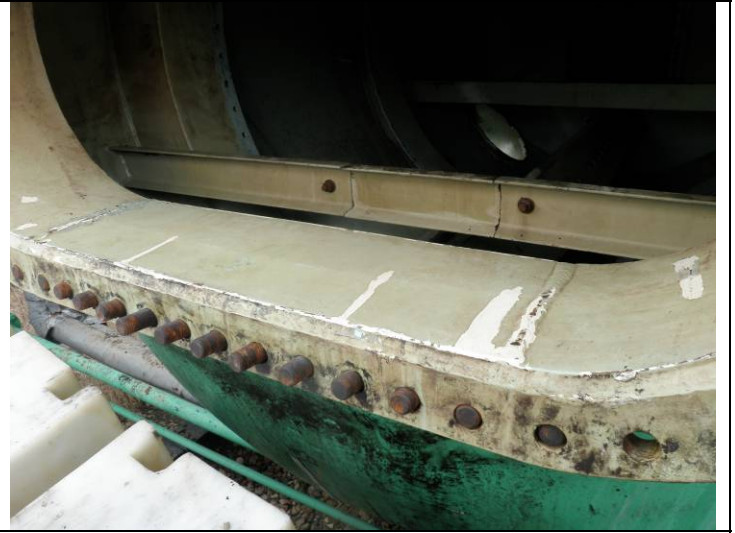
Previous coating repairs

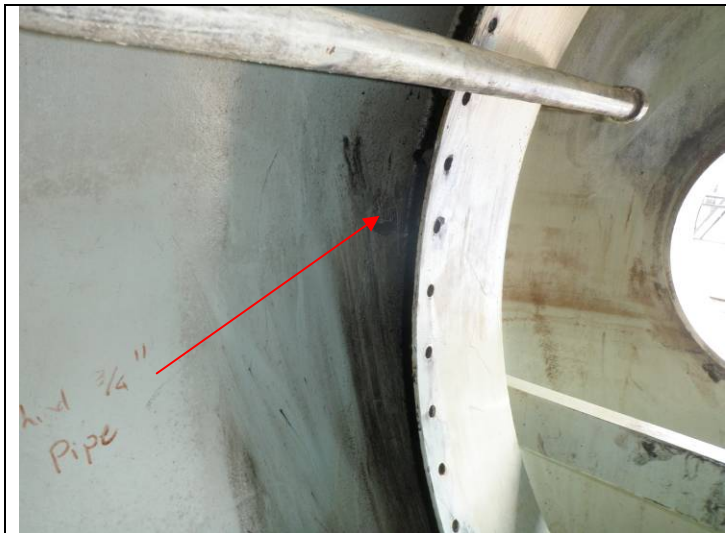
Coating failure at shell

Internal Inspection Items	G	F	P	N/A	Comments
Coating Assess coating. Describe area coated, general condition of coating.		X			Coating is in fair condition. Some minor failures at manways, shell and nozzles. Surface corrosion to depths of 0.010 inches at failed locations. <u>These coating failures were patched with Davoc #142</u>
Anodes. How many, type, condition. % consumed. Are they being replaced?	X				2 Anodes measuring 42 x 3 inches are installed in Treater. Consumption of approximately 10 %. Existing anodes will be installed.
Internal Piping Is there any? If so, carbon or stainless steel. Describe condition, dents, corrosion, erosion, etc. Ensure supports are secure and any bolts are suitable for future use.	X				Internal piping is in good condition. No signs of deflection. Well supported.
Trays How many? Type of material. Are valves in place? Check for erosion/ corrosion; wear on tray valve legs. Cleanliness?				X	No trays.

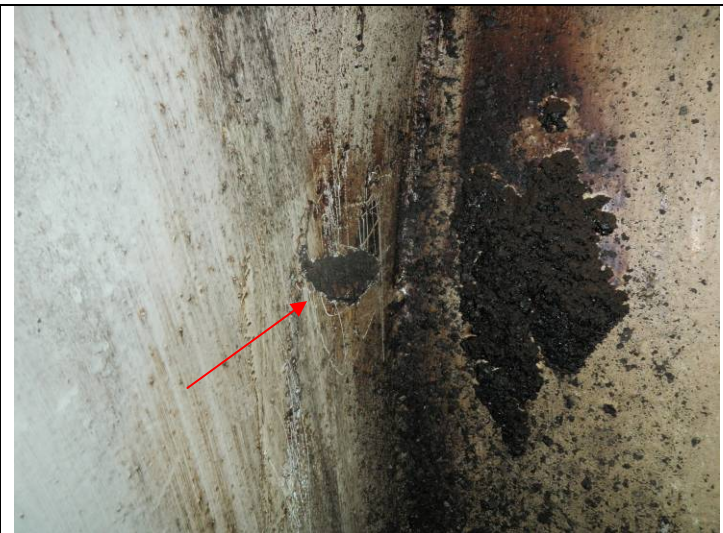
Coating Failure - surface corrosion to depth of 0.010 inch

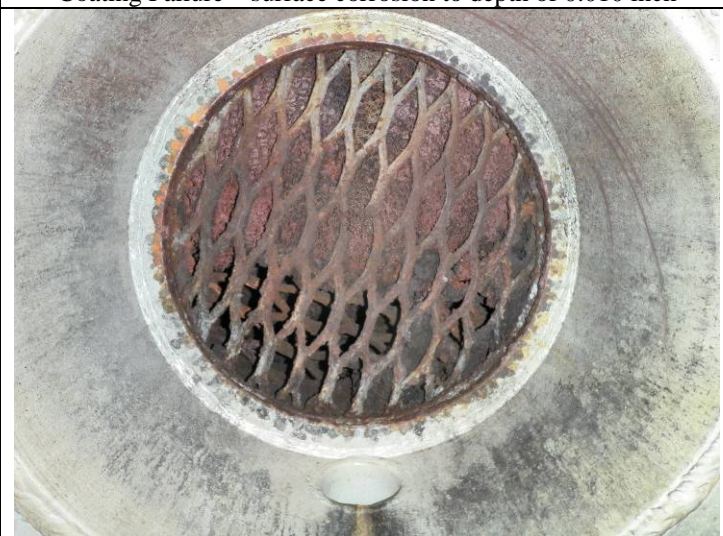
Demister pad Is it in place? Is it clean? If any corrosion is apparent in vessel, lift pad and check top head for corrosion.			X		Dirty and corroded.
Welds Inspect all welds, including attachment welds. Record all service-related damages and if there is any discuss with Chief Inspector before closing.	X				Good condition, no corrosion or pitting.
Repairs Required. If yes, ensure procedure and copy of AB 40 is on file, and one sent to local ABSA, and Chief Inspector	X				Patch repairs to coating were carried out.
NDE Was any NDE done. (MI coordinator to review results)				X	No internal NDE at this time.
Recommendations or corrective actions : Vessel is Fit for Service or describe corrective actions required) (MIC to review corrective actions with Operations, discuss with Chief Inspector where necessary, and get remedial action implemented) Recommendations: Replace demister pad. Plan for possible complete coating of vessel next outage. Summary: This vessel is in good overall condition, visual internal carried out. Vessel is fit for service

Demister pad - dirty and corroded

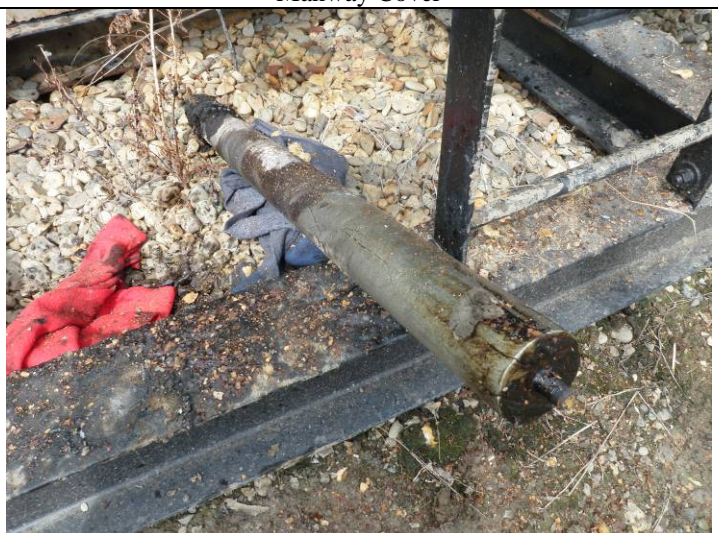
Typical Anode - 10 % loss
