**Canadian Natural Resources Limited
GENERAL PRESSURE VESSEL INFORMATION**

Job # 05.01610

District: Fort St John, B.C.	Skid No.
Facility: Flat Rock Compressor Station	Location (LSD): 5-2-85-17 W6M
Vessel Name Equipment Number: Inlet Contactor	
Orientation: Vertical	
Status: In Service	Regulatory Inspection

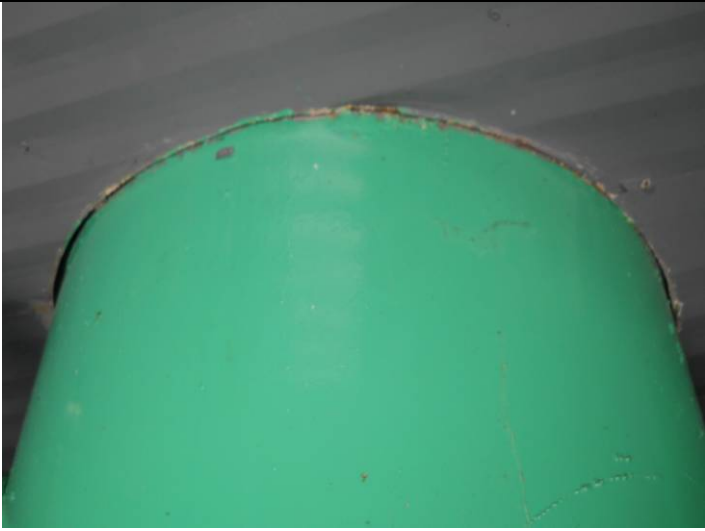
External Inspection Items	G	F	P	N/A	Comments
Insulation Verify sealed around manways, nozzles, no damage present, and there is no egress of moisture.	X				No Insulation present. Roof seal is broken
External Condition Assess paint condition, areas peeling, record any corrosion, damage, etc (record location, size and depth of corrosion or damage)	X				Paint is in good overall condition – no exposed metal
Leakage Record any leakage at flanges, threaded joints, weep holes on repads, etc.	X				No leaking detected.
Saddle/skirt Assess condition of paint, fire protection, and concrete. Look for corrosion, buckling, dents, etc. Look at vessel surface area near supports. Verify no signs of leakage at attachment to vessel and attachment welds are acceptable. Ground wire attached?	X				Skirt is in good condition – no buckles or distortion. Internally skirt is corroding Paint intact – with little to no corrosion. Vessel grounded through the skid package. No signs of leakage.

Roof seal

Recommendations: 1) Sandblast and paint under skirt.2) Repair roof seal

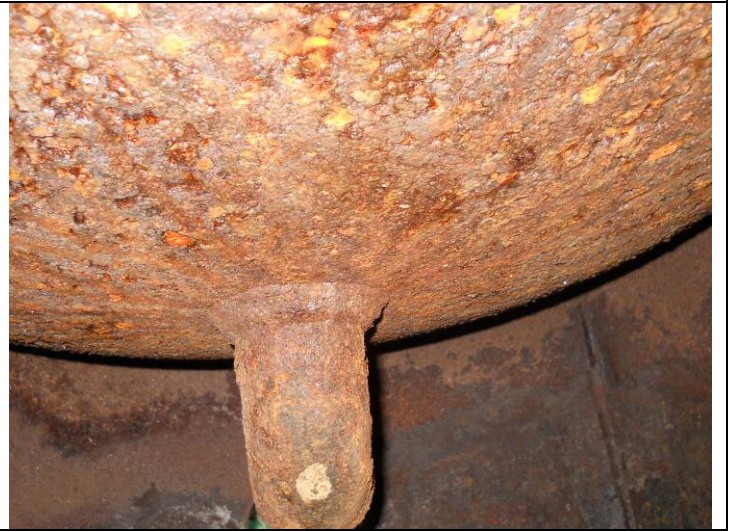
Heavy External scaling under skirt
