Canadian Natural Resources Limited
GENERAL PRESSURE VESSEL INFORMATION **Job # 05.002893**

District: Fort St. John BC.	Skid No.
Facility: Jedney Field	Location (LSD): d-B1-L/94-G-8
Vessel Name Equipment Number: Flare Knock Out Drum	
Orientation: Horizontal	
Status: In Service	Regulatory Inspection

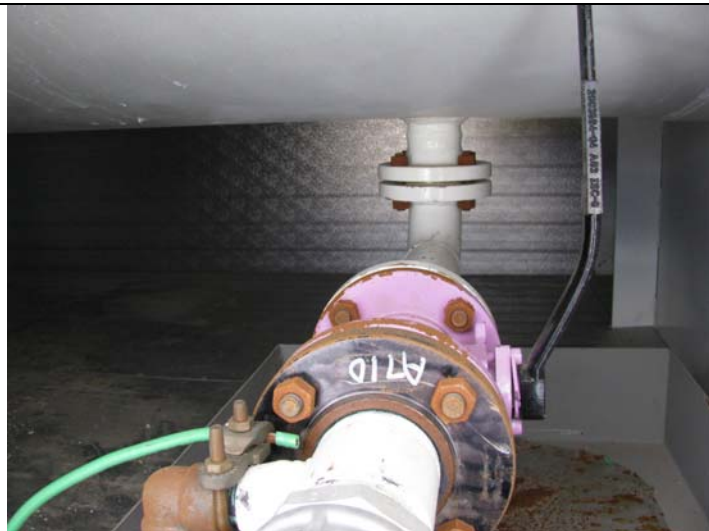
Truck-out piping is in good condition.

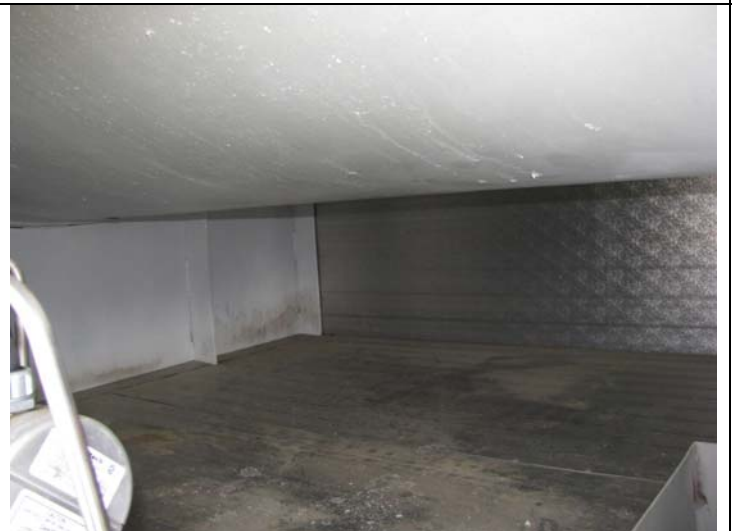
No underside corrosion.

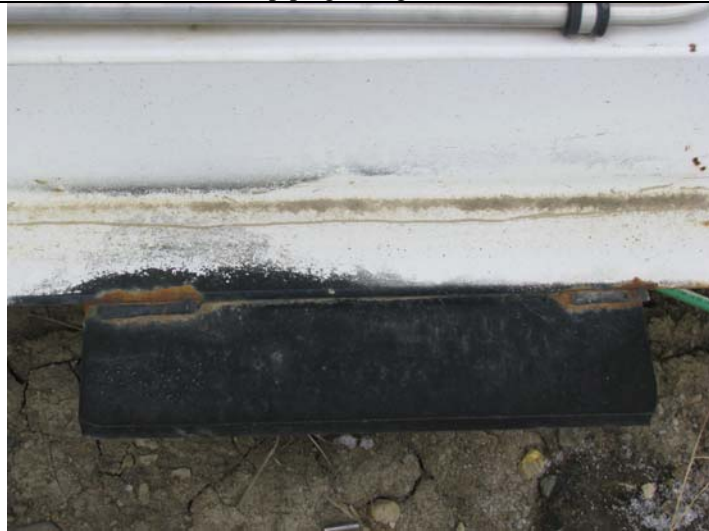
Anchor Bolts Hammer tap to ensure secure. Look for cracking in treads or signs of deformation.	X				Welded to pilings.
Concrete foundation Check for cracks, spalling, etc.				X	
Ladder / Platform Describe general condition, ensure support is secure to vessel, describe any hazards.				X	
Nozzle Assess paint, look for leakage, and ensure stud threads are fully engaged. Record any damage, deflection, etc. Are nozzles gusseted?	X				Stud threads are fully engaged to nuts. No leaks observed. No damage or deflections. Nozzles are not gusseted.
Gauges Ensure gauges are visible, working, no leakage, and suitable for range of MAWP/ Temp.	X				Gauges are clear and appear functional. Within range of the MAWP.
External Piping Ensure pipe is well supported. All clamps, supports, shoes, etc. in place. Look for evidence of structural overload, deflection, etc. Paint condition, external corrosion?	X				Piping is in good condition and well supported. No apparent overloads or obviously deformed sections. Paint is in good condition.

Vessel is welded to the pilings.

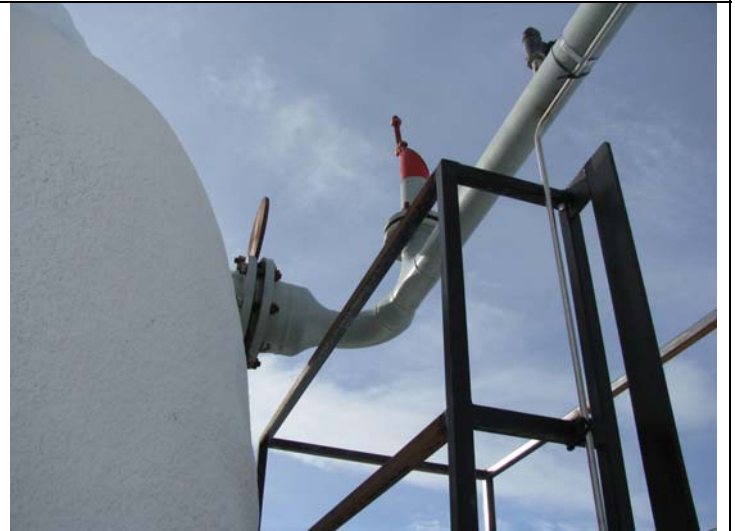
Piping is in good condition and well supported.
