Canadian Natural Resources Limited
GENERAL PRESSURE VESSEL INFORMATION **Job # 10.111579**

District: Fort St. John BC.	Skid No.
Facility: Jedney Field	Location (LSD): d-B1-L/94-G-8
Vessel Name Equipment Number: Flare Knock Out Drum	
Orientation: Horizontal	
Status: In Service	Regulatory Inspection

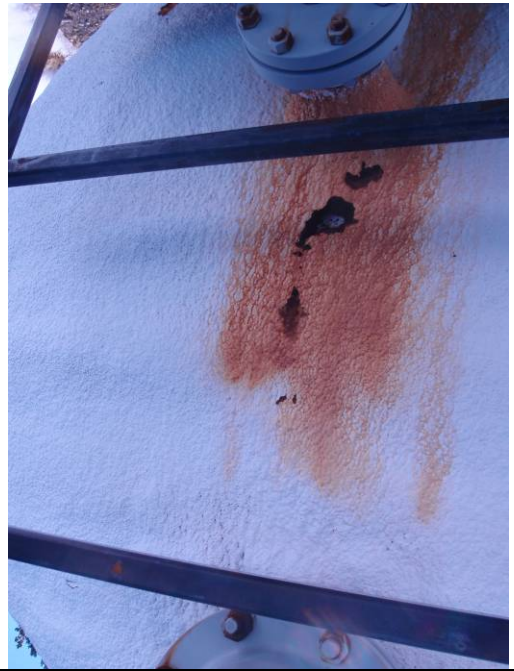
damage to insulation - inlet
