**Canadian Natural Resources Limited  
GENERAL PRESSURE VESSEL INFORMATION**

District: <b>Fort St. John BC.</b>	Skid No.
Facility: <b>Beaton Gas Field – K Battery</b>	Location (LSD): <b>d-48-K-94-H-2</b>
Vessel Name Equipment Number: <b>Group Separator</b>	
Orientation: <b>Vertical</b>	
Status: <b>In Service</b>	<b>Regulatory Inspection</b>

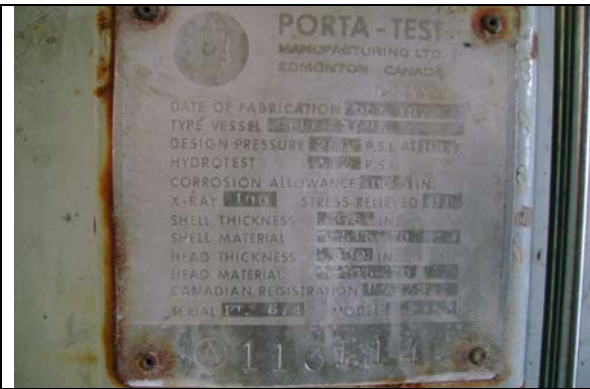
vessel data plate

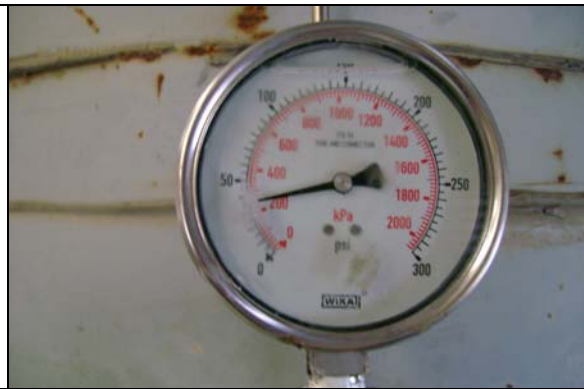
vessel pressure gauge

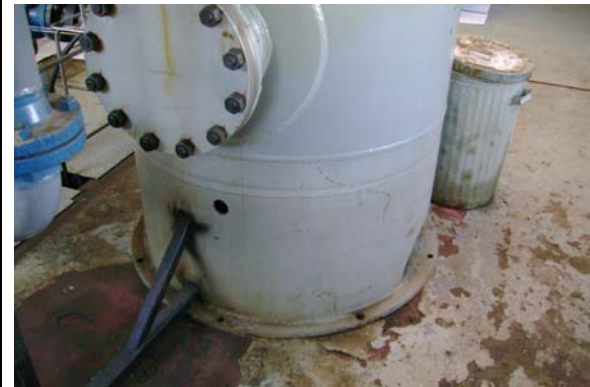
<b>Anchor Bolts</b> Hammer tap to ensure secure. Look for cracking in treads or signs of deformation.				X	<b>Vessel not anchored to deck.</b>
<b>Concrete foundation</b> Check for cracks, spalling, etc.				X	
<b>Ladder / Platform</b> Describe general condition, ensure support is secure to vessel, describe any hazards.				X	
<b>Nozzle</b> Assess paint, look for leakage, and ensure stud threads are fully engaged. Record any damage, deflection, etc. Are nozzles gusseted?	X				<b>Stud threads are fully engaged. No leaks observed</b> <b>No damage or deflections</b> <b>Nozzles are not gusseted</b>
<b>Gauges</b> Ensure gauges are visible, working, no leakage, and suitable for range of MAWP/ Temp.	X				<b>Gauge is clear and clean. No leakage</b> <b>Suitable for range of MAWP/Temperature</b> <b>Pressure gauge 0 – 2000 KPa</b>
<b>External Piping</b> Ensure pipe is well supported. All clamps, supports, shoes, etc. in place. Look for evidence of structural overload, deflection, etc. Paint condition, external corrosion?	X				<b>Piping is well supported – all clamps and supports are in place.</b> <b>No structural overloads or deflections.</b> <b>Paint in good condition – no corrosion.</b>

vessel skirt not anchored

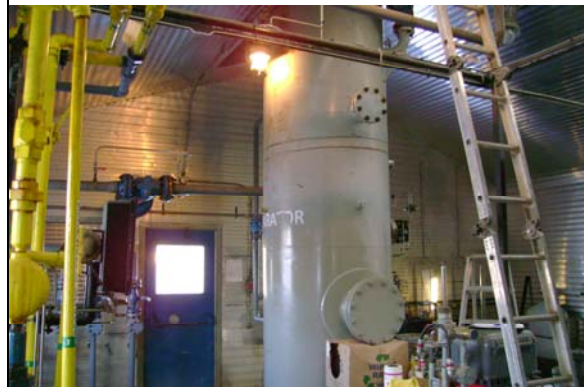
vessel overview

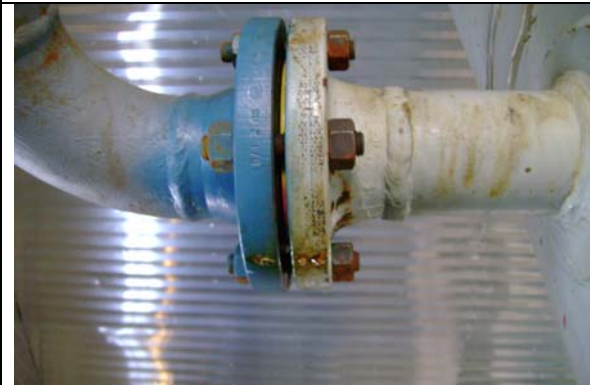
vessel piping flange to nozzle leak
