**Canadian Natural Resources Limited
GENERAL PRESSURE VESSEL INFORMATION**

District: Grande Prairie	Skid No.
Facility: G&D Oilfield Services Yard in Fort St. John	Location (LSD):
Vessel Name Equipment Number: Separator	
Orientation: Vertical	
Status: Out of Service	Regulatory Inspection

**Canadian Natural Resources
G&D Oilfield Services Yard (Fort St John)
Vertical Separator, A 113114**

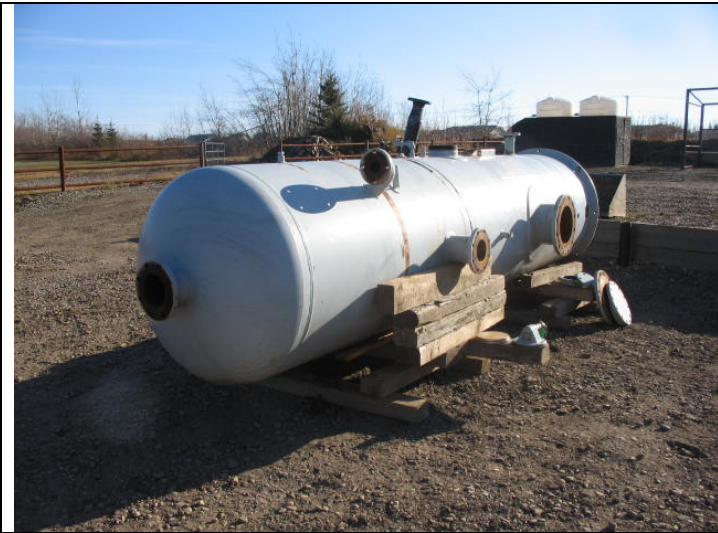
Vessel Overview

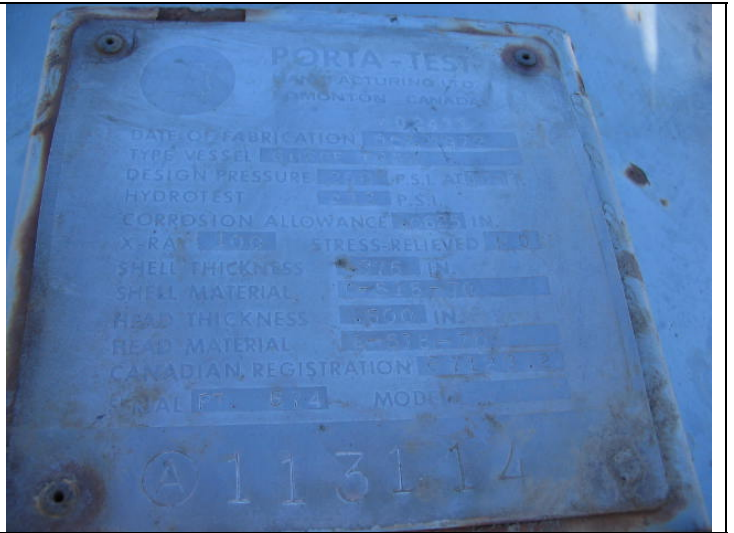
Data plate

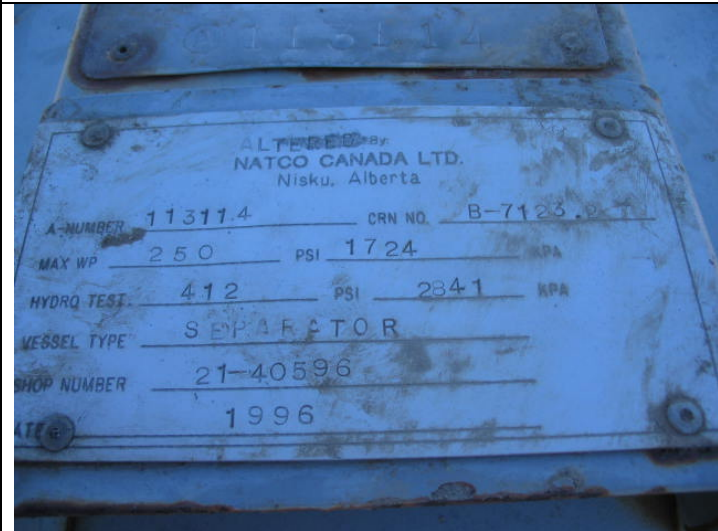
Alteration data plate

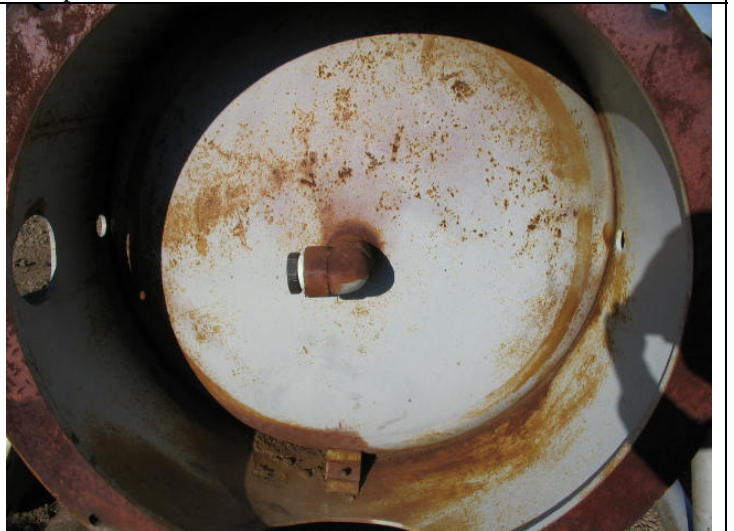
External of bottom head

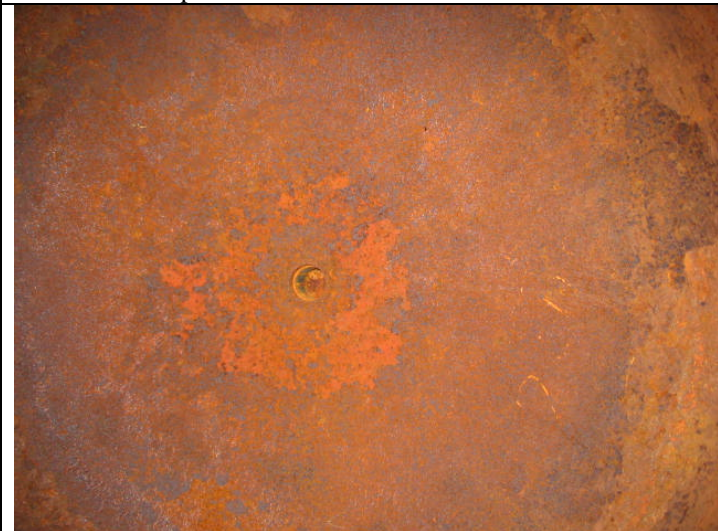
Bottom head Note all corrosion, erosion or mechanical damage. (If vessel is horizontal identify direction of this head)	X				Minor scale buildup No pitting noted
Shell Sections Record number of shell sections. Record location, size and depth of all erosion, corrosion or mechanical damage. Describe general condition. If any corrosion greater than corrosion allowance is observed in either shell or head, discuss with Chief Inspector before closing vessel.	X				Two shell sections No corrosion or pitting noted
Demister pad Is it in place? Is it clean? If any corrosion is apparent in vessel, lift pad and check top head for corrosion.	X				Intact, in place and clean
Welds Inspect all welds, including attachment welds. Record all service-related damages and if there is any discuss with Chief Inspector before closing.	X				No corrosion or damage
Repairs Required. If yes, ensure procedure and copy of AB is on file, and one sent to local ABSA, and Chief Inspector				X

Internal of bottom head

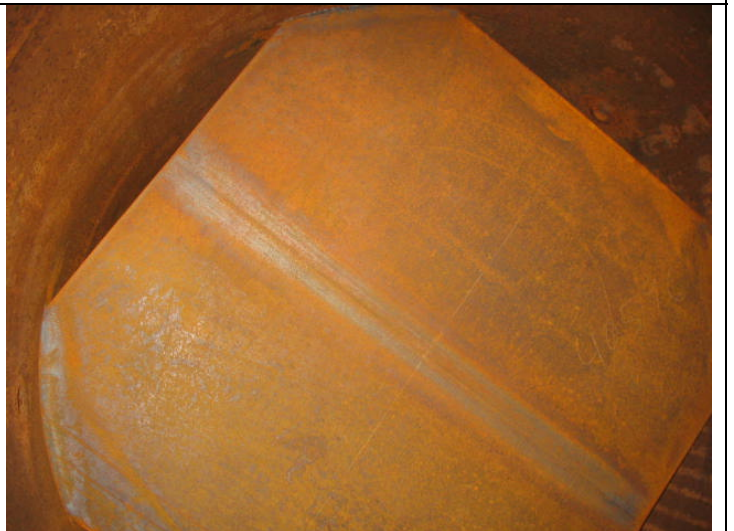
Inlet diffuser plate

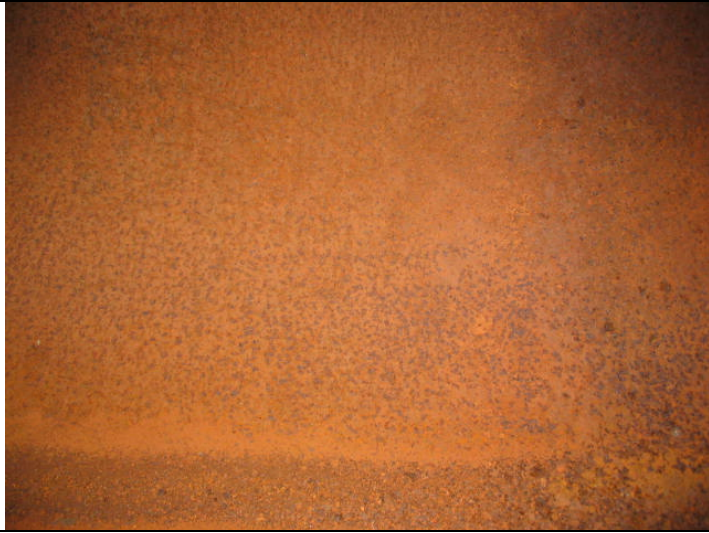
Internal of shell

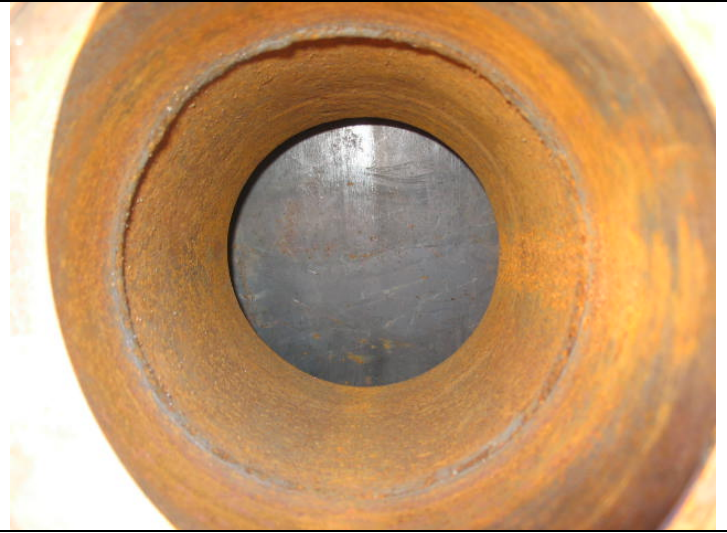
Inlet nozzle showing deflector plate

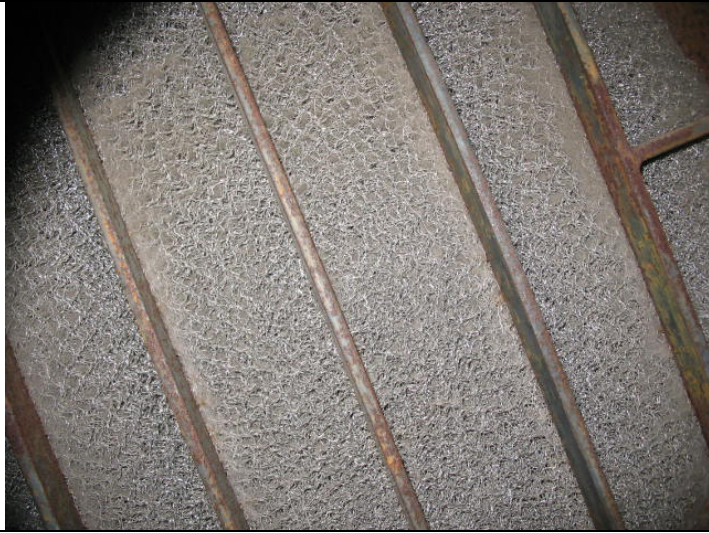
Demister pad

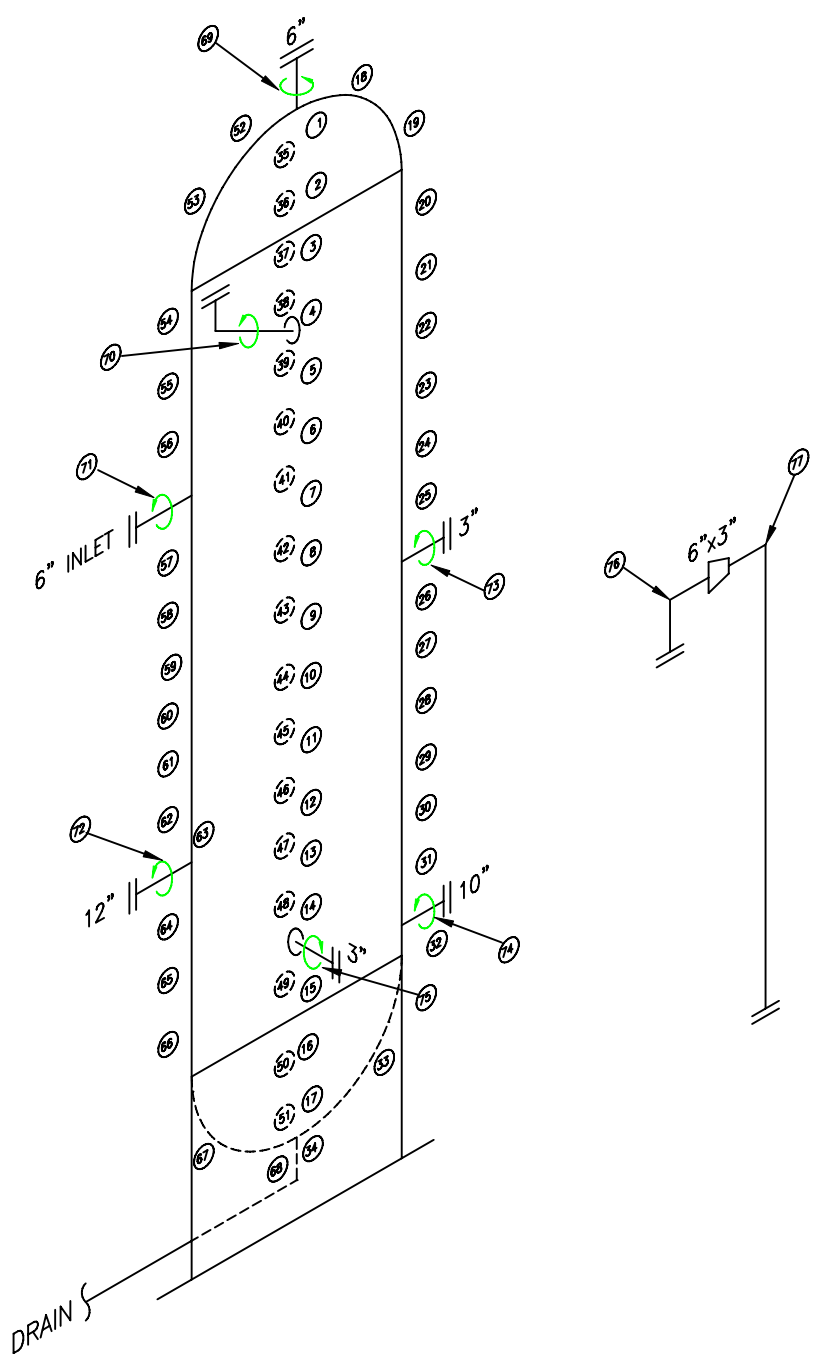
CLIENT	CANADIAN NATURAL RESOURCES LTD	
FACILITY	G&D OILFIELD SERVICES YARD(FORT ST JOHN)	
ITEM	VERTICAL SEPARATOR	
BY: CS	DATE: 10/2005	DWG.# 1

Shell							
Point#	Thickness (mm)	Point#	Thickness (mm)	Point#	Thickness (mm)	Point#	Thickness (mm)
3	9.9	20	10.1	37	9.8	54	9.8
4	10.0	21	9.9	38	9.9	55	9.9
5	10.1	22	9.9	39	10.0	56	10.0
6	10.0	23	9.8	40	10.0	57	10.0
7	10.0	24	9.9	41	10.0	58	10.0
8	10.0	25	9.8	42	9.9	59	10.0
9	9.9	26	9.9	43	10.0	60	10.0
10	10.0	27	9.6	44	10.0	61	9.9
11	10.1	28	9.6	45	9.7	62	10.1
12	10.0	29	9.7	46	9.8	63	10.1
13	9.7	30	9.6	47	9.6	64	9.6
14	9.7	31	9.9	48	9.8	65	9.6
15	9.9	32	10.1	49	9.8	66	9.7

Top Head							
Point#	Thickness (mm)	Point#	Thickness (mm)	Point#	Thickness (mm)	Point#	Thickness (mm)
1	14.7	18	14.5	35	14.6	52	14.8
2	14.5	19	14.5	36	14.4	53	14.8

Bottom Head							
Point#	Thickness (mm)	Point#	Thickness (mm)	Point#	Thickness (mm)	Point#	Thickness (mm)
16	14.2	33	14.6	50	n/s	67	14.6
17	14.6	34	14.1	51	n/s	68	14.3

Nozzles					
Point	Min	Avg	Point	Min	Avg
69	11.1	11.4	74	11.5	12.6
70	10.8	11.4	75	11.0	11.5
71	17.6	18.4	76	7.0	7.2
72	12.4	12.9	77	5.3	5.5
73	7.5	7.7
