PRESSURE VESSEL **VISUAL INSPECTION** REPORT

156825-KK-16 05/23/2012 2 of 21

04-07-045-21W4M

A0220737

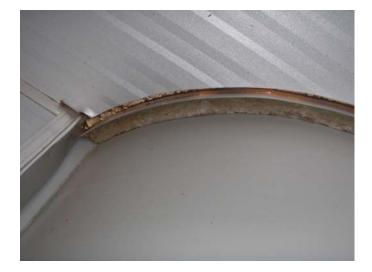
The vessel piping to wall and vessel to roof interface is in fair condition, and could use minor sealant repairs.

04-A0220737 Vessel to Wall Interface

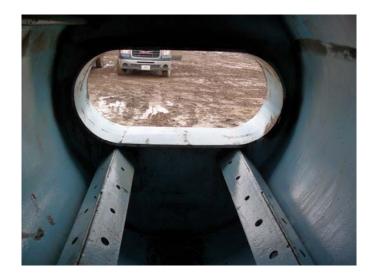
Multiple areas of coating failure noted on the shell and manway openings.

05-A0220737 Manway Opening

Repair coating damage on the shell and manway throats.

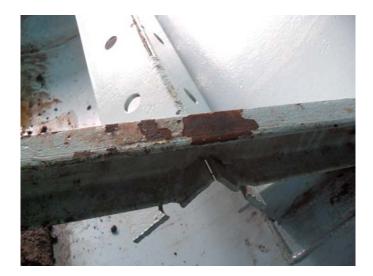
The firetube support structure has similar superficial coating failure.

06-A0220737 Firetube Support Coating Damage

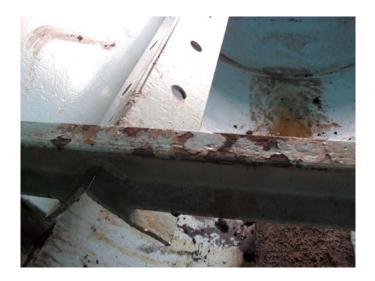
07-A0220737 Firetube Support Coating Damage

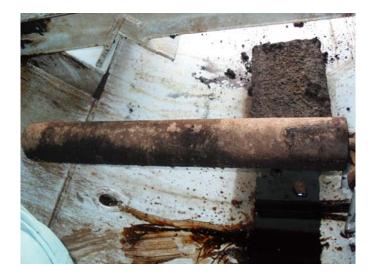
08-A0220737 Anode Condition

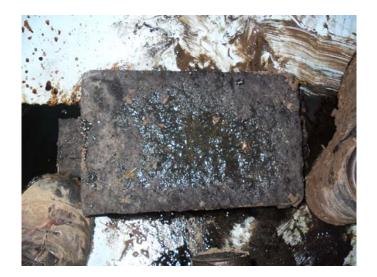
The inlet diverter, and weirs are in overall good condition. The bottom drain filters are plugged solid. The anodes are in good condition.

10-A0220737 Drain Filter Plugged

Perform an installation inspection once this vessel is relocated or determined to be put back into service. Replace the drain filters.

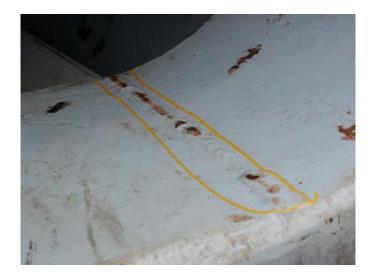
12-A0220737 Coating Damage at Manway

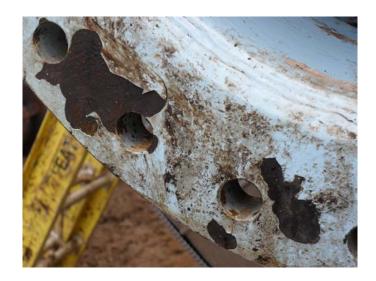
13-A0220737 Coating Chips on Flange

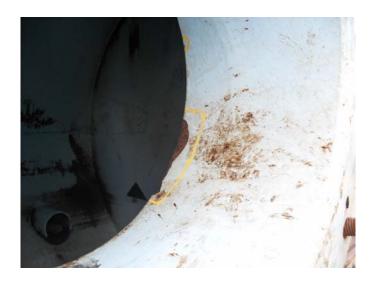
14-A0220737 Side Manway Coating Chips

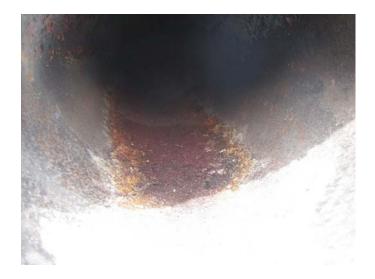
16-A0220737 Firetube Hot Side Scale

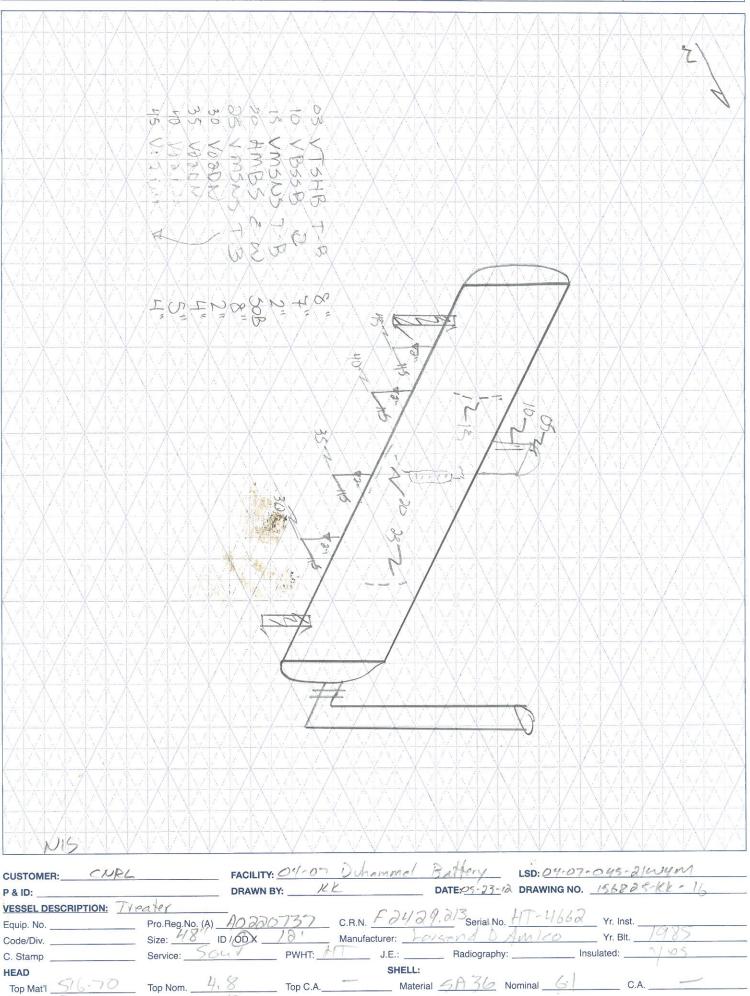
A0220737 UT Readings Readings in Inches

SOB	EOB	MIN
LOC 5	0.361	0.396	40.250
LOC 10	0.317	0.340	0.282
LOC 15	0.265	0.271	0.265
LOC 20	0.274	0.274	0.271
LOC 25	0.258	0.256	0.238
LOC 30	0.213	0.211	0.208
LOC 35	0.200	0.204	0.196
LOC 40	0.223	0.210	0.201
LOC 45	0.232	0.217	0.203
