**FIRE-TUBE INSPECTION REPORT**

ABSA Number: 0228209

Date of Inspection: SEPT 24/08

NATCO CANADA NISKU

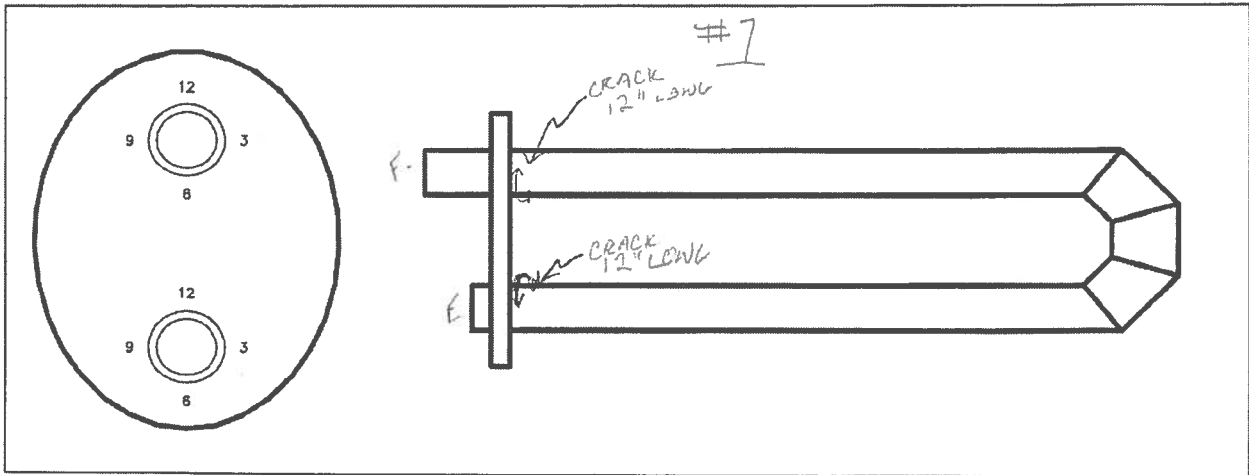
Cracks found by MPI (indicated on diagram)

Visual Defects (indicated on diagram)

Top				Bottom			
	12	3	6	9	12	3	6	9
	9.3	9.4	9.5	9.4	9.3	9.4	9.5	9.5
	9.4	9.4	9.5	9.4	9.7	9.5	9.5	9.5
	9.3	9.3	9.4	9.5	9.7	9.5	9.5	9.4
	9.3	9.4	9.5	9.4	9.4	9.4	9.5	9.4
m	9.4	9.3	9.4	9.3	9.7	9.8	9.4	9.5
M	9.5	9.4	9.6	9.3				
M	9.4	9.3	9.1	9.3
