**Canadian Natural Resources Limited
GENERAL PRESSURE VESSEL INFORMATION**

Job# 10.111395

District: Fort St. John, BC	Skid No.
Facility: Umbach Compressor	Location (LSD): c-37-F/94-H-03
Vessel Name Equipment Number: Condensate Storage Bullet	
Orientation: Horizontal	
Status: In Service	Regulatory Inspection

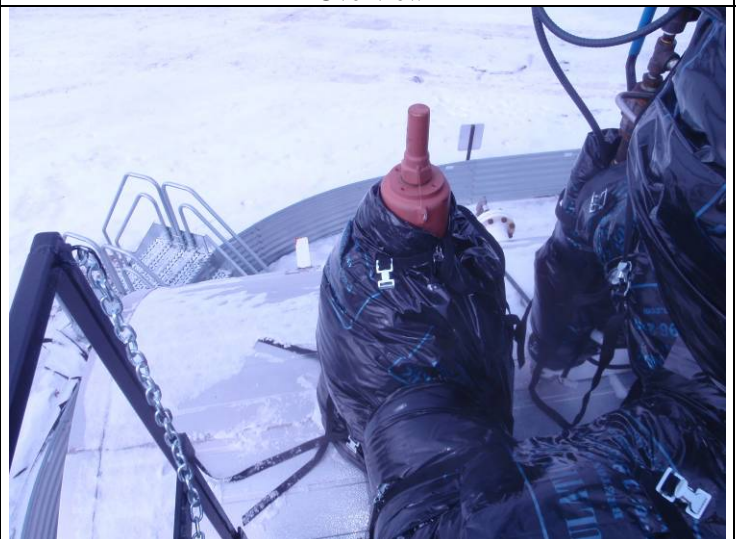
Valving Ensure no leaks are visible. Valves are properly supported and chained if necessary.	X				No leaks are visible. Valves are properly supported.
PSV Ensure PSV is set at pressure at or below that of vessel.	X				PSV is located on the top shell – set at the vessel MAWP – seal is intact – PSV vents to closed header
NDE methods Was UT/ MPI done on vessel (MI coordinator to review results)	X				Ultrasonic thickness survey carried out-no metal thickness detected below nominal minus corrosion allowance.
<p>Recommendations or corrective actions : Vessel is Fit for Service or describe corrective actions required) (MIC to review corrective actions with Operations, discuss with Chief Inspector where necessary, and get remedial action implemented)</p> <p>Recommendations: None</p> <p>Summary: This vessel is in good over all condition, visual external and ultrasonic thickness survey carried out-no metal thickness detected below nominal minus corrosion allowance.</p> <p>Long term corrosion rate based on greatest thickness loss – no corrosion rate to assess.</p> <p>Vessel is fit for service.</p>
