Canadian Natural Resources Limited
GENERAL PRESSURE VESSEL INFORMATION

Job# 10.111395

District: Fort St. John North		Skid No.					
Facility: Umbach Compressor		Location (LSD): c-37-F/94-H-03					
Vessel Name Equipment Number: Inlet Separator							
Orientation: Vertical							
Status: Not in Service				Regulatory Inspection			
PRESSURE VESSEL NAMEPLATE DATA							
“A” or “G” or “S” (Sask.) or BC Registration Number. A0550804				CRN Number: K 9873.213			
Vessel serial number: 5-1758				Size: 30 inch x 144 inch			
Shell thickness: 31.8 mm				Shell material: SA 516 70N			
Head thickness: 30.2 mm				Head material: SA 516 70N			
Tube wall thickness:				Tube material:			
Tube diameter:				Tube length:			
Channel thickness:				Channel material:			
Design pressure	Shell: 1480 PSI			Operating pressure	Shell:		
	Tubes:				Tubes:		
Design Temp.	Shell: 100° F			Operating temperature	Shell:		
	Tubes:				Tubes:		
X-ray: RT 1				Heat treatment: yes			
Code parameters: ASME VIII, DIV 1				Coated: No			
Manufacturer: SILVERADO OILFILED				Year built: 2006

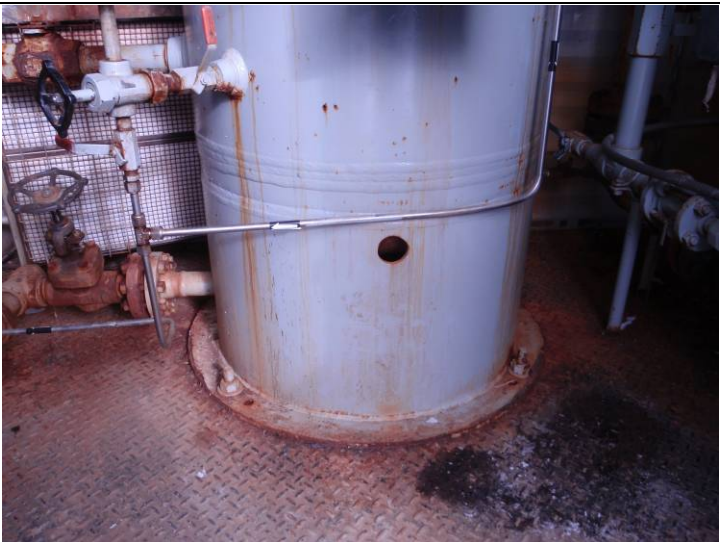
Anchor Bolts Hammer tap to ensure secure. Look for cracking in treads or signs of deformation.	X				Anchor bolts are securely fastened - no sign of deformation
Concrete foundation Check for cracks, spalling, etc.				X	None.
Ladder / Platform Describe general condition, ensure support is secure to vessel, describe any hazards.				X	None.
Nozzle Assess paint, look for leakage, and ensure stud threads are fully engaged. Record any damage, deflection, etc. Are nozzles gusseted?	X				Paint in good condition - Stud threads are fully engaged - No damage or deflections observed – no leaks. Nozzles are not gusseted.
Gauges Ensure gauges are visible, working, no leakage, and suitable for range of MAWP/ Temp.	X				Pressure gauge: 0 – 1000 PSI Temp gauge: -40 – 160 F
External Piping Ensure pipe is well supported. All clamps, supports, shoes, etc. in place. Look for evidence of structural overload, deflection, etc. Paint condition, external corrosion?	X				Piping is well supported - No signs of structural overload, all clamps and supports are in place. Paint in good overall condition – no corrosion

Bolted to skid floor

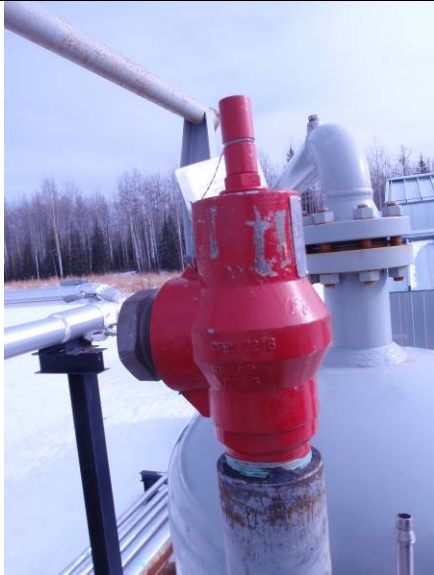
Valving Ensure no leaks are visible. Valves are properly supported and chained if necessary.	X				No leaks are visible. Valves are properly supported.
PSV Ensure PSV is set at pressure at or below that of vessel.		X			Located on upper shell – set below the vessel MAWP –PSV discharge is blinded off – seal intact
NDE methods Was UT/ MPI done on vessel (MI coordinator to review results)	X				Ultrasonic corrosion survey carried out – pipe metal thickness detected below nominal minus corrosion allowance. Thickness calculations carried out: UT point 410 (3" Elbow) – nominal thickness is 5.5mm / min thickness is 4.3mm / T min thickness is 3.2mm.
Recommendations or corrective actions : Vessel is Fit for Service or describe corrective actions required) (MIC to review corrective actions with Operations, discuss with Chief Inspector where necessary, and get remedial action implemented) Recommendations: Summary: This vessel is in good over all condition, visual external and ultrasonic thickness survey carried out-pipe metal thickness detected below nominal minus corrosion allowance. Thickness calculations carried out to ensure sufficient metal exists for safe operation. Long term corrosion rate based on greatest thickness loss – no corrosion rate to assess. Vessel is fit for service.
