## VESSEL INSPECTION SUMMARY

Report #: **141168-SS-91**  
Inspect Date: 04/15/2010  
Page: 1 of 5  
IRISNDT #: 141168

Client: CNRL District: Med. Hat - West Field: Taber  
Facility: 09-17-011-16W4 Unit / Skid #: N/A LSD: 09-17-011-16W4  
Jurisdiction #: A0227873 Equip Tag #: N/A Serial #: LM-2191  
CRN #: H0330.2 Nat'l Bd #: N/A Year Built: 1987  
Manufacturer: C.E. Natco Ltd. Equipment Description: Free Water Knockout Drum  
Status: In Service - Date Removed From Service: \_\_\_\_\_ Service: Sour  
MAWP Shell: 75 Psi @ 200 °F Height/Length: \_\_\_\_\_ Code Stamp: ☒ Y ☐ N  
MAWP Tube: \_\_\_\_\_ @ \_\_\_\_\_ Size/Diameter.: \_\_\_\_\_ Insulated: ☒ Y ☐ N  
MDMT: -20 °F RT: RT-4 Volume: \_\_\_\_\_ PWHT: ☐ Y ☒ N  
Support Type: Saddle Manway: ☒ Y ☐ N  
C.A.: 0.0625 in. Coated: ☐ Y ☒ N Clad: ☐ Y ☒ N J.E.: N/A (No Remote Access: ☐ -

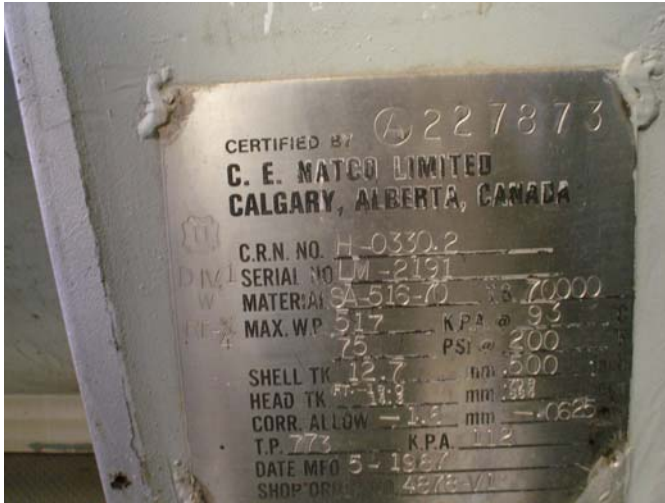
Figure 1\_Nameplate\_16April2010

Nameplate secure & legible
