VESSEL INSPECTION SUMMARY

Report #: **127020-WF-06**
Inspect Date: 06/07/2007
Page: 1 of 2
IRISNDT #: 127020

Client: CNRL District: Medicine Hat - West Field: 09-17-11-16W4
Facility: Taber Unit: _____ LSD: 09-17-11-16W4
Jurisdiction #: A0161747 Equip Tag #: _____ Serial #: L-8-143
CRN #: B-5946.2 Nat'l Bd #: _____ Year Built: 1980
Manufacturer: Natco Equipment Description: Horizontal Group Treater
Status: Out Of Service Date Removed From Service: _____ Service: Sour
MAWP Shell 345 kPa @ 93 °C Height/Length: 9144 mm Code Stamp: ☒ Y ☐ N
MAWP Tube _____ Select @ _____ Pick Size/Diameter: 2438 mm I.D. Insulated: ☒ Y ☐ N
Support Type: Saddle RT: 2 Volume: _____ ft³ / m³ PWHT: ☐ Y ☒ N
C.A. _____ Coated ☒ Y ☐ N Clad: ☒ Y ☐ N Manway: ☒ Y ☐ N

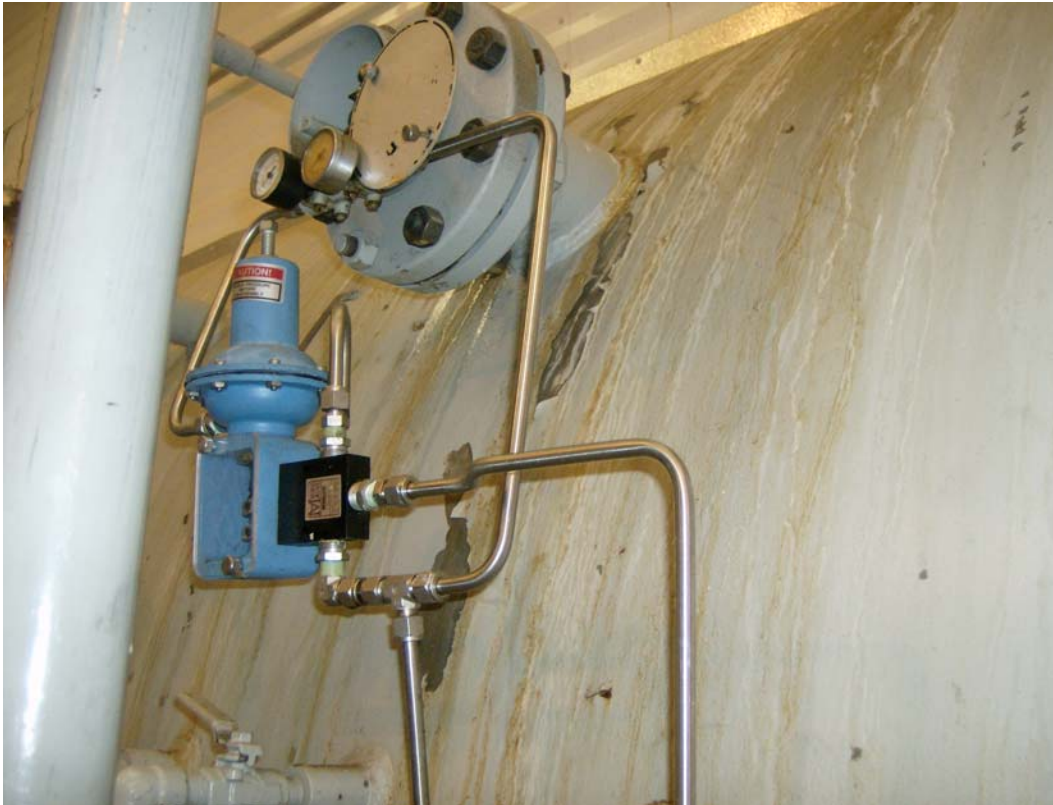
- Vessel has partial insulation on the sections outside of the building. Insulation was in good condition.
- The vessel was painted on all areas without insulation. The paint was lifting and peeling on an isolated area of the upper mid shell. The building wall is not sealed properly to the vessel to prevent water ingress. Light surface corrosion is present on the areas missing coating.
- The sight glasses, temperature and pressure gauges were in good condition.
- An external UT survey was performed with no significant wall loss noted.
- No access to PSV scaffold required.

A0161747_Paint Peeling External West Shell_06Jun07

- The building wall is to be properly sealed to the vessel shell to prevent environmental deterioration.
- The external surface of the shell is to be repainted as required.
- The fillet welds of the slip-on flanges for the fire tube are to be repaired.
- The deeply pitted sections of pipe for the fire tube are to be replaced.
- The pitted area of the tube sheet is to be ground smooth to assist surface condition and is to be considered for weld overlay.

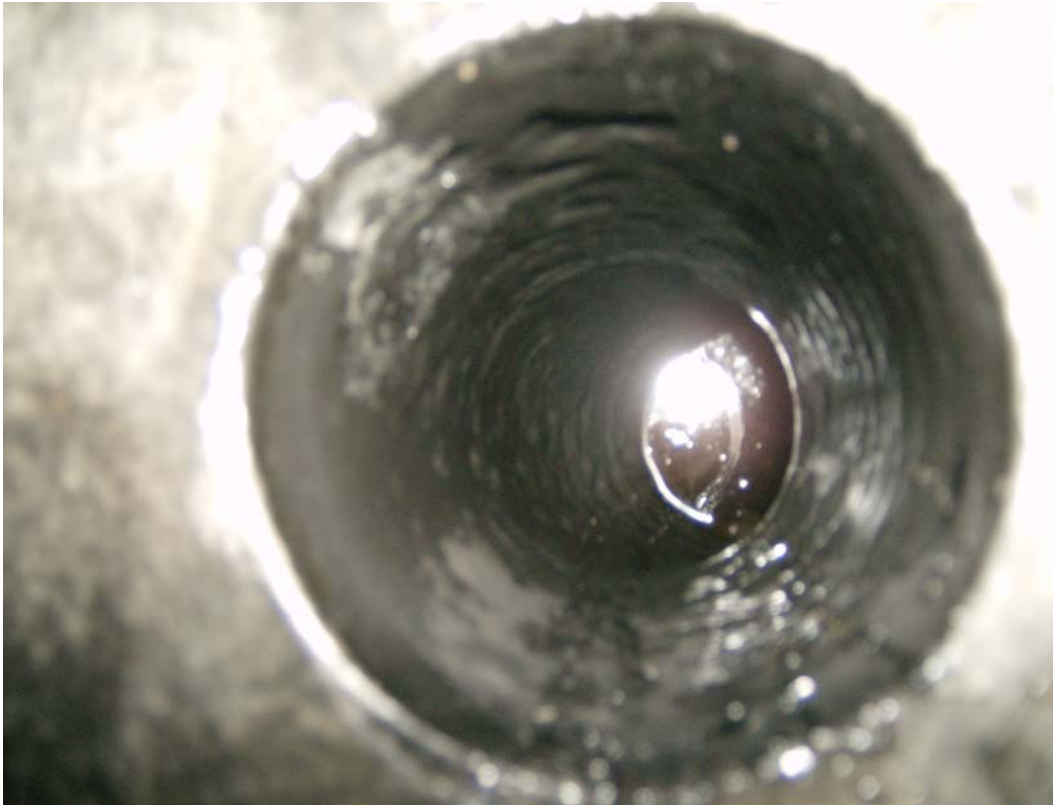
- The coating was intact on the shell, weir plates and baffles. There were isolated coating breaks on the bottom of the north and south manways. These areas were recoated.
- There were small coating breaks on the I-beams for the rail system to install and remove the fire tubes. These areas were recoated.
- There was pitting on the bottom shell of the cold side up to 0.100" deep. The coating was intact on all of the pitted areas.
- The 2 drain nozzles on the fire side were pitted, however all of the coating on the internal surfaces of the nozzles was intact. The neck and the elbow of both nozzles were scanned with UT. The lowest thickness found was 0.245".

A0161747_Pitting on Btm Drain Nozz_05Jun07

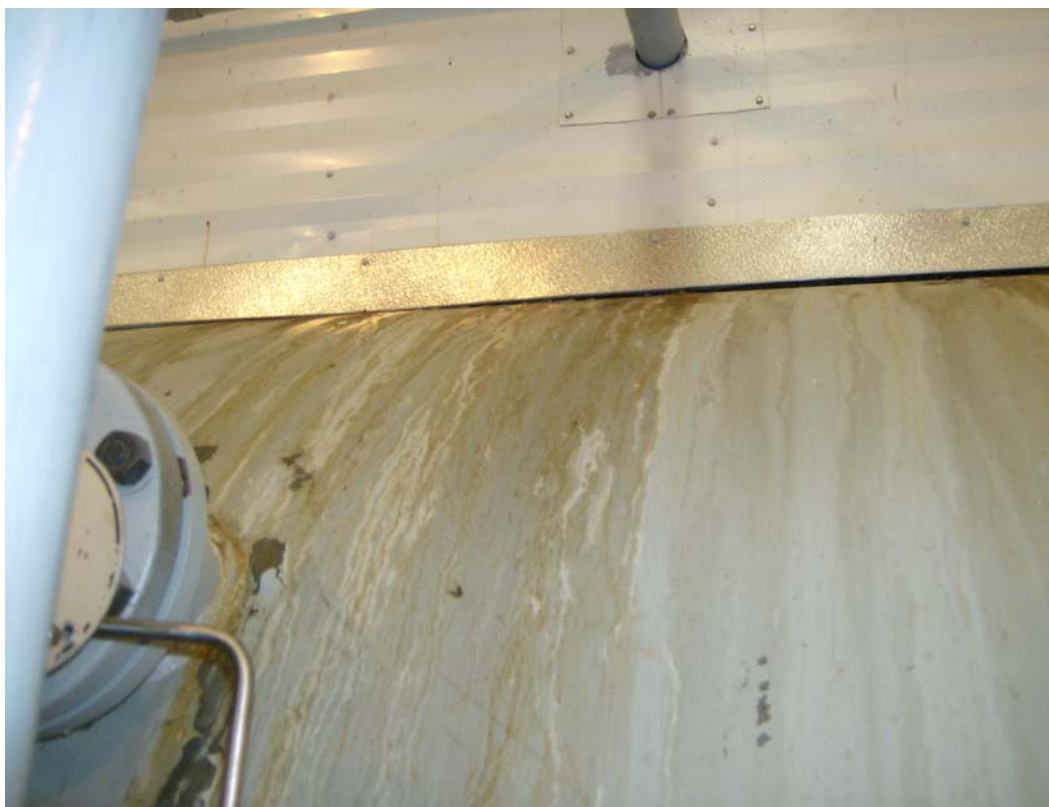
A0161747_Water Ingress From Building Wall_06Jun07

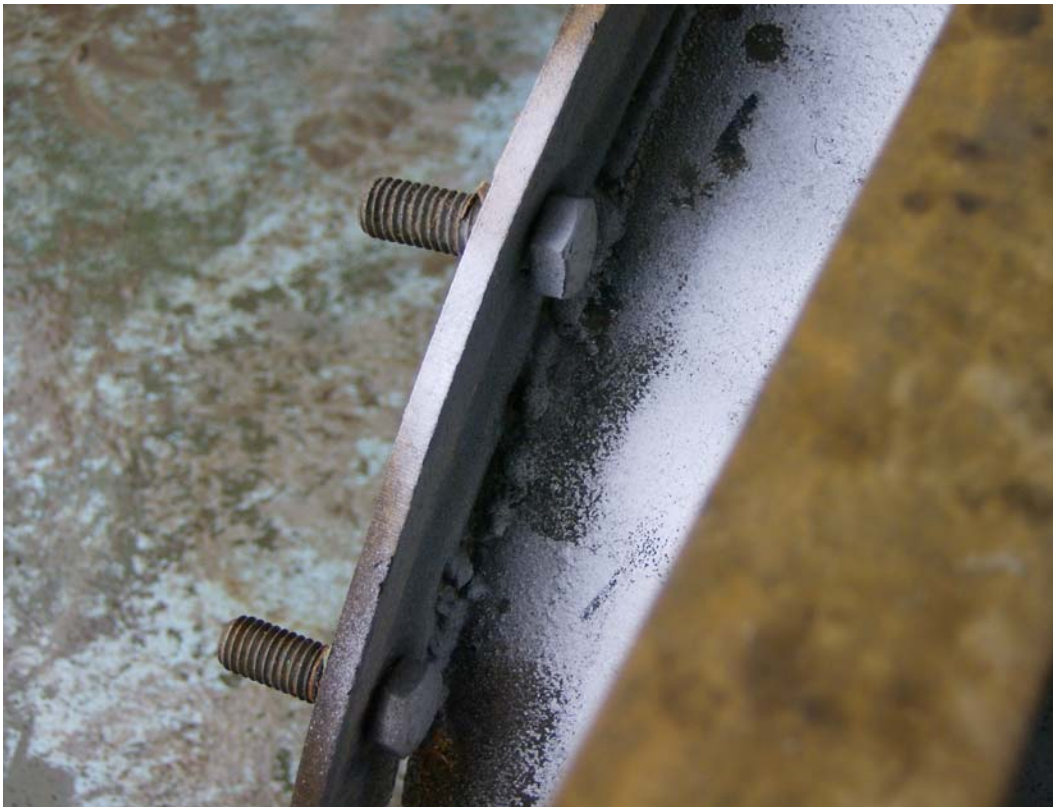
- There was light pitting found on the rest of the external piping up to a depth of 0.020".
- One of the slip-on flange fillet welds was holed through for seven inches around the circumference. The original fillet weld on the OD of the flange is of very poor quality with little to no fusion or reinforcement in many areas.

A0161747_External Fillet Weld-Minimal Fusion&Reinforcement_06Jun07

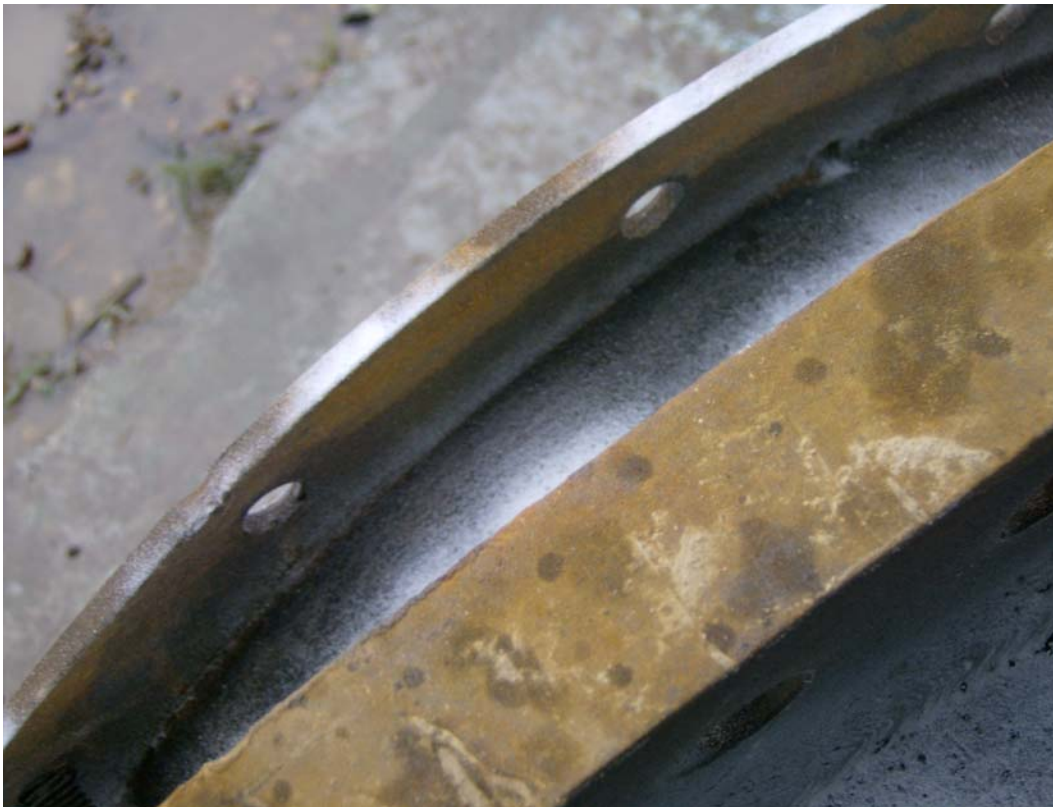
- The slip-on flange opposite of the one mentioned above did not have a fillet weld on the OD of the flange from original fabrication.
- Random UT thickness measurements were taken on the piping. The average thickness of pipe on the first 8 inches of the piping from the tube sheet was 0.550 inches. The rest of the piping displayed an average of 0.360 inches.

A0161747_No External Fillet Weld_06Jun07

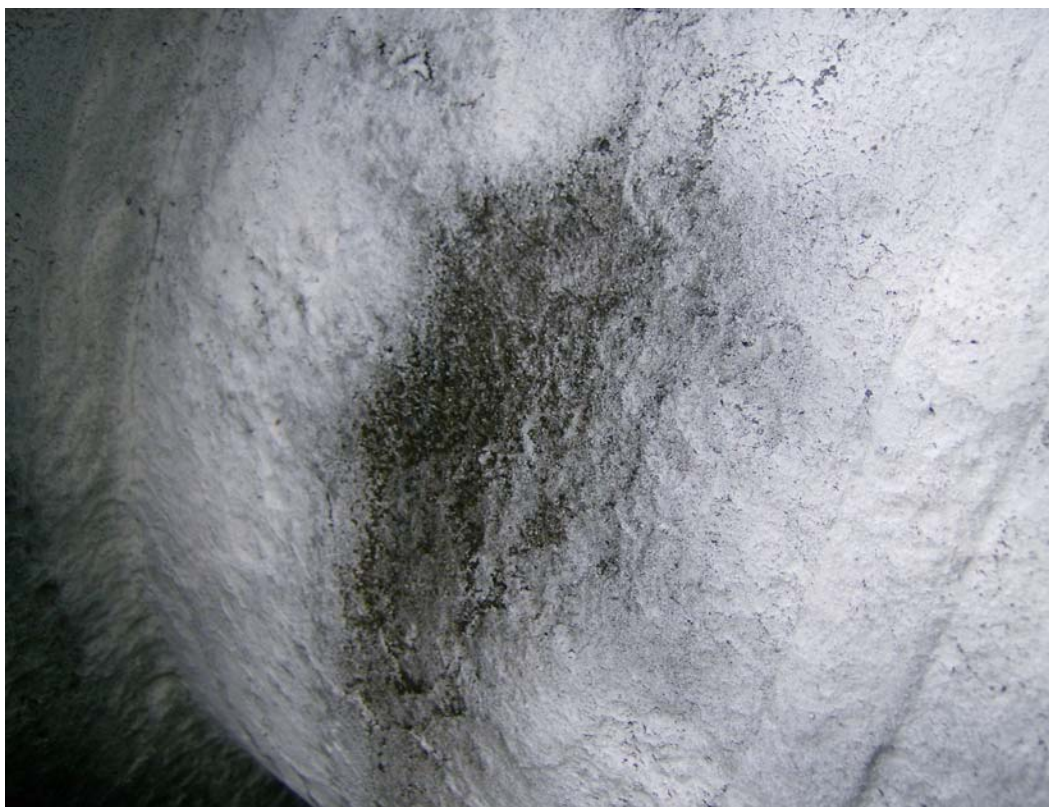
A0161747_Pitting External Pipe_06Jun07

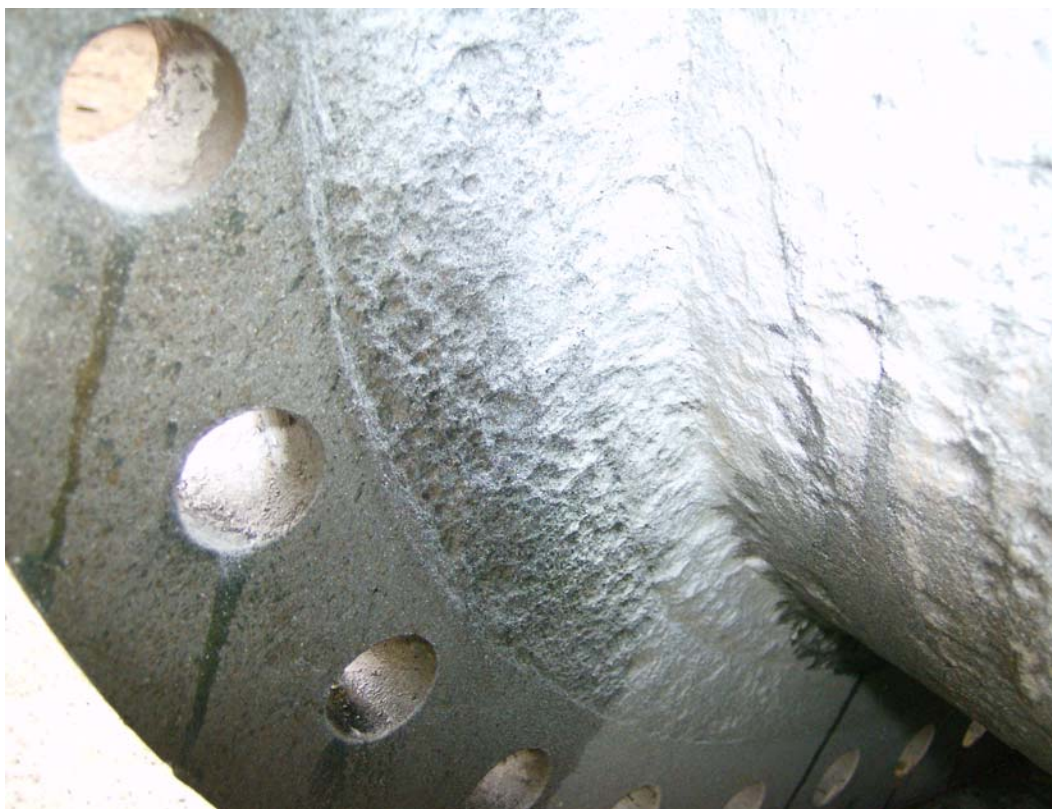
- The first 9 inches of the external/internal surface of the pipe is corroded and pitted on the product side of the tube sheet to a depth of 0.100".
- The tube sheet on the product side is corroded and pitted up to a 0.110" deep.

A0161747_Pitting Tube Sheet_06Jun07
