## VESSEL INSPECTION SUMMARY

Client:	CNRL District:	Medicine Hat - West	Field:	09-17-11-16W4		
Facility:				09-17-11-16W4		
	.0227873 Equip Tag #:			LM-2191		
CRN #:	H0330.2 Nat'l Bd #:		Year Built:	1987		
Manufacturer: Natco		ipment Description: Horizo				
Status: Out Of Service Date Removed From Service: Service: Sour MAWP Shell 75 Psi @ 200 °F Height/Length: 360 in. Code Stamp: X Y X N						
MAWP Shell 75	Psi @ 200 °F Heigh	t/Length: 360	in. (	Code Stamp: X Y N		
MAWP Tube		Diameter: 96 in.	I.D.	Insulated: ⊠ Y ☐ N		
Support Type: Sa		Volume:	ft <sup>3</sup> / m <sup>3</sup>	PWHT: □ Y ⊠ N		
C.A. 1.6	<del></del>			Manway: ⊠ Y □ N		
	Material Nominal Minimum	Component	Material	Nominal Minimum		
	SA-516-70 12.7 mm					
	SA-516-70 18.0 mm					
South Head	SA-516-70 14.3 mm					
PSV Static Data						
PSV –1 Tag #:	Serial #:		CRN:			
Model #:	Capacity:	SCFM	_	Select		
Manufacturer:			ervice Company:			
Shell/Tube Side: She	all / Tubo		Service Date:

Report #: 127020-WF-07 Report Date: 06/07/2007 Page: of 2 IRISNDT #: 127020

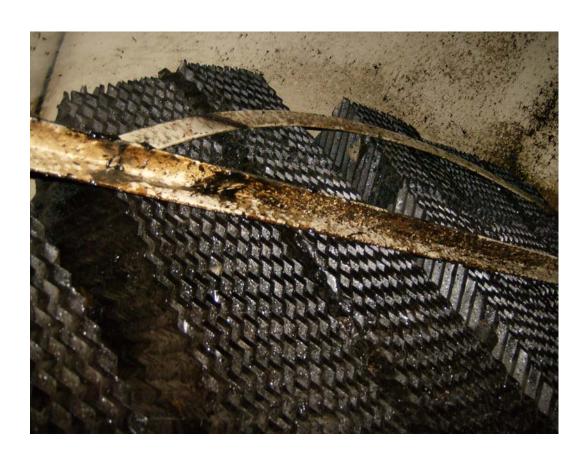
Client:	CNRL	LSD:	09-17-11-1	6W4	Jurisdiction #:	A0227873	
Additional Attachment	s ⊠ # of pages _	7		to Vessel Insp	pection Report # 127	7020-WF-07	
	MT PT	ET [	RT 🗌 OTH	ER 🗌			
NDE Report # NCR Raised □ Op	erational Action Item	Daisad   D	anair Action Itam	Daisad 🗆	Deferred Action Item	Doised	
		Raised L Re	epair Action Item	Raised 🔲	Deferred Action Item	n Raised 🔲	
An internal/externa		s carried out on	Group Free Wate	er KO and the	findings are as follow	/S:	
<ul><li>The vessel was</li><li>The sight glasse</li><li>An external UT</li></ul>	al insulation on the sein good condition with s, temperature and p survey was performed V scaffold required.	n the paint intact ressure gauges	on all areas with were in good cor	out insulation. Idition.	good condition.		
<ul><li>east manways. The</li><li>The corrugated of</li></ul>	se areas were recoat	ed. acked with proce	ess sludge. The b	undles have a	ing breaks on the bot lso fallen slightly out condition.

A0227873\_Corrugated Diffuser Bundles Fallen Out Of Alignment\_06Jun07

Recommendations:							
	iffuser bundles at the	next shutdown	to align them prop	perly.			
·			<b>.</b>	·			
Unit #228	<del></del>		onsumables:	Inspector: Wes Farquh	ar	PESL:	
<u></u>	Out Hrs _ Out Hrs				(Print)	API: 29669	_
	Out 1113 _			I am in full agre	(Signature) ement with report contents		
				l

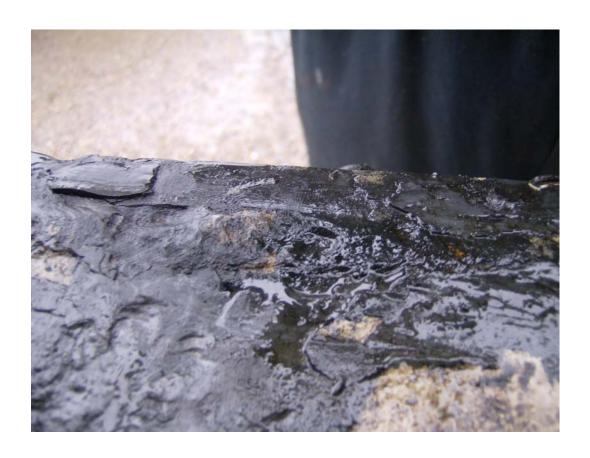
A0227873\_Pitting North Manway\_06Jun07

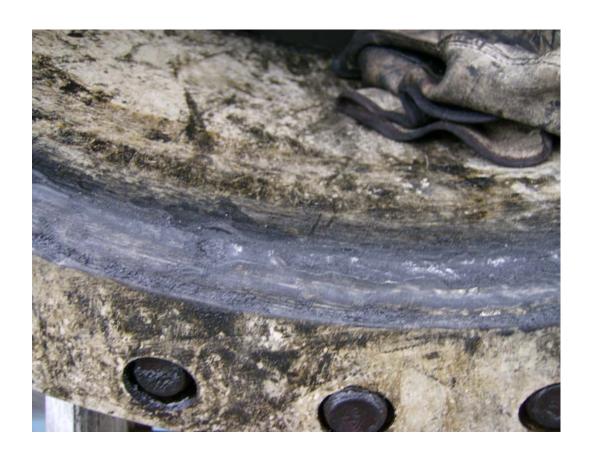
A0227873\_Pitting South West Manway\_06Jun07
