VESSEL INSPECTION SUMMARY

Report #: 123790-MC-14 Inspect Date: 05/25/2010 Page: 1 of 6 IRISNDT #: 123790

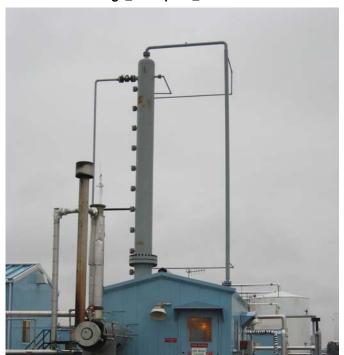
Fig2_A0439849 ext_05-2010

Previous UT Survey	\boxtimes	$\overline{\Box}$	Ē				Company: M		
Priority 1 - Goal date is 30 Priority 2 - Goal date is 90	days			-	Priority 4 - Goal date				
External Visual Observations	3				Manual Review Requi	ired By Cust	omer Represe	entative -	
This vessel was in service at the time of inspection. The nameplate is legible. The external vessel surface is in satisfactory condition. No deformations were noted. The skirt is secure to the floor. The paint is in good condition. NPT connections are acceptable. Flange connections are tight and the treads are fully engaged. No leaks noted at the time of inspection. The PSV meets code requirements. UT was carried out with GE DMS2 IRISNDT#. 31074 Refer to the attached photos, UT data and drawing for details.									
5311 – 86 Street, Edmonton, Alberta	16F 5	Γ8 Phon	e: (780) 4:	37-2022 Fax: (78	(0) 438-1436

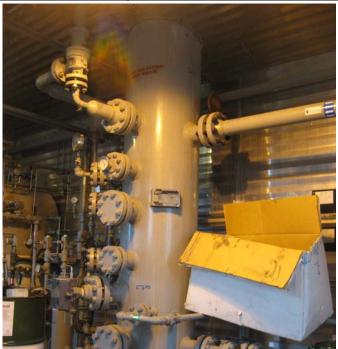
Fig2_A0439849 int_05-2010

Item	Υ	N	N/A	Condition	1	Comment	NCR	Action Item	Priority
Shell			\boxtimes						
Heads			\boxtimes						
Manway			\boxtimes						
Gasket Surfaces									
Welds			\boxtimes						
Refractory			\boxtimes						
Heating Coils			\boxtimes						
Demister Pad			\boxtimes						
Vane Pack			\boxtimes						
Baffles			\boxtimes						
Trays									
Filter			\boxtimes						
Internal Coating			\boxtimes						
Tubesheet									
Tube Bundle			\boxtimes						
LEGEND: Priority 0 - General Recommendations. Priority 1 - Goal date is 30 days from the activity date. Priority 2 - Goal date is 90 days from the activity date.									
Internal Visual Observations						Manual Review Require	ed By Custom	ner Represen	tative -
No internal inspection perf							-	·	
5311 – 86 Street, Edmonton, Alberta	a T6E :	5T8 Pho	one: (780)	437-2022 Fax: (780) 438-1436				
Calgary (403) 279-61 Lloydminster (780) 875-64 Barhead (780) 674-30 Nisku (780) 955-76	55 18				Cold Lake Fort McMurray High Level Red Deer Medicine Hat	(780) 594-1114 (780) 743-1536 (780) 956-4094 (403) 347-1742 (403) 527-6284	Dee Mat Tex	pus Christi, TX er Park, TX rix, Houston, TX as City, TX sa, OK	(361) 888-4700 (281) 476-4444 (713) 722-7177 (490) 945-2262 (918) 446-8773
