**Canadian Natural Resources Limited
GENERAL PRESSURE VESSEL INFORMATION**

Job# 10.180528

District: Fort St John, BC	Skid No.
Facility: South Buick Compressor Station	Location (LSD): d-78-I / 94-A-11
Vessel Name Equipment Number: Oil Treater	
Orientation: Horizontal	
Status: In Service	Regulatory Inspection

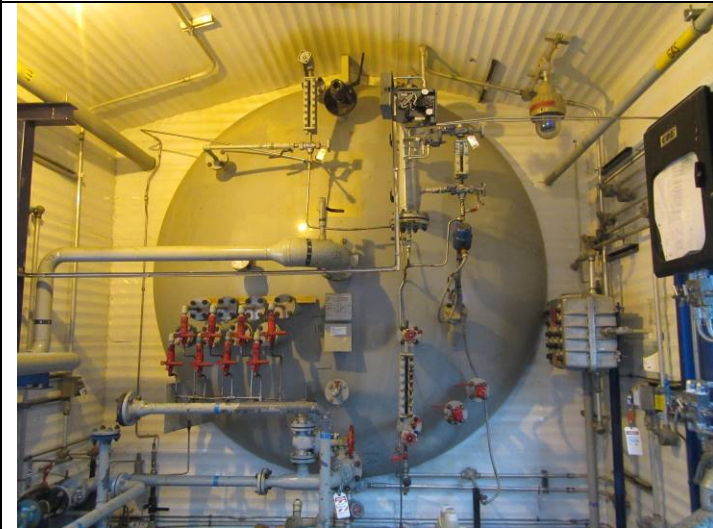
Repair data plate found on fire tube

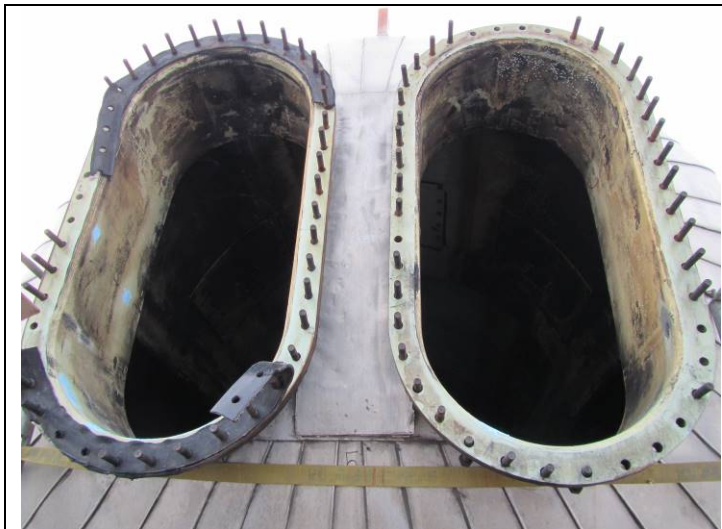
Valving Ensure no leaks are visible. Valves are properly supported and chained if necessary.	X				Well supported – no leaks.
PSV Ensure PSV is set at pressure at or below that of vessel.	X				Located on top shell – no access to the PSV at this time
NDE methods Was UT/ MPI done on vessel (MI coordinator to review results)				X	No NDE at this time.
Other					
Recommendations or corrective actions : (Vessel is Fit for Service or describe corrective actions required) (MIC to review corrective actions with Operations, discuss with Chief Inspector where necessary, and get remedial action implemented) Recommendations: see inspection summary below

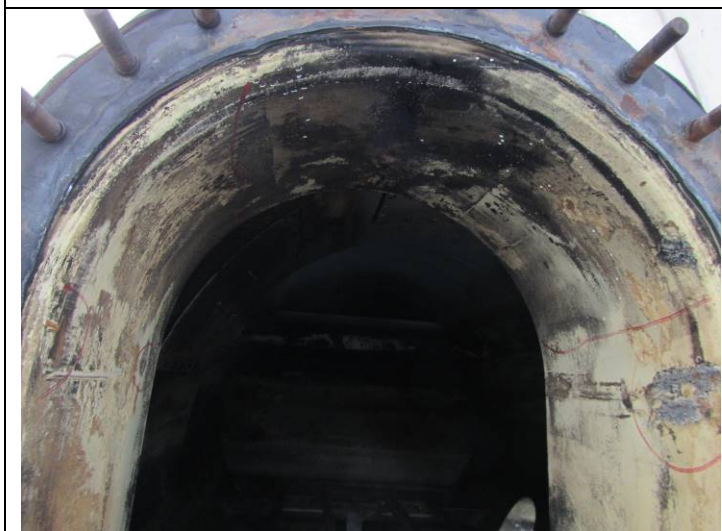
Coating damage and blistering to upper portion of fire tube nozzle right

<p>Recommendations or corrective actions : (Vessel is Fit for Service or describe corrective actions required) (MIC to review corrective actions with Operations, discuss with Chief Inspector where necessary, and get remedial action implemented)</p> <p>Recommendations: 1.Repair the remainder of damaged coating. 2. Replace all anodes</p> <p>Summary: Vessel is in overall good condition, visual internal and external inspection performed—no metal thickness detected below nominal minus the corrosion allowance. All coating damage to the heads, shell and the 6:00 of the fire tube nozzles were repaired at the time of inspection. The remainder of the coating damage is isolated to the upper sections of the fire tube nozzles; caused mechanically by the removal of the tubes and blistering by possible heat exposure. Approximately 5 square foot area of damage total.</p> <p>Fire tube dimensions: 24inch x 24 ft. Spill box height from bottom shell: 96 inches Vessel is fit for service.</p>

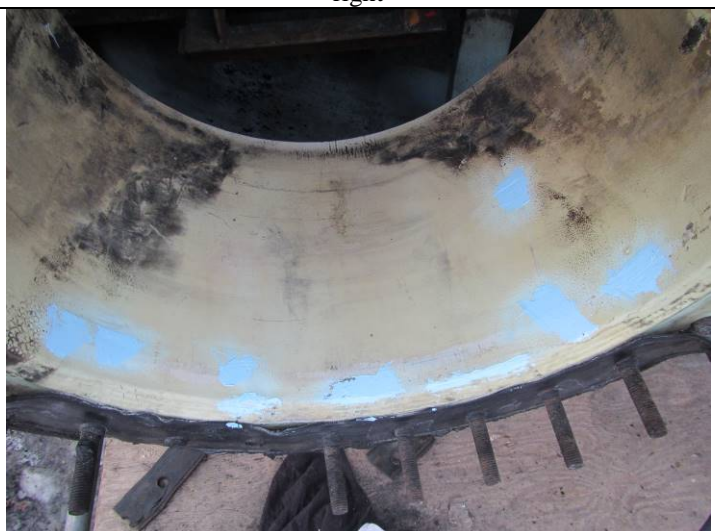
Coating damage and blistering to upper portion of fire tube nozzle left

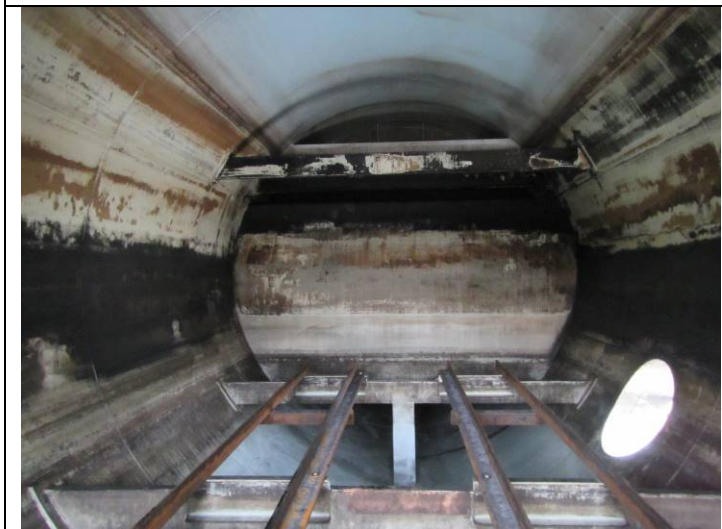
Coating repairs

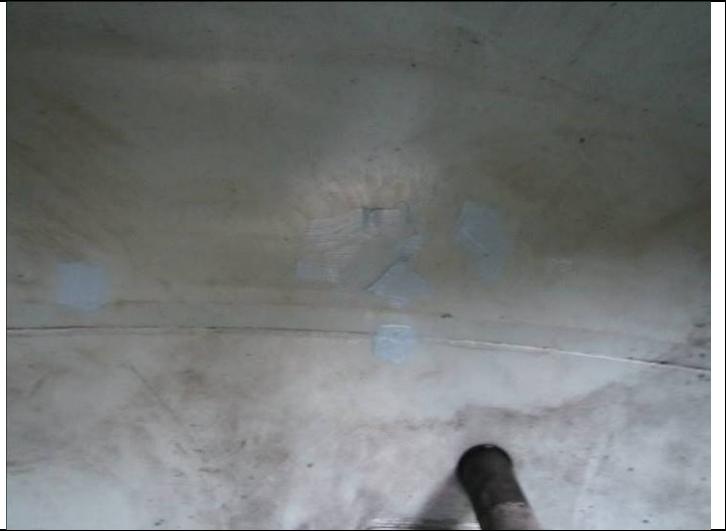
Minor coating damage

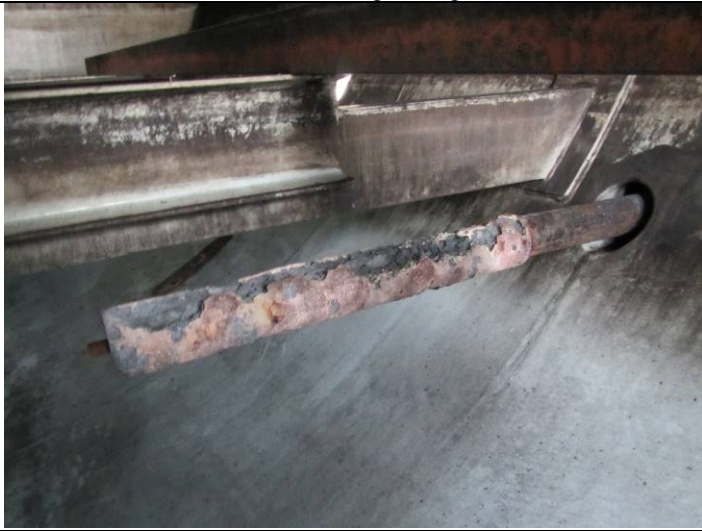
Repairs to coating

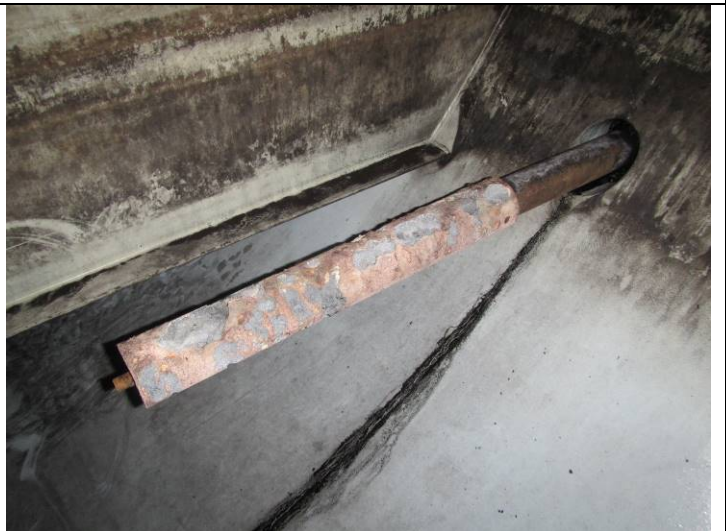
Coating blistering to inlet defuser – not pressure envelope

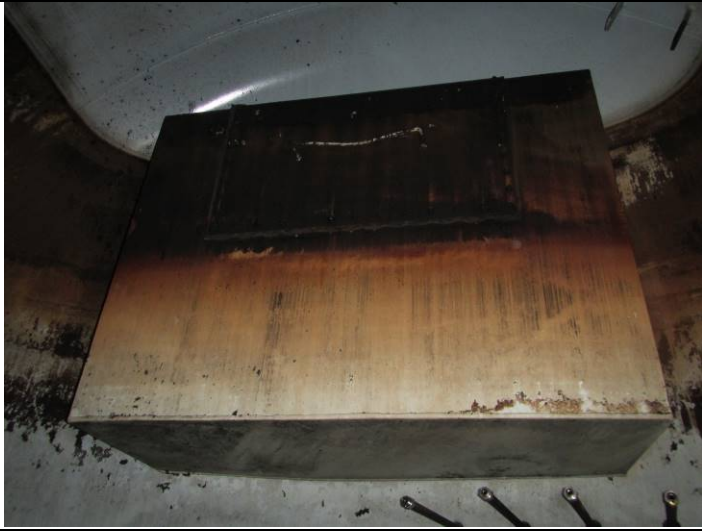
Demister pad Is it in place? Is it clean? If any corrosion is apparent in vessel, lift pad and check top head for corrosion.	X			Demister pas in place at time of inspection – bottom 4 inches were found to be plugged with solids but is in otherwise good clean condition
Welds Inspect all welds, including attachment welds. Record all service-related damages and if there is any discuss with Chief Inspector before closing.	X			All welds inspected were found full and complete – no corrosion or service related damage
Repairs Required. If yes, ensure procedure and copy of AB 40 is on file, and one sent to local ABSA, and Chief Inspector	X			No repairs required
NDE Was any NDE done. (MI coordinator to review results)	X			MPI was carried out on fire tubes welds – no cracking detected
Fire Tubes	X			Fire tubes were found in good clean condition – no corrosion, cracking or mechanical damage noted Dimensions: 24 ft. in length, 24 inch diameter, UT suggests a nominal of 12.7 mm
