ULTRASONIC INSPECTION REPORT

CA0619-UT1-619 Page 1 of 3

Equipment Tag #: A0451115 Treater

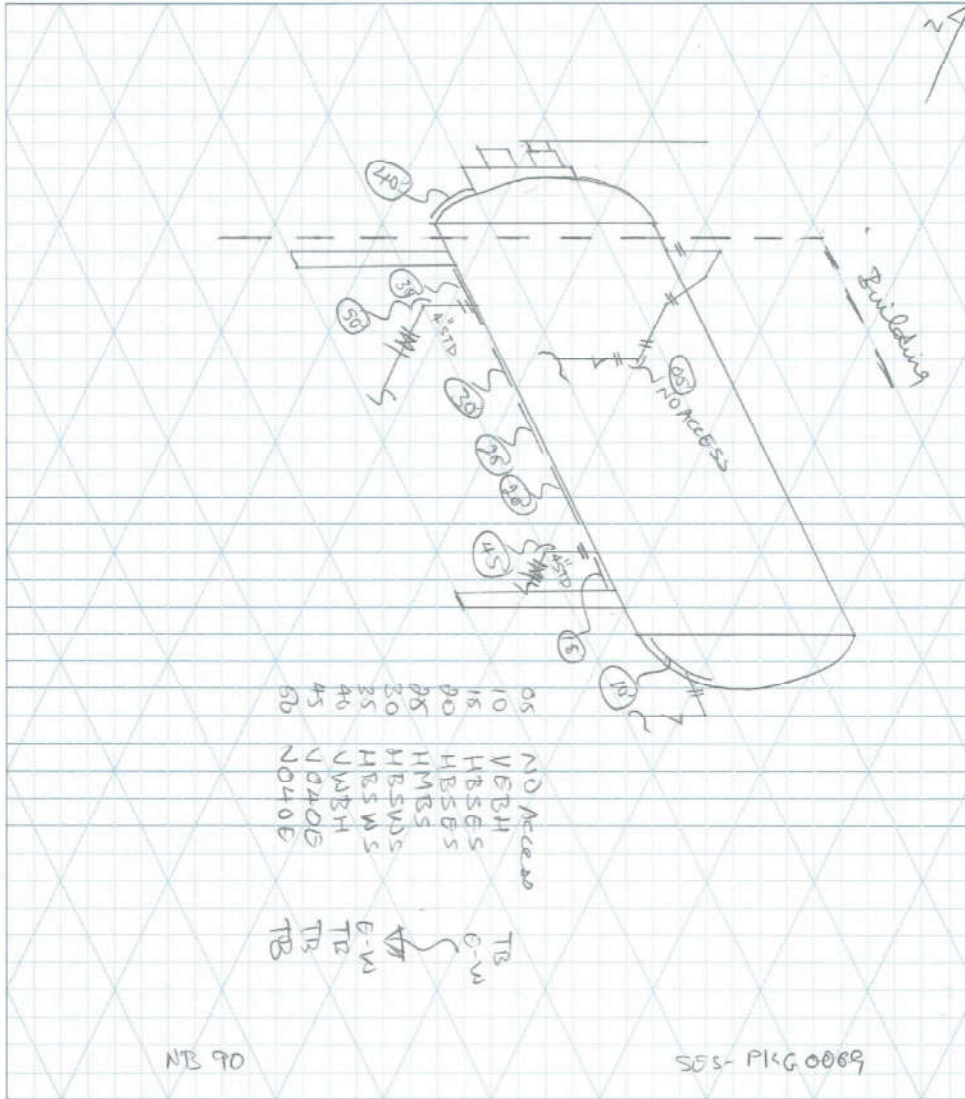
LOCATION #	NOMINAL (inches)	Minimum Thickness Values	Maximum Thickness Values	Average Thickness Values	*T-MIN	WALL LOSS (Min - Nom)	COMMENTS	Location Desc.	Coating/paint Condition
05	No Access	No Access	No Access	No Access		No Access	No Access	No Access	No Access
10	NA	0.464	0.483	0.476		0.000	External Condition: Painted surface, No corrosion or pitting found. Internal Condition: No erosion, corrosion or pitting found.	Vertical East Bottom Head T-B	Intact, no corrosion
15	NA	0.388	0.390	0.389		0.000	External Condition: Painted surface, No corrosion or pitting found. Internal Condition: No erosion, corrosion or pitting found.	Horizontal Bottom Shell East Side E-W	Intact, no corrosion
20	NA	0.388	0.401	0.390		0.000	External Condition: Painted surface, No corrosion or pitting found. Internal Condition: No erosion, corrosion or pitting found.	Horizontal Bottom Shell East Side E-W	Intact, no corrosion

25	NA	0.388	0.392	0.389		0.000	External Condition: Painted surface, No corrosion or pitting found. Internal Condition: No erosion, corrosion or pitting found.	Horizontal Middle Bottom Shell E-W	Intact, no corrosion
30	NA	0.392	0.395	0.394		0.000	External Condition: Painted surface, No corrosion or pitting found. Internal Condition: No erosion, corrosion or pitting found.	Horizontal Bottom Shell West Side E-W	Intact, no corrosion
35	NA	0.387	0.400	0.396		0.000	External Condition: Painted surface, No corrosion or pitting found. Internal Condition: No erosion, corrosion or pitting found.	Horizontal Bottom Shell West Side E-W	Intact, no corrosion
40	NA	1.057	1.092	1.077		0.000	External Condition: Painted surface, No corrosion or pitting found. Internal Condition: Manufactured wall loss and/or erosion, with No corrosion or pitting noted.	Vertical West Bottom Head T-B	Intact, no corrosion
45	0.237	0.210	0.229	0.218		0.027	External Condition: Painted surface, No corrosion or pitting found. Internal Condition: Manufactured wall loss and/or erosion, with No corrosion or pitting noted.	4" Outlet Elbow T-B	No corrosion, Some erosion

50	0.237	0.219	0.232	0.225		0.018	External Condition: Painted surface, No corrosion or pitting found. Internal Condition: Manufactured wall loss and/or erosion, with No corrosion or pitting noted.	4" Outlet Elbow T-B	Intact, no corrosion
						Loss of 10% - 20%		Loss of 21% or Greater	
						AREAS OF CONCERN			
*T-min (thickness minimum) was not provided prior to inspection.						PAGE 3 OF 3

3 yr interval, request a U1A from ABSA to confirm nominal thickness.
