VESSEL INSPECTION SUMMARY

CA1246-VIS-46
Date: 06-Mar-18
Page 1 of 8
IRISNDT #: CGE1700097

A visual external installation inspection was performed on A0451115 Horizontal Treator at the Secure Energy Chamberlain CHFST plant site to aid in an integrity assessment, and to help determine the suitability for service. The results are as follows:

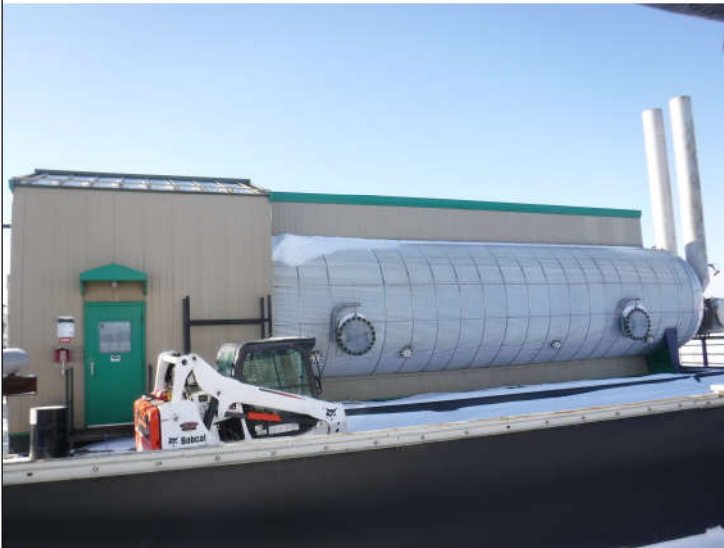
-The Treator is in service but currently shut down, it is partially located inside a building, the west head and north shell protrude through the building walls, it is insulated, horizontal in orientation and supported by saddles anchored to a skid welded to pilings.

01-A0451115 Horizontal Treater

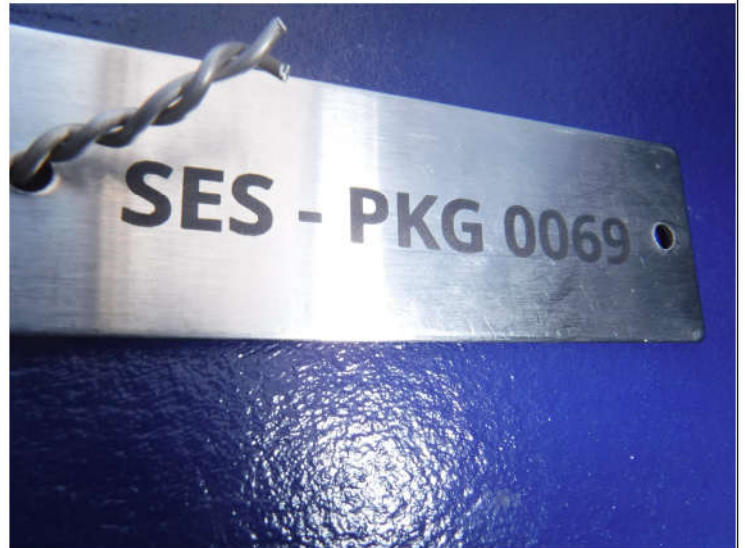
-The data plate is secure and legible and the A# stamping was located on the Data Plate; Tag # SES-PKG-0069 was attached to the west door with a 16 gauge wire.

02-Building Tag attached

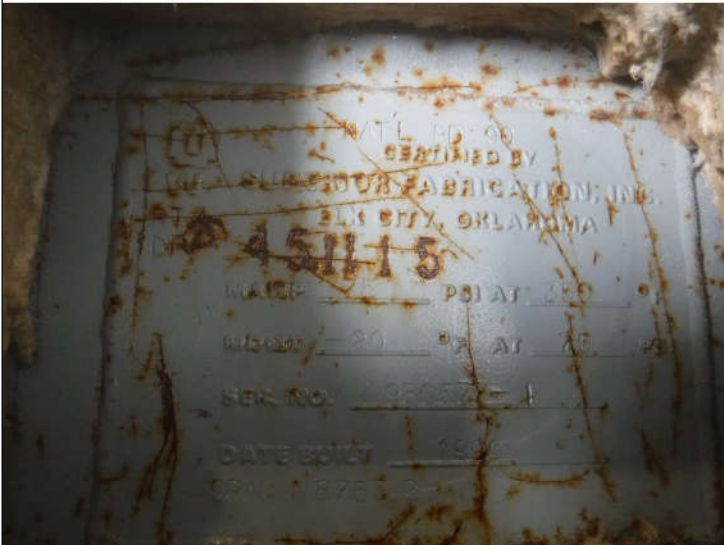
The data plate is legible and firmly attached but contained limited information. The A# stamping is located on the Data Plate.

03-A0451115 Horizontal Treater Data Plate

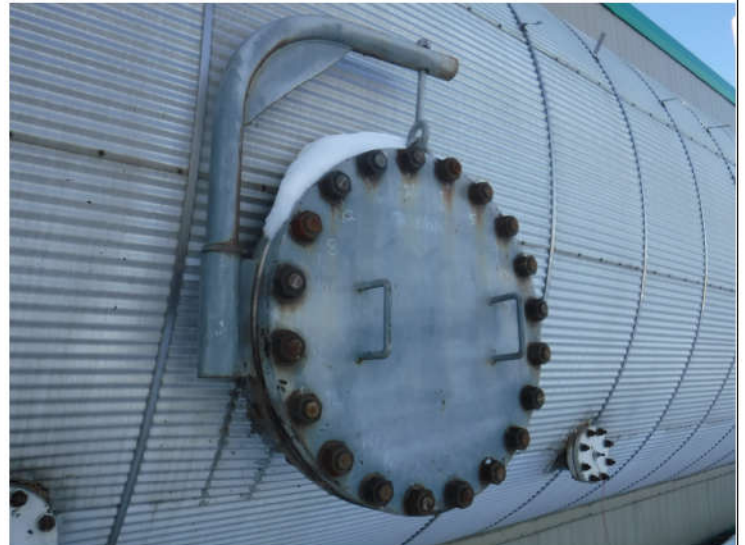
-Paint deterioration and corrosion was found on the exposed/uninsulated areas of the shell, heads, piping, flanges, nozzles, manways, nuts, bolts and supports. The more significant corrosion was located on the bottom nozzles, nuts and bolts (buffing required to determine severity).

04-Corrosion on manway, nuts and bolts, no depth

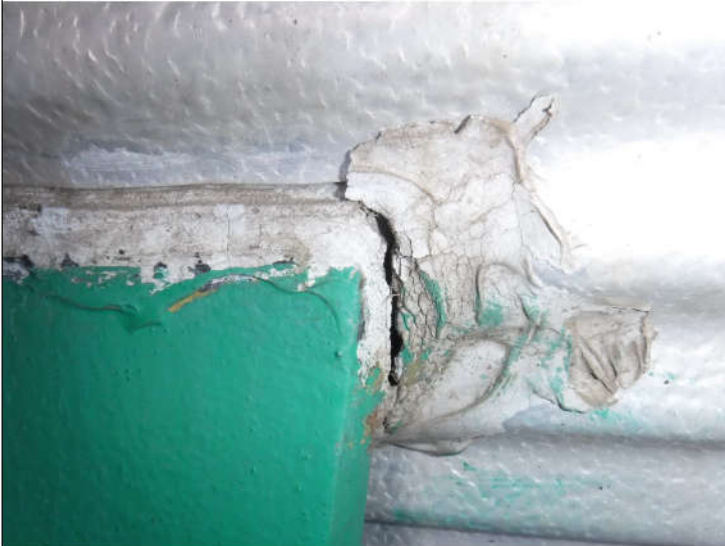
-Sealant deterioration, missing sealant, missing insulation, and/or insulation damage was found on the shell and heads, attached piping, around cladding penetrating points, and at the building wall interfaces, allowing environmental ingress. Biological growth observed in the west bottom head inspection port indicative of environmental ingress.

05-Typical sealant deterioration around penetrating points

- Double nut the west saddle support loose to allow for expansion and contraction.
- Determine if the PSV is overdue for servicing.
- Ensure the burner piping is supported correctly, aligned, level, secure and not making contact with the adjacent burner piping.
- Install/repair the sealant and insulation as required to prevent future environmental ingress.
- Monitor the corrosion for future growth.
- Inspection the site, foundation and grounding once the snow melts.

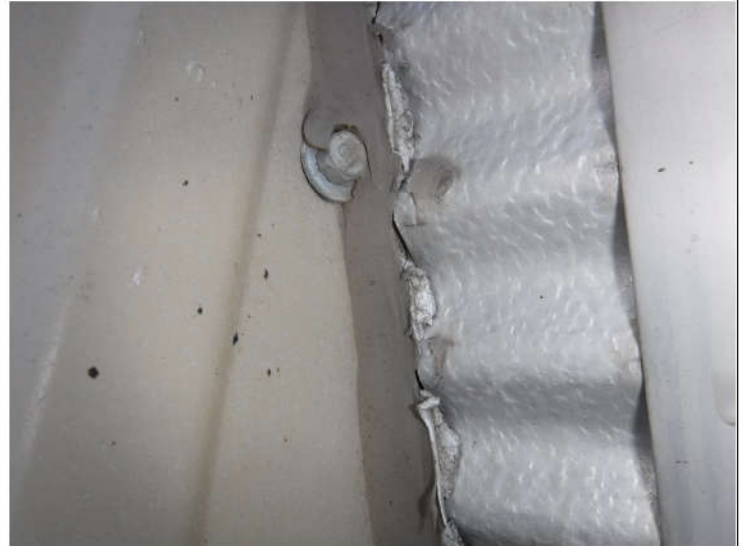
06-Typical sealant deterioration at building interfaces

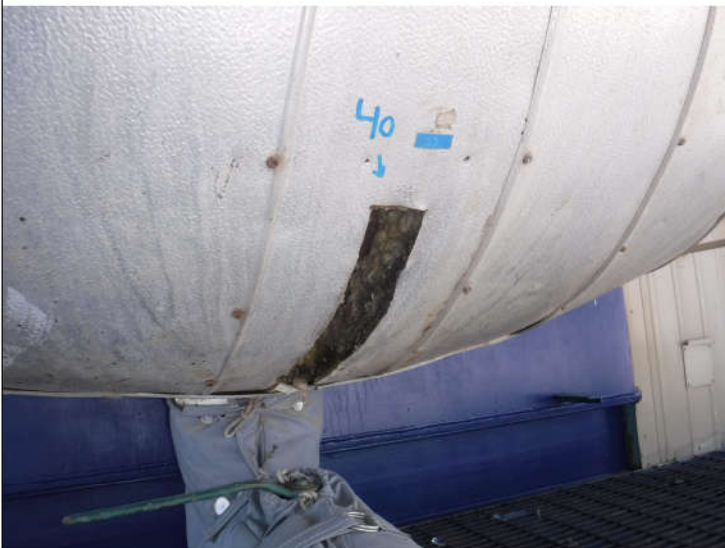
07-Missing insulation covers

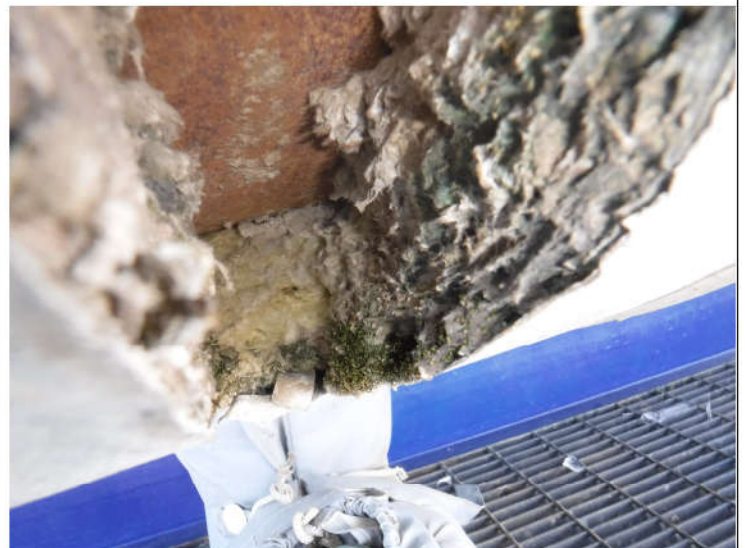
08-Surface corrosion on head and biological growth

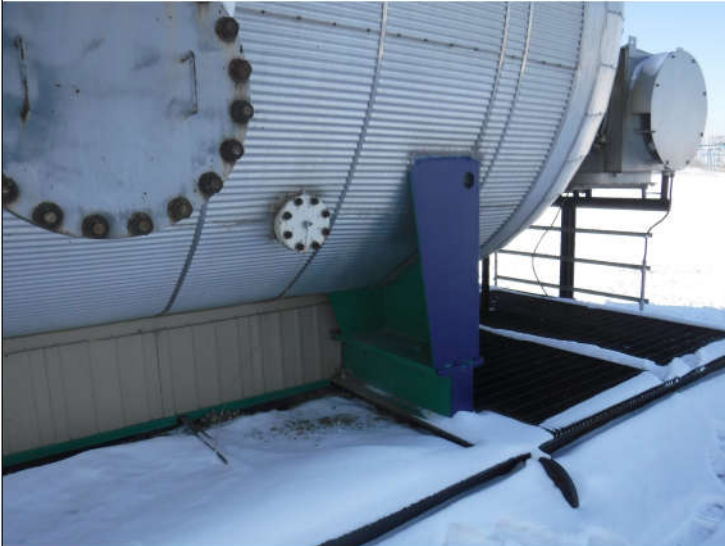
-The west sliding saddle end is single nutted securely with lock washers. It is recommended to double nut the anchor bolts on the sliding saddle end loose with washers to allow for expansion and contraction. The treator appears to be aligned level and secure.

09-The sliding saddle end is bolted securely

Regulatory VE Inspection
Action Items #1 - Correct saddle bolting to allow for expansion.

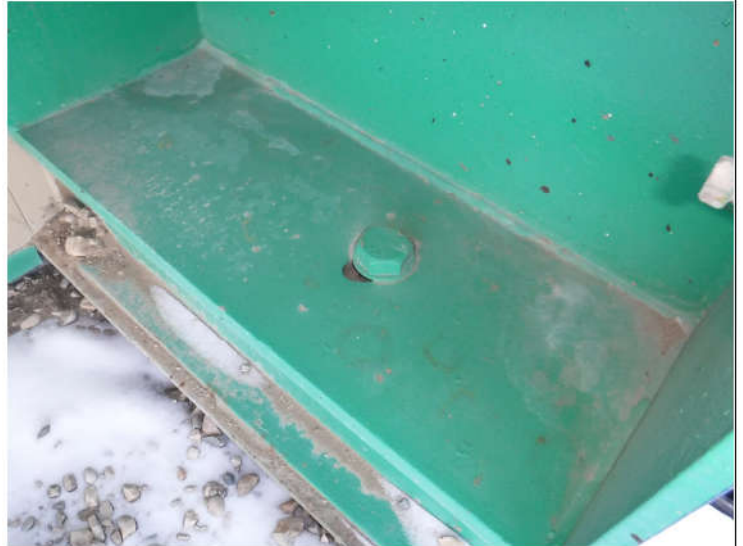
10-The sliding saddle end is bolted securely

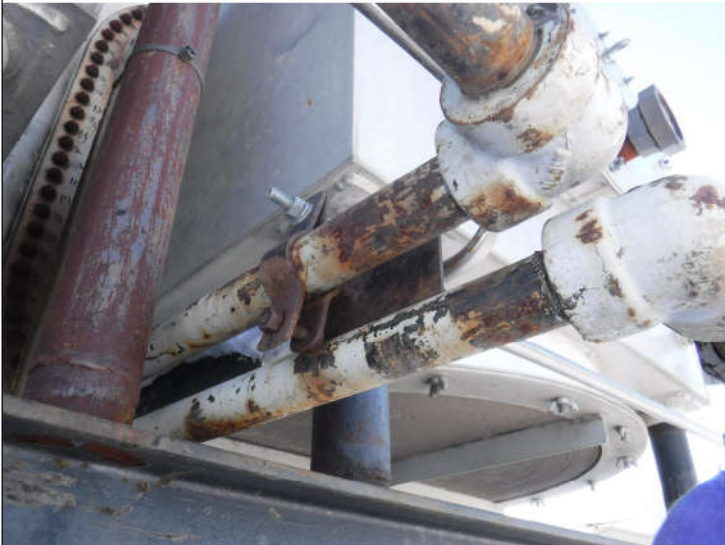
-There is no medium between the bolt-on supports and the O.D. of the piping, and the burner inlet pipe supports are loose, no medium and the supports are contacting the adjacent piping. The associated piping appears to be aligned and level, and full engagement was found on all exposed bolting.

11-Loose support in contact with adjacent burner pipe

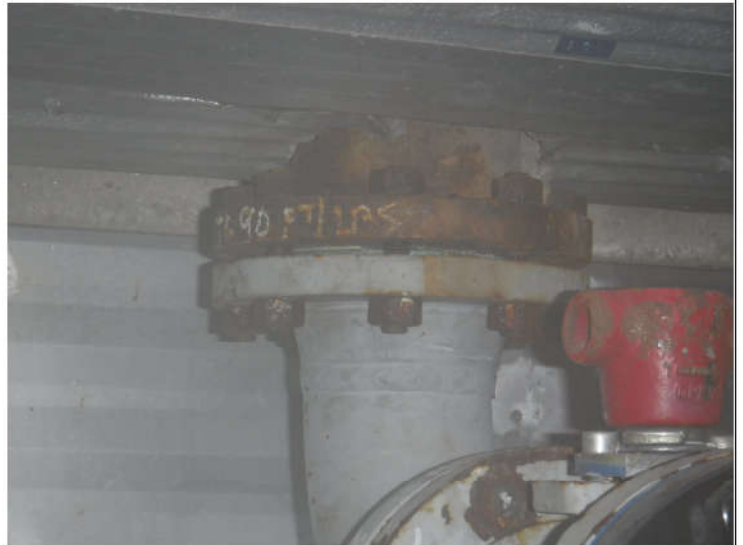
12-Significant corrosion on bottom nozzles, nuts and bolts

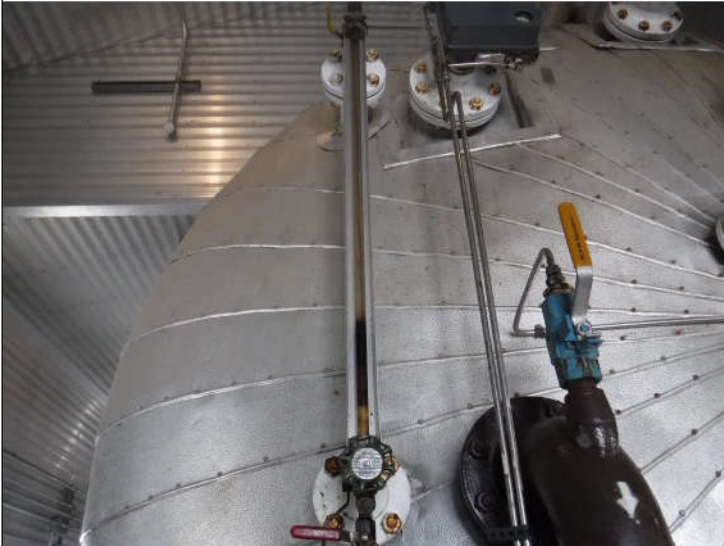
-The liquid level gauge is not clear but remains legible. The associated pressure gauges are free of visible defects, clear and legible.

13-Level gauge is not clear but legible

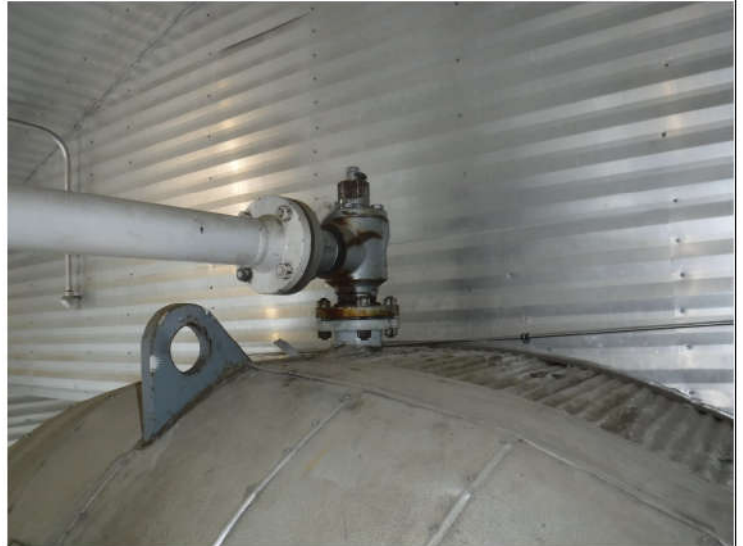
The PSV data plate, service tag and equipment tag are legible and secure.
The PSV appears to be secure, supported and set the same as the MAWP of the equipment it protects.
Tag # SES-PSV-0213 was attached with A 16 gauge wire.

14-PSV located on the top east shell
