Pressure Vessel Assessment Report

Project Information		
Client: RARE Oilfield	Location: Nisku, AB	Date: 1/23/2021
Contact: Rob Gryba	API Inspector: Skye Bowman	
Rare Project#: 44750	SL Project#: 1005	
Vessel Description:	10' O.D x 40' S/S 75 Psi Horizontal Heated Treater	
Vessel Identification:	A-451115 / SN. 980577-1 / CRN. N8753.2

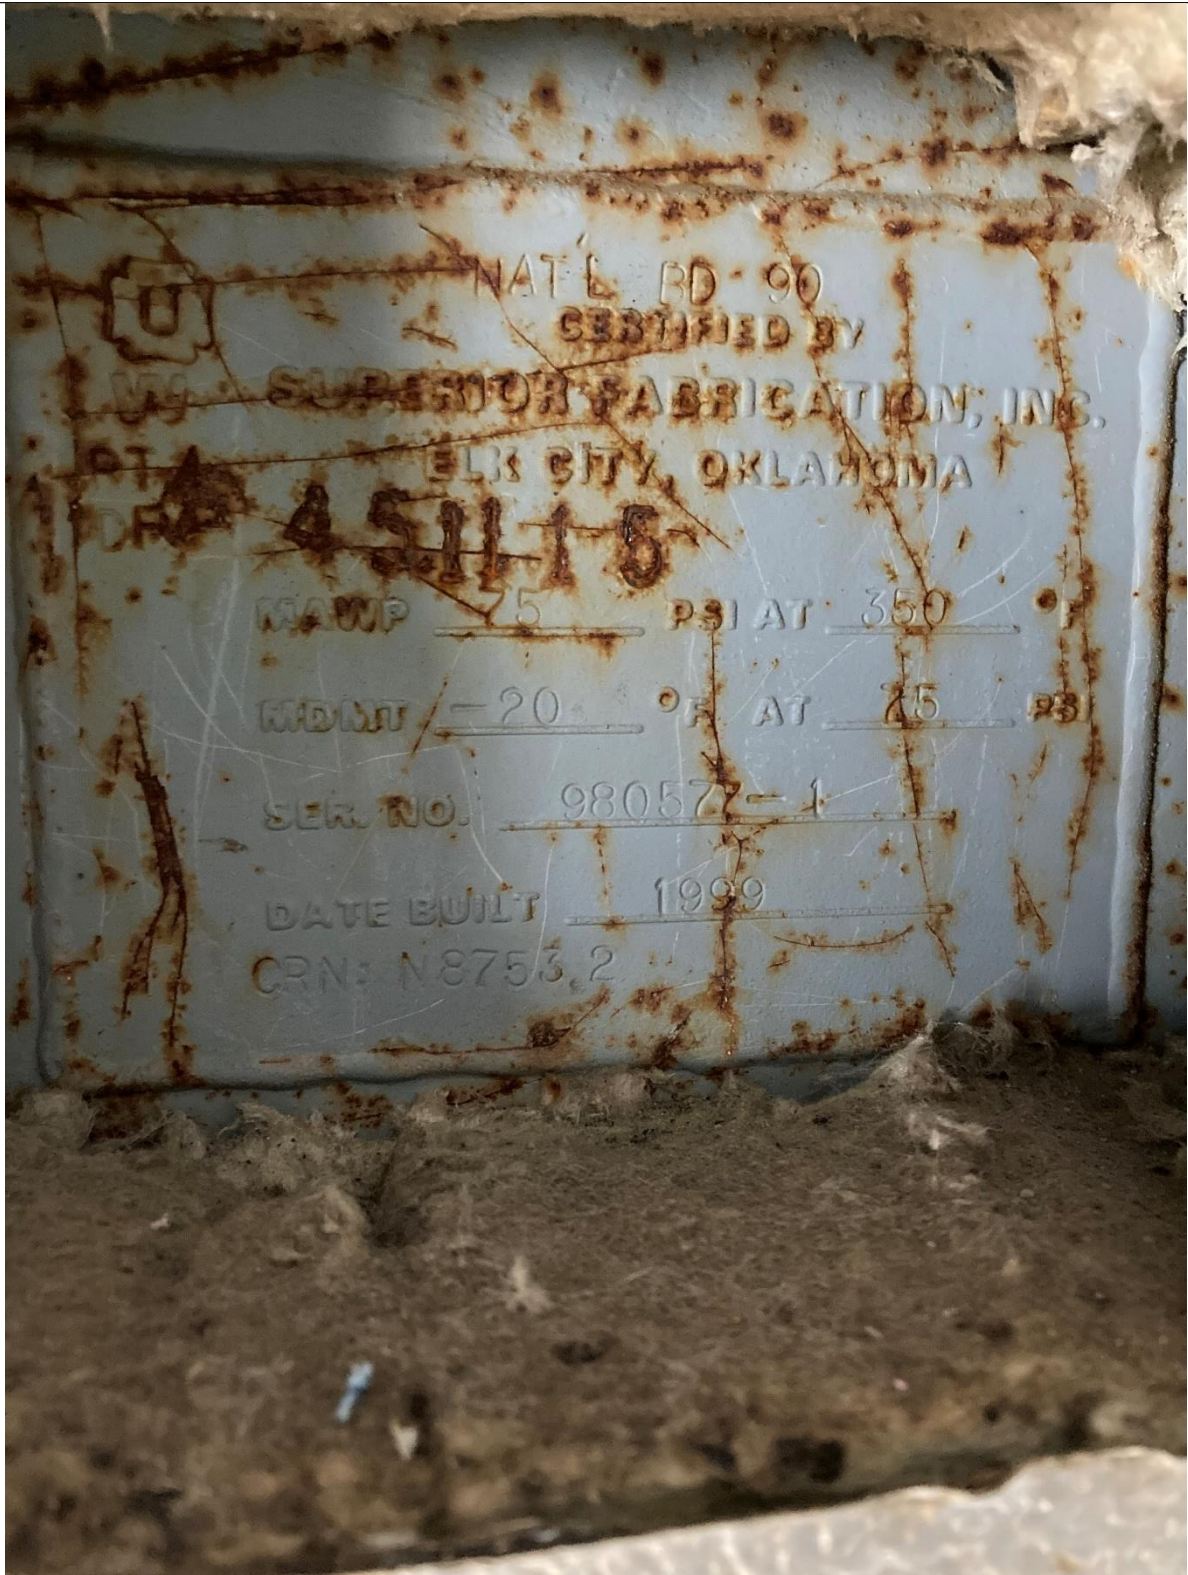
The data plate was intact and legible.

Data Plate Picture
Page 7 of 11

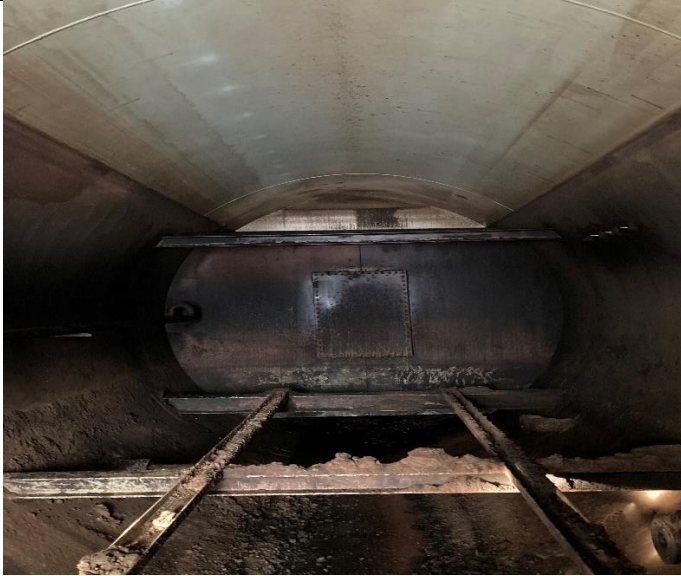
Firetube end picture of internal Weir

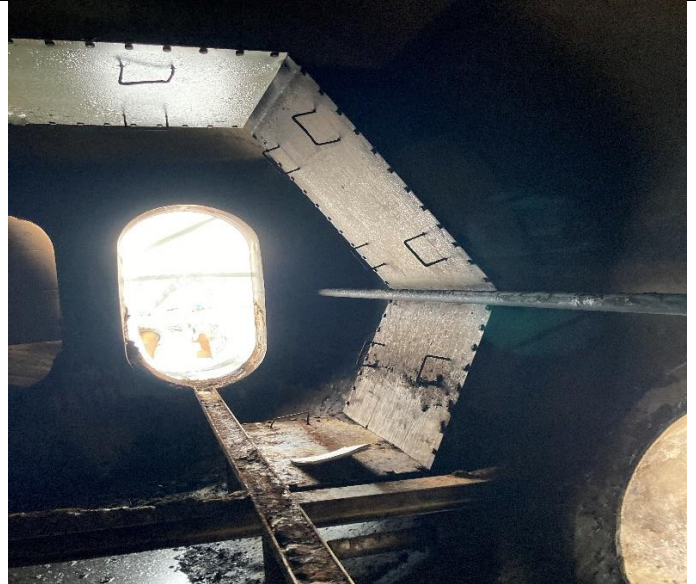
Inlet diverter prior to cleaning

Inlet diverter to be removed during cleaning and inspected (visually and coating inspecting on vessel shell) to ensure no defects and proper clearance. Internal Weir has coalescing pack attached and appeared plugged at time of inspection and requires to be cleaned thoroughly in place or removed and cleaned to ensure proper communication between the two sections of the vessel. Oil box removable to be removed and clean internally and inspection completed prior to reassembling.

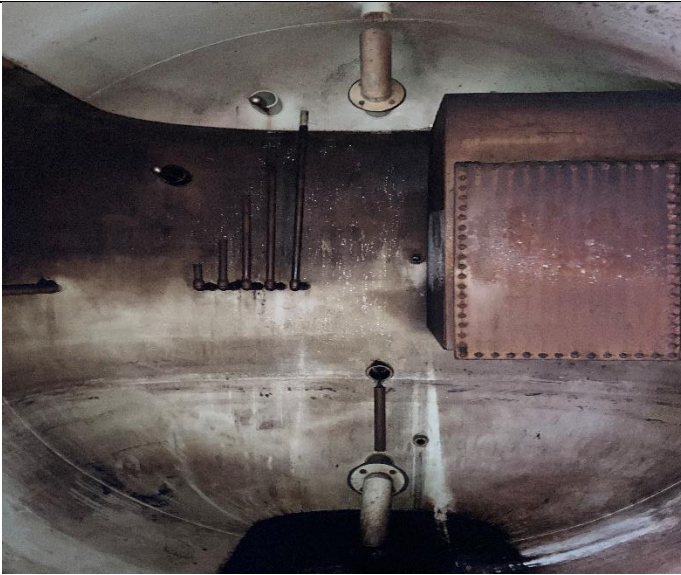
Oil end internal picture of oil box and
sample connections

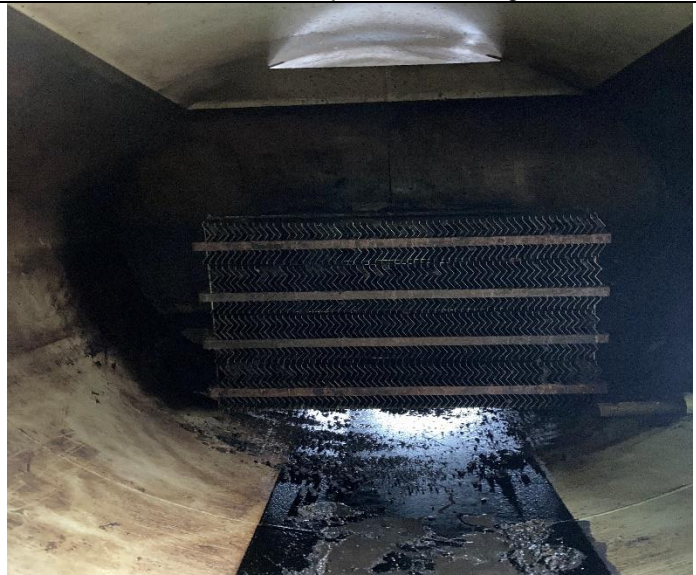
Weir and Coalescing pack prior to
cleaning

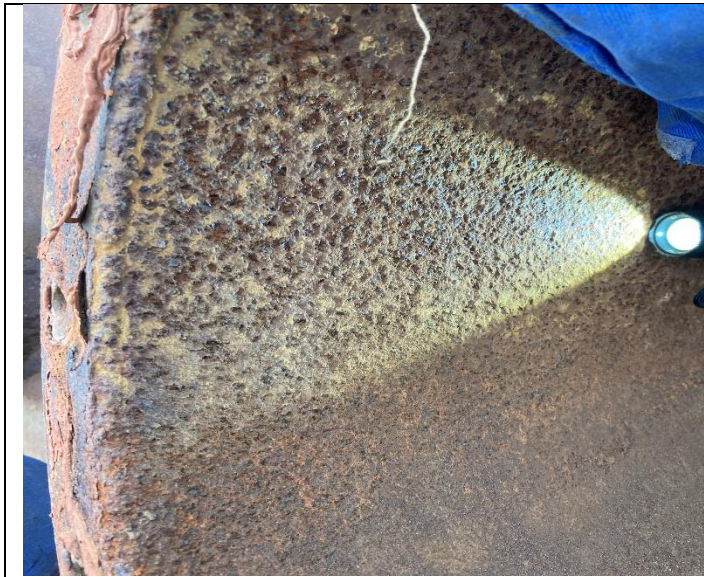
The Firetubes require blast and mag particle inspection to be completed on existing welds. Minor pitting was found inside the stack side of the tubes do to atmosphere contaminants. UT inspection to be completed to determine thickness of existing material.

Top tube of Firetube corrosion due to rain and contaminants through stack

Firetubes need special attention and care to confirm they are in good working order with no defects present and/or future potential damages that may occur due to existing issues/damages. Install rain caps on stacks to prevent future contaminants to enter Firetubes while in service.

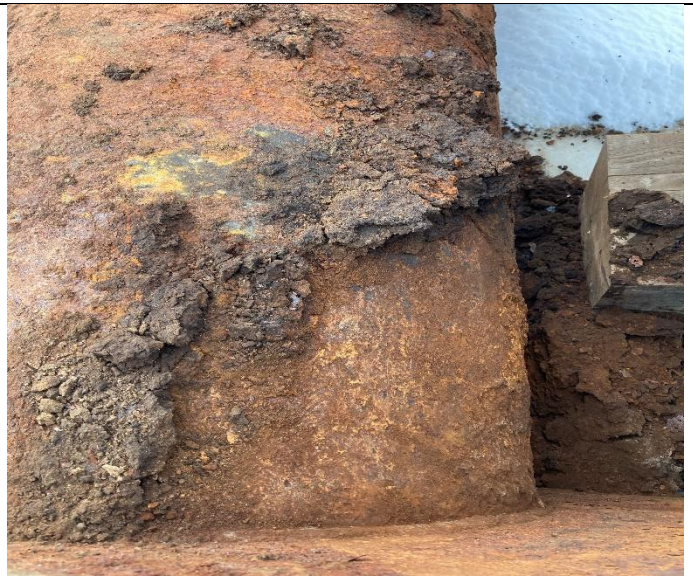
Pitting was located on fire tubes where they penetrate into the vessel and require sandblast for further inspection. Based on these findings, special attention should be taken in these areas and may require repairs. Firetubes require meg particle inspection on plate and miter welds to ensure no cracks or defects are present and UT to verify thickness.

External corrosion on Firetubes due to oil and sand build up

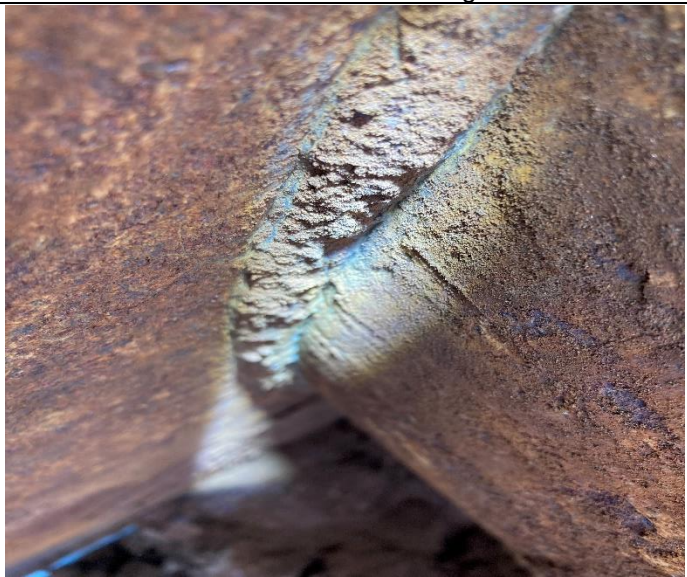
External corrosion on plate to tube weld due to oil and sand build up

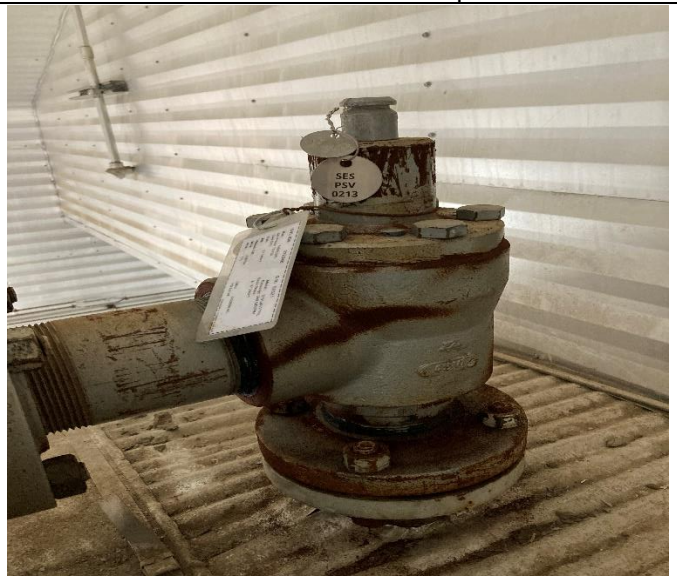
Vessel PSV looked in good condition and was hooked up to piping at time of inspection.

Vessel PSV installed on Nozzle N10

PSV to be re-certified and shipped lose upright properly secured to shipping platform/pallet.

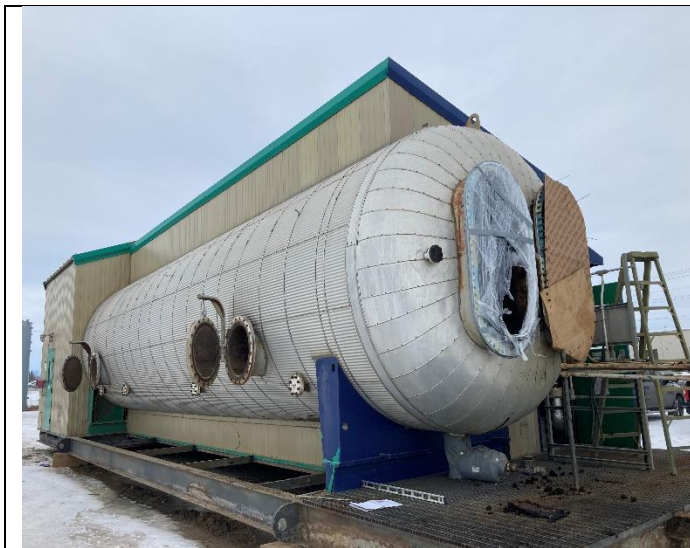
Vessel side picture

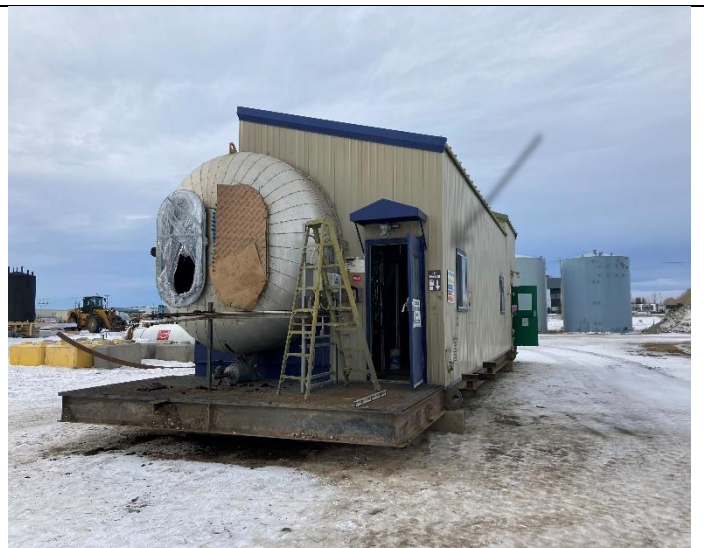
Package/building side picture

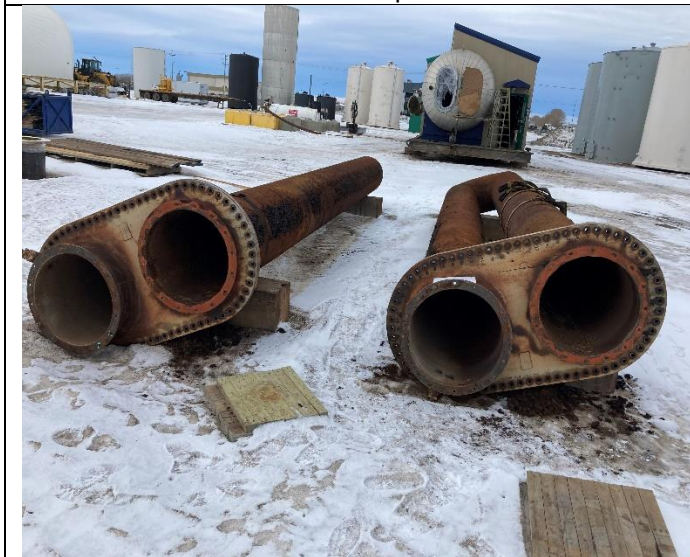
Overall picture of Firetubes

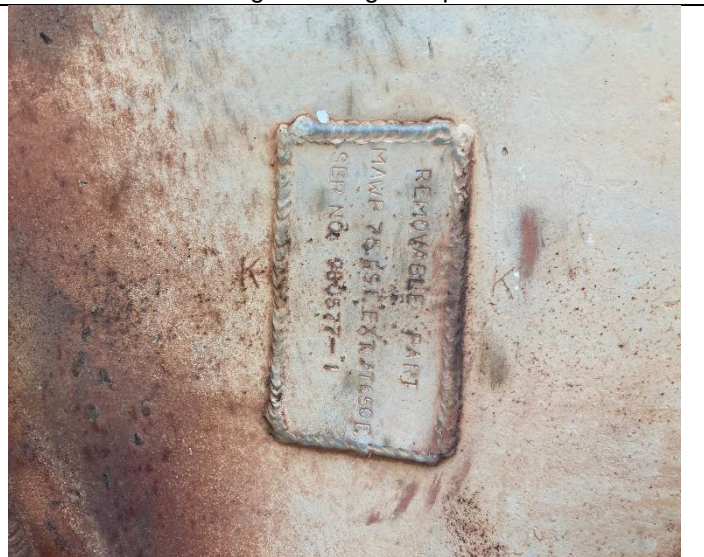
Firetube identification tag picture
