## Field Inspection Report

Client	CNRL			Date of Inspection	July 12, 2011			
Prov. Reg.#	A2864617			Inspection Type	VE, UT			
Equipment	Test Separator			Location	Taber Battery			
Tag/Equip. #	V 100			LSD	06-24-010-17W4M			
Vessel Status	NOT In Service			Comp./Unit #				
Manufacturer	West Fab Industries Limited.			MAWP / Temp	285 PSIG @ 100 F			
Serial #	WF 93245	CRN #	M 0788.2	MDMT@ Pressure	-20 F @ 285 PSIG			
Corrosion Allowance		Shell Material	SA516-70	Shell Thickness	0.500"			
Year Built	1993	Head Material	SA516-70	Head Thickness	0.500"			
Diameter	48" OD	Length		Height	RT	RT-3	HT	
Service	Sour	Next Inspection		Next Insp. Type				
ASME Stamp	No	Next Inspection		Next Insp. Type				
PSV Tag #		CRN#		Set Pressure				
Manufacturer				NB#		ASME Stamp		
Type/Model		Serial #		Inlet Size				
Capacity		Service Company		Outlet Size				
Service Date				Next Service Date				
Valve Location	On Vessel On Piping Vents to Flare Vents to Atmosphere	Valve Connection	Threaded Flanged Welded	ABSA CODE TYPE

**General Comment's: Test Separator was found to be in good general condition. Vessel was NOT in service at time of inspection.**

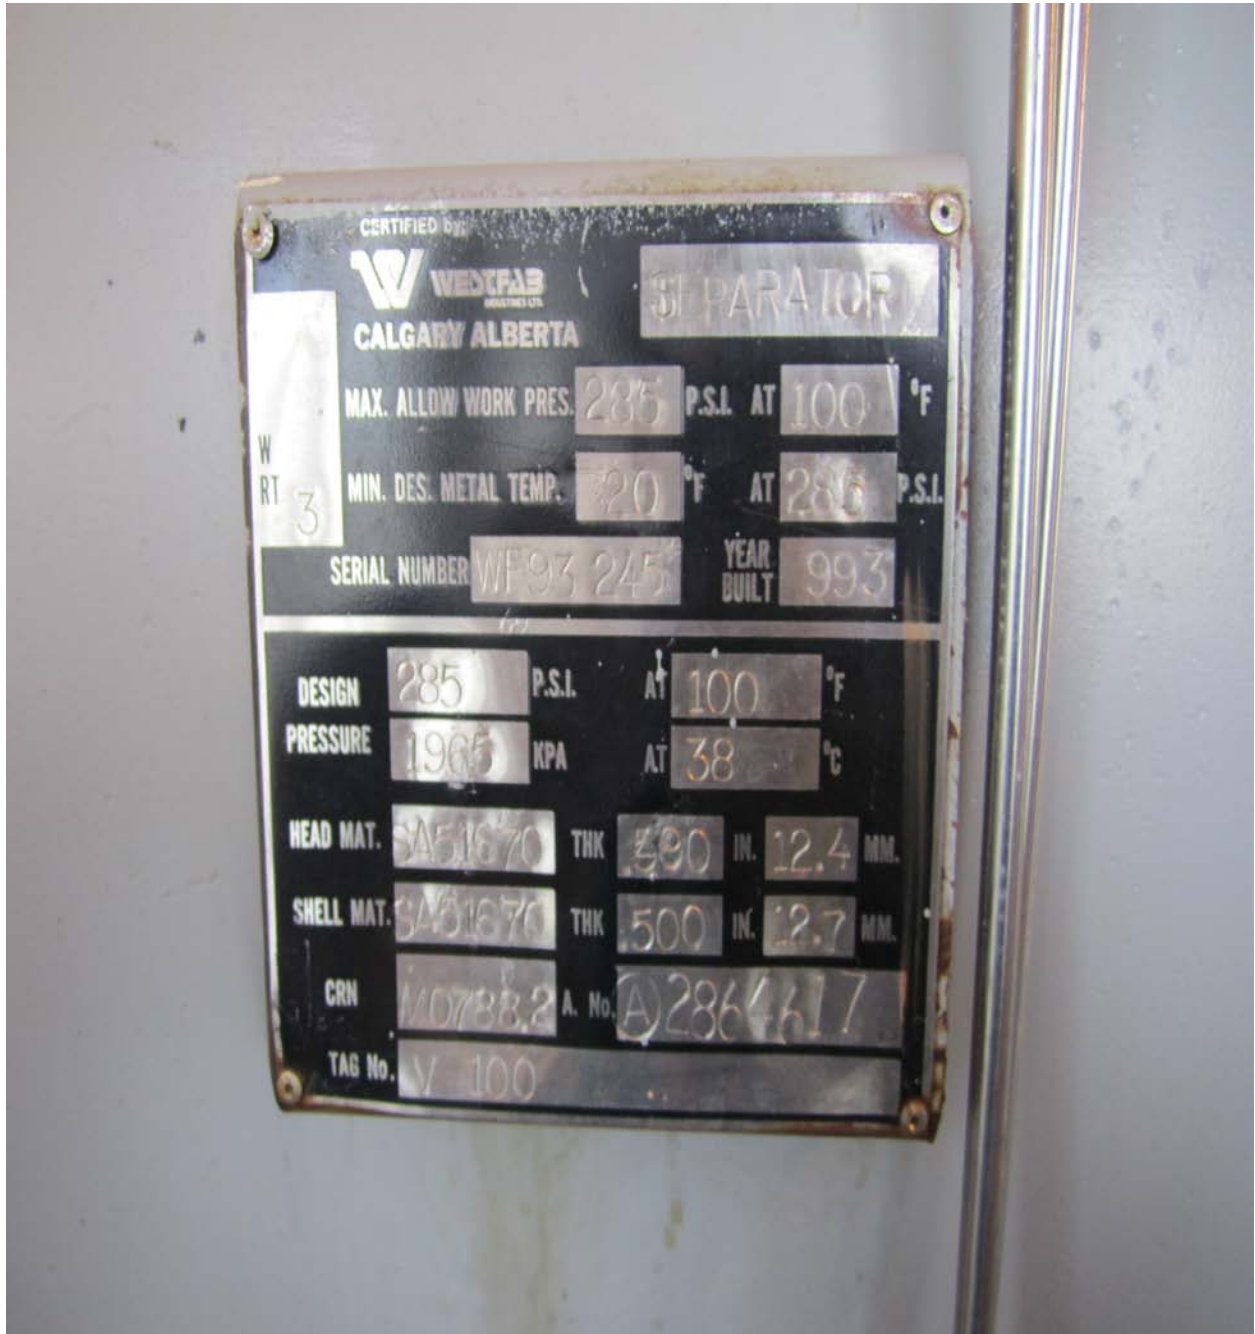
A2864617\_Name plate\_16July2011

- Name plate was intact and readable.
- Paint was in good condition with no external corrosion or erosion.
- External insulation was in good shape.
- Wall to shell interface seal was in good shape with no signs of corrosion.

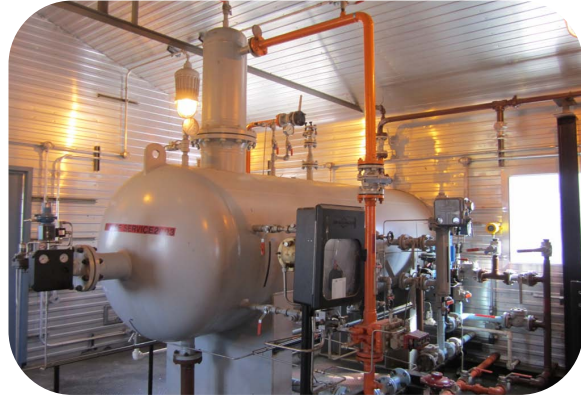
A2864617\_Side view\_16July2011

- Vessel is supported on saddles; shell to saddle welds were in good shape.
- Saddles were bolted securely to the floor.
- All external nozzles were in good condition, no leaking flanges, gaskets, or threaded connections.

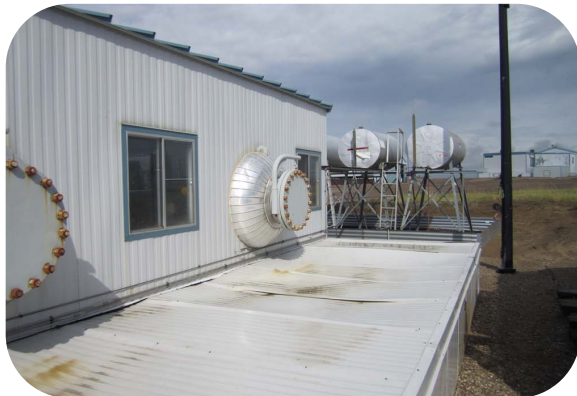
A2864617\_North head, Manway and Davit Arm\_16July2011

- Temperature and Pressure gauges were in good shape.
- North manway bolting was all in place and secure, davit arm was in good working order.
- No deflection or deformation was found on the heads, shell or nozzles.
