Field Inspection Report

Client	CNRL			Date of Inspection	July 12, 2011			
Prov. Reg.#	A2864631			Inspection Type	VE, UT			
Equipment	Test Separator			Location	Taber Battery			
Tag/Equip. #	V 110			LSD	06-24-010-17W4M			
Vessel Status	NOT In Service			Comp./Unit #				
Manufacturer	West Fab Industries Limited.			MAWP / Temp	285 PSIG @ 100 F			
Serial #	WF 93246	CRN #	M 0788.2	MDMT@ Pressure	-20 F @ 285 PSIG			
Corrosion Allowance		Shell Material	SA516-70	Shell Thickness	0.500"			
Year Built	1993	Head Material	SA516-70	Head Thickness	0.490"			
Diameter	48" OD	Length		Height	RT	RT-3	HT	
Service	Sour	Next Inspection		Next Insp. Type				
ASME Stamp	No	Next Inspection		Next Insp. Type				
PSV Tag #		CRN#		Set Pressure				
Manufacturer				NB#		ASME Stamp		
Type/Model		Serial #		Inlet Size				
Capacity		Service Company		Outlet Size				
Service Date				Next Service Date				
Valve Location	On Vessel On Piping Vents to Flare Vents to Atmosphere	Valve Connection	Threaded Flanged Welded	ABSA CODE TYPE

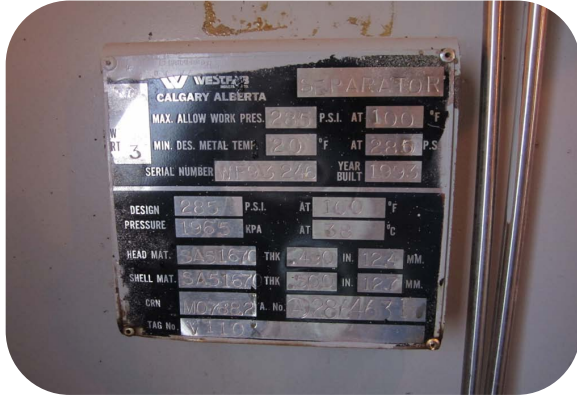
A2864631_Name plate_16July2011

- Name plate was intact and readable.
- Paint was in good condition with no external corrosion or erosion.
- External insulation was in good shape.
- Wall to shell interface seal was in good shape with no signs of corrosion.

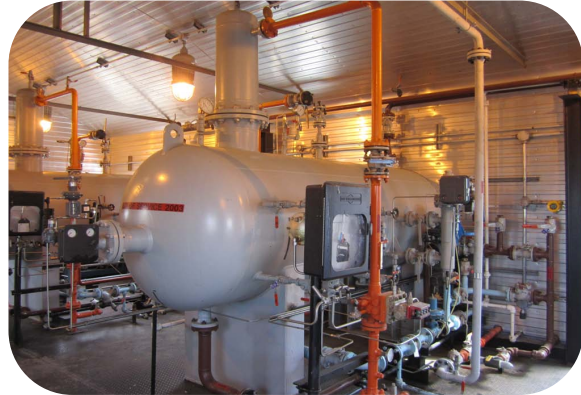
A2864631_Side view_16July2011

- Vessel is supported on saddles; shell to saddle welds were in good shape.
- Saddles were bolted securely to the floor.
- All external nozzles were in good condition, no leaking flanges, gaskets, or threaded connections.

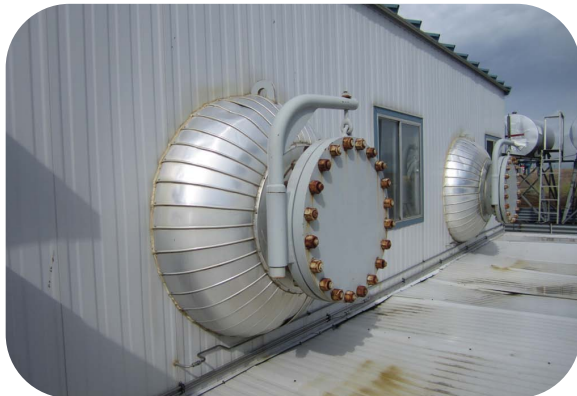
A2864631_North head, Manway and Davit Arm_16July2011

- Temperature and Pressure gauges were in good shape.
- North manway bolting was all in place and secure, davit arm was in good working order.
- No deflection or deformation was found on the heads, shell or nozzles.
