**Canadian Natural Resources Limited
GENERAL PRESSURE VESSEL INFORMATION**

Job# 10.111395

District: Fort St. John North	Skid No.
Facility: Umbach Compressor	Location (LSD): c-37-F/94-H-03
Vessel Name Equipment Number: Inlet Separator	
Orientation: Horizontal	
Status: In Service	Regulatory Inspection

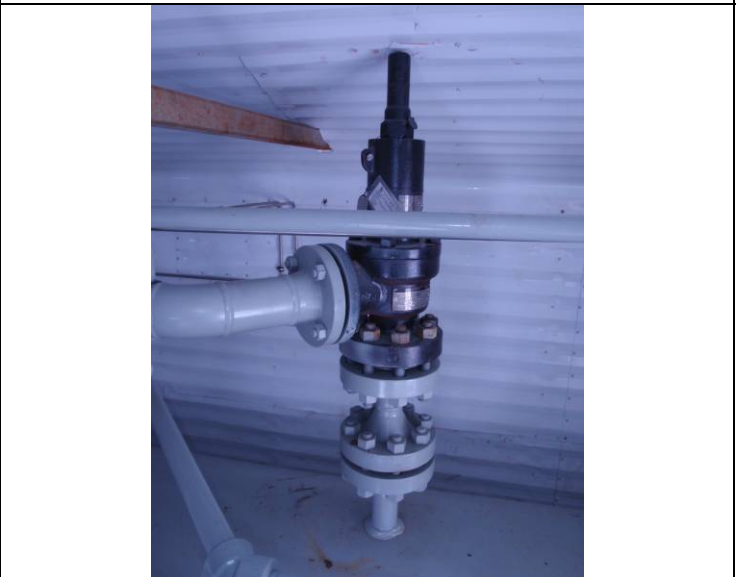
Valving Ensure no leaks are visible. Valves are properly supported and chained if necessary.	X				No leaks are visible. Valves are properly supported.
PSV Ensure PSV is set at pressure at or below that of vessel.	X				Located on upper shell – set below the vessel MAWP - No block valve present - Seal is intact - PSV vents to closed header.
NDE methods Was UT/ MPI done on vessel (MI coordinator to review results)	X				Ultrasonic corrosion survey carried out – pipe metal thickness detected below nominal minus corrosion allowance. Thickness calculations carried out: UT point 205 (8” Elbow) – nominal thickness is 18.3mm / min thickness is 15.8mm / T min thickness is 11.5mm.
<p>Recommendations or corrective actions : Vessel is Fit for Service or describe corrective actions required) (MIC to review corrective actions with Operations, discuss with Chief Inspector where necessary, and get remedial action implemented)</p> <p>Recommendations:</p> <p>Summary: This vessel is in good over all condition, visual external and ultrasonic thickness survey carried out-pipe metal thickness detected below nominal minus corrosion allowance. Thickness calculations carried out to ensure sufficient metal exists for safe operation.</p> <p>Long term corrosion rate based on greatest thickness loss – no corrosion rate to assess.</p> <p>Vessel is fit for service.</p>
